**Local Neighborhood**

**Humble, TX**

**November 2009**

**Mr. and Mrs. Typical home**

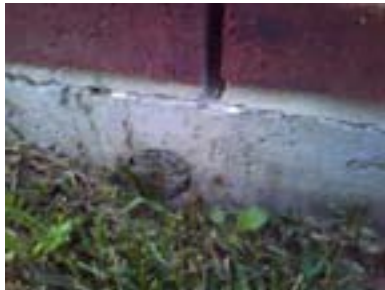
⌋ Post tension live end tips are exposed and should be covered;just starting to break through on kitchen corner,however all must be covered on front east side,

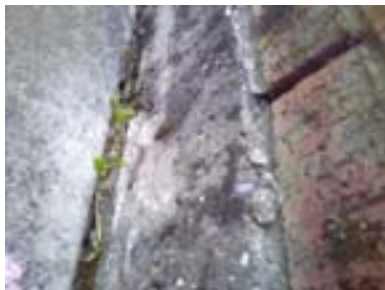
⌋ Nails or metal is exposed which could be a hazard and could be removed and covered;behind ac unit,

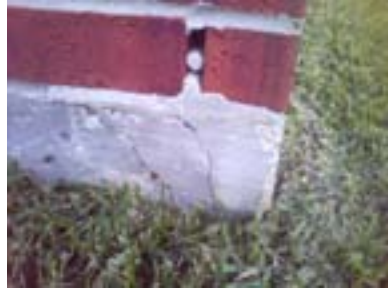
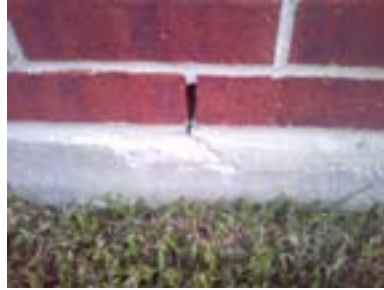
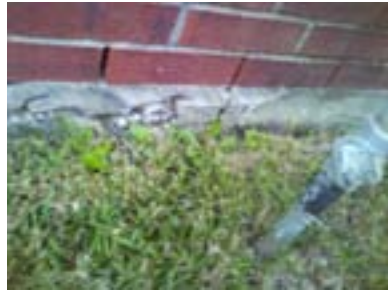
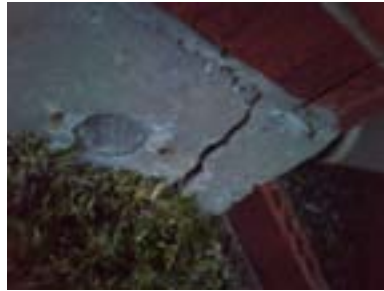
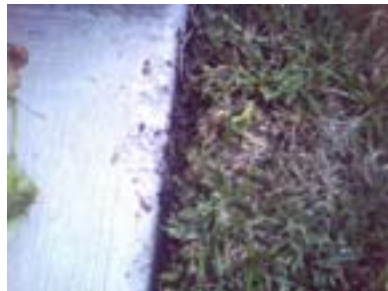
⌋ Observed typical spalling (crumbling of slab) or honey combing which is very common. This can be epoxied or touched up and usually happens around the corner/edges of the slab because the stress will break the slab and on back patio to name some.

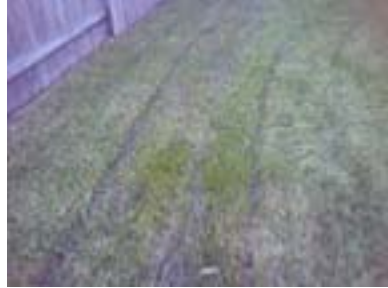
⌋ Erosion or ponding next to foundation/driveway or in yard;west side of yard which gutters or a drain system would help,

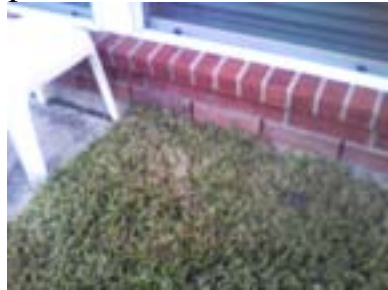
⌋ Inadequate grading clearance (high soil) to exterior wall surface;little high in back at only 1 location,

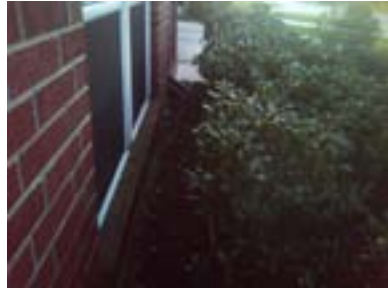
⌋ French drain system that should be monitored for leaks so that water does not seep into the ground and work under the slab;should be free flowing at ends and not blocked;

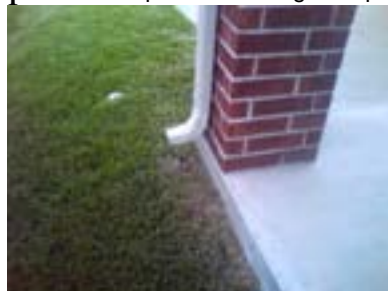
⌋ Downspout is missing the splash blocks at several locations causing water to sit against the house;

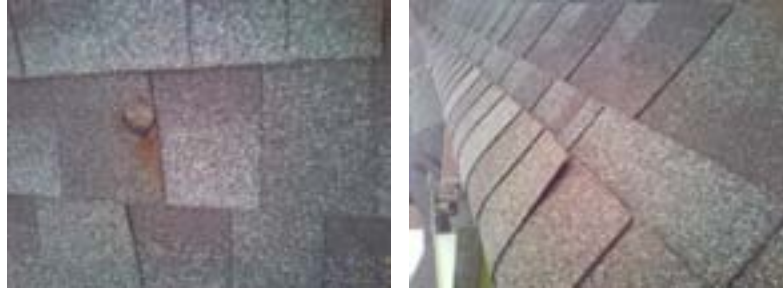
⌋ Some damaged,missing or raised shingles;firework damage on front,some lifted on west side most noticed and a few raised on front ridge.

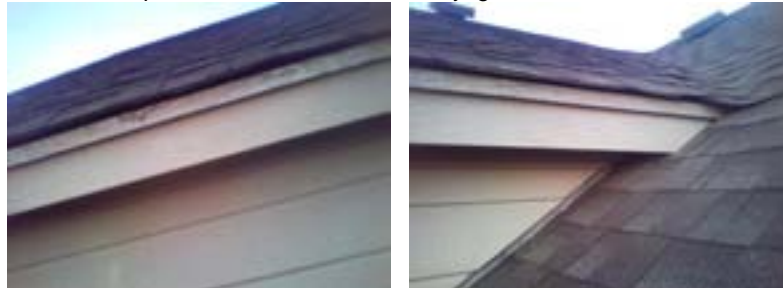
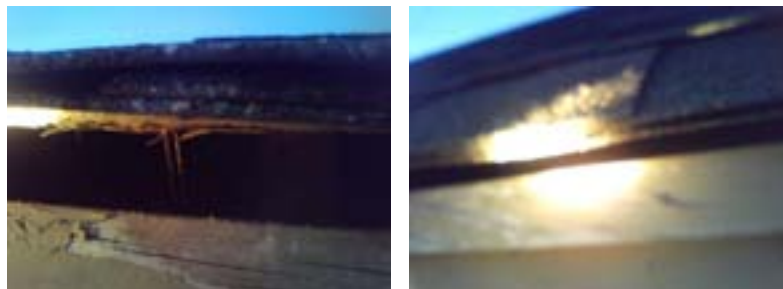
⌋ Roof decking deflection and/or sagging;the back west edge was lifted most likely from storm damage and should be repaired. and can also view daylight from attic area,

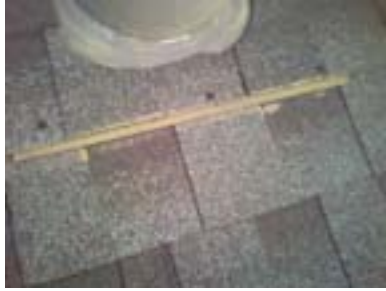
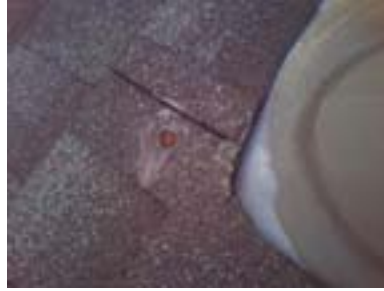
⌋ Observed some exposed nails and/or staples showing that should be covered or caulked as part of routine maintenance;on most extensions,

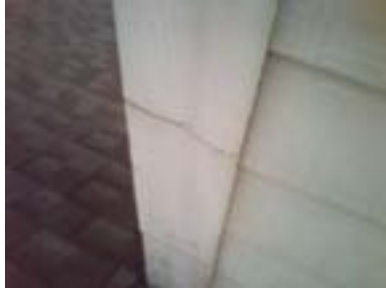
b Trim, soffit, fascia boards are in need of repair;cracked on chimney,around lifted area.

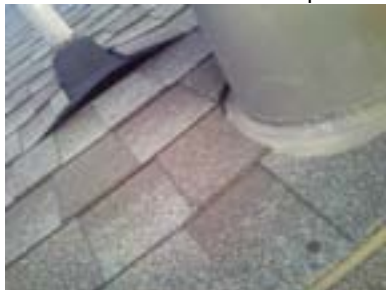
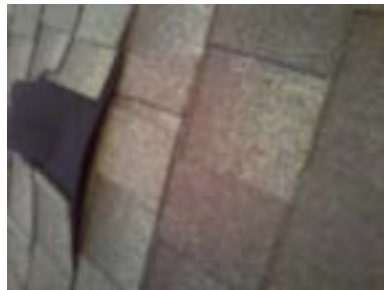
b Roof penetration(s) or flashing not properly secure, flashed/sealed; several roof jacks have been lifted on west side and must be repaired.

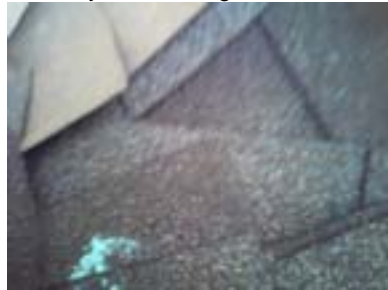
⌋ Valley/step or counter flashing in need of repair or replacement;this roof does not have a metal drip edge and only a wood edge,must secure all raised flashing,

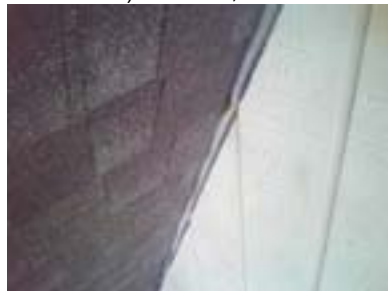
⌋ Missing step flashing (about 8 inch sheets) where a roof intersects at exterior wall which is the type approved per most manufactures and/or J-flashing (long continuous sheet, which if water enters could run continuous) is in use;

⌋ The roof covering is in need of repairs, a Certified Roofing Company should be consulted

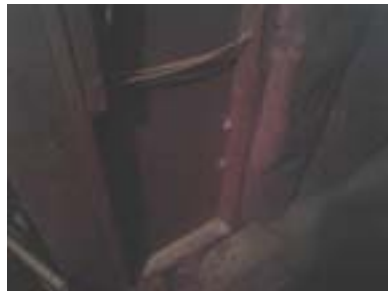
Ⓟ Noticed an area that should have insulation added or extra layers throughout;vertical wall has some areas that have fallen,

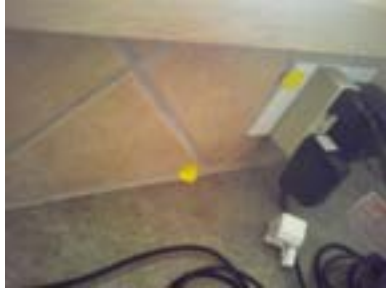
Ⓟ Caulking/sealant is separated or missing in some areas;around kitchen counter and backsplash,

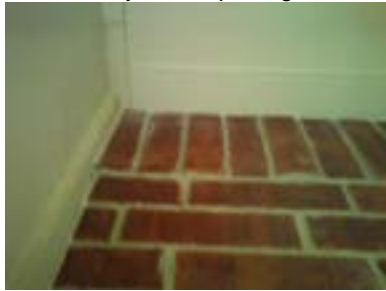
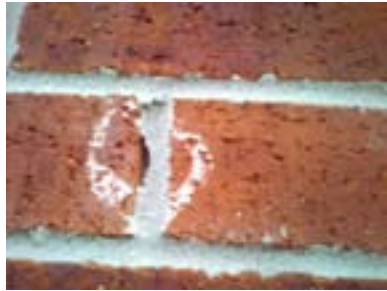
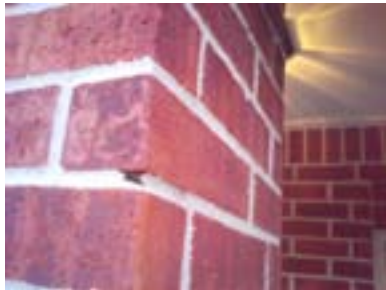
- .. Fascia/trim boards are damaged at several areas;
- ⌋ Mortar is separated or missing in some areas;between some bricks at corners,under west patio,and east window,only a few openings noticed.

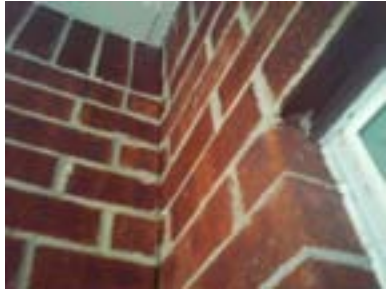
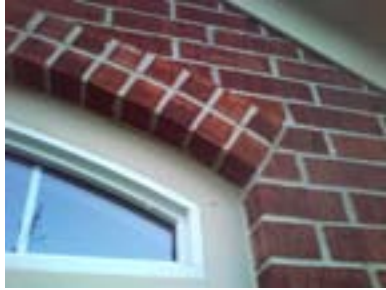
between the wall and trim work and at brick intersections, some windows, picture in front.

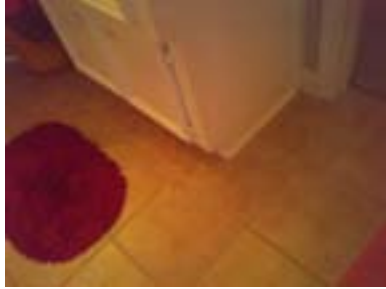
⌋ Observed tiles that sounded hollow when tapped with a hard object which is a result of lack of adhesive spread evenly underneath tile, loose tile, air pockets or water has penetrated underneath the tile. Discovered 3 or more in master bathroom and a couple in hall bath.
