New Builder Community

Humble, TX

June 29, 2010

This Limited, Visual Inspection Report is prepared exclusively for

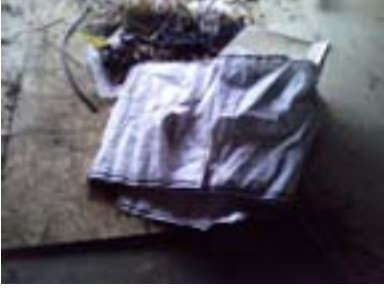
⌋ Approved plans and specifications cannot be verified on site;only partial in trash pile;torn and tattered.

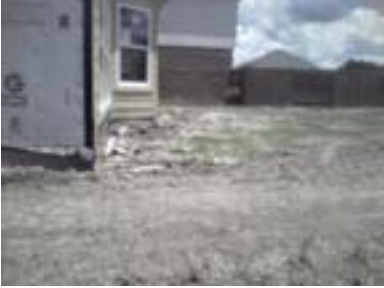
⌋ Improper drainage from foundation and not a decline at all locations away from slab and/or a 6 inch decline at 10 feet away or less than a 5% slope to swale when barrier prevents 6in/10ft;back yard grading will need adjusting;

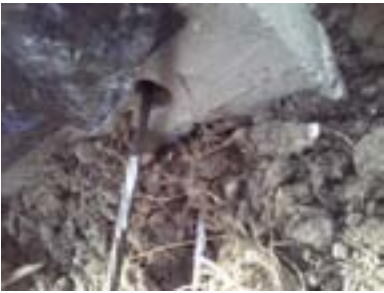
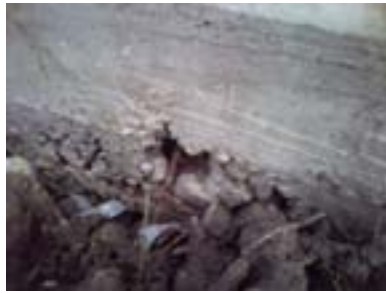
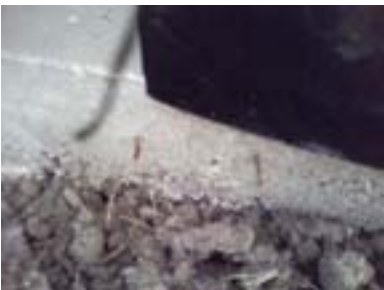
⌋ Post tension ends should be clipped and sealed along with pocket and all nails around and should be clipped and patched in front along with honey combing before driveway is poured;

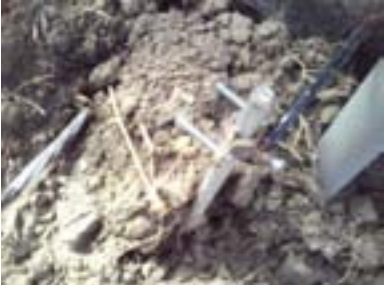
⌋ Ground wire not connected correctly to grounding rod/concrete encased electrode not verified between walls and an improper (bronze or zinc) clamp in use which should be an acorn clamp;

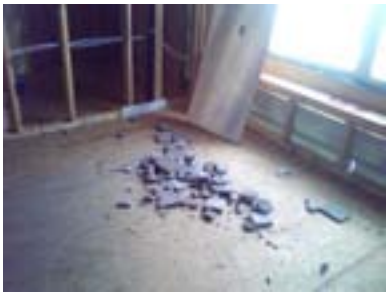
⌋ Debris inside and outside which needs cleaning,

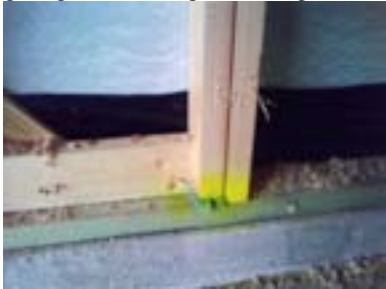
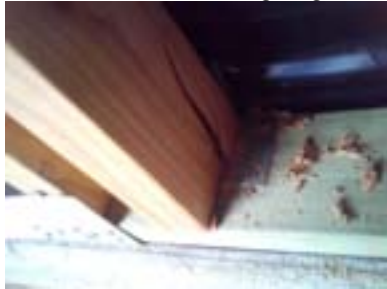
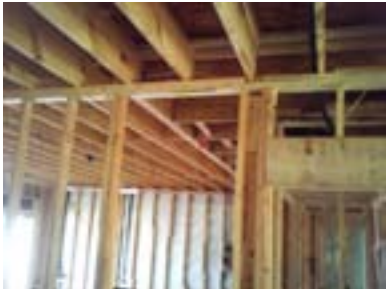
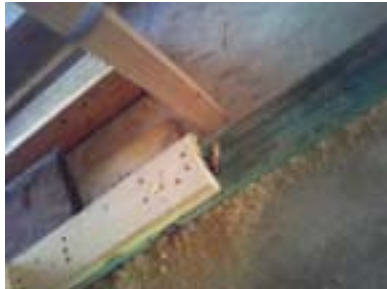
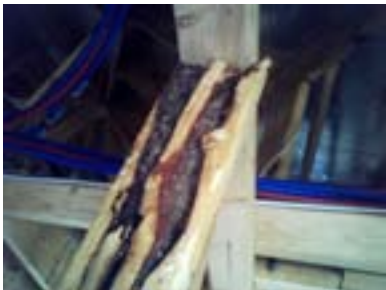
⌋ Studs must fully bear on Min 2 in sole plate and was off;observed several are loose or damaged;(loose between living room and garage,1 missing,1 damaged at top,and some off cuts in garage which are shimmed) and most marked .

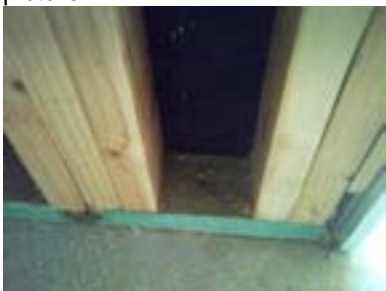
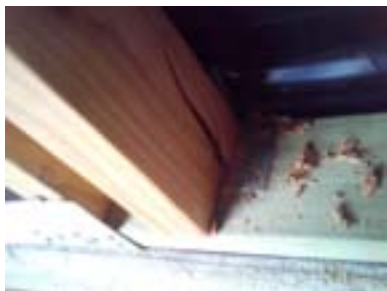
⌋ Anchor bolts not within 12 inches from the end of the sill plate (corner), not verified by left of front and back doors;as seen in 2nd picture.

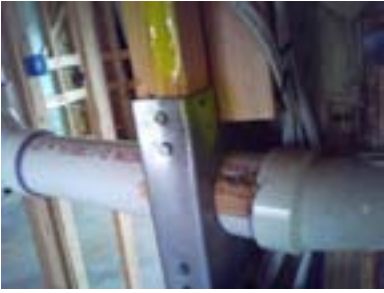
⌋ Observed round and oval holes are not filled with the proper nail for the minimum load and/or square holes not filled for the max load in all connectors;most marked including garage,

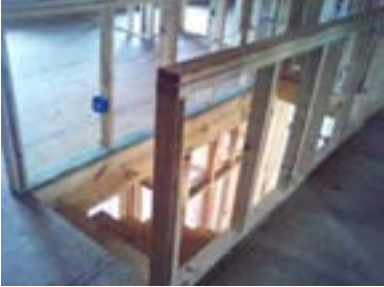
⌋ Sill and Sole plates may not be protected against decay and termites;may compare to plans if required;
⌋ Hand railing is loose/missing at one or more locations;most likely a temp. handrail/guardrail;

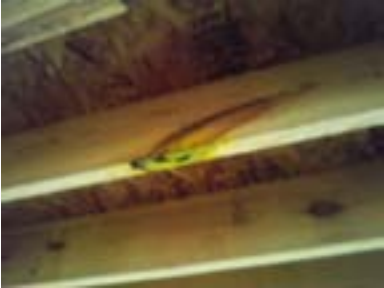
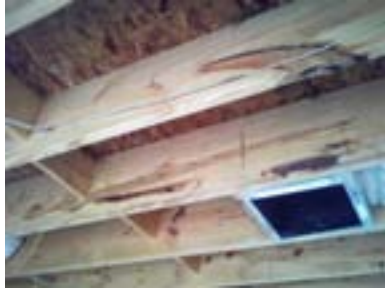
⌋ Joists have knots or splits in living room that that may need attention;

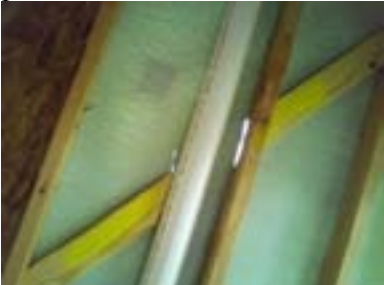
⌋ The braced shear wall and/or wind brace was cut and needs attention or sheer osb now added in the living room at that location;

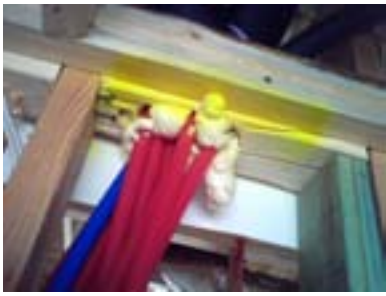
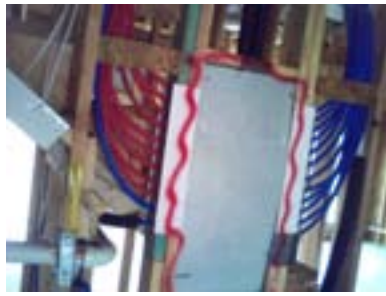
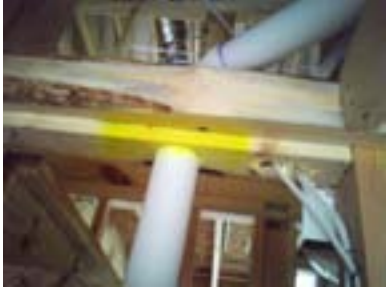
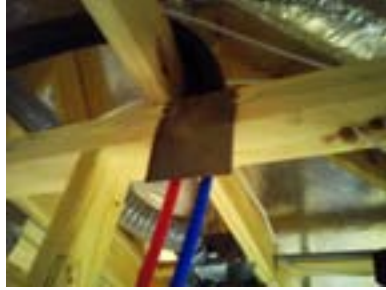
⌋ Did not observe a shield plate over the plumbing pipes if within 1 1/2 inch from outside wall which most were marked;in laundry over shut off access,bathroom to name some and should be as seen in 4th picture. Also appears water lines are in the way of the upstairs shower pan and may need re-routing.

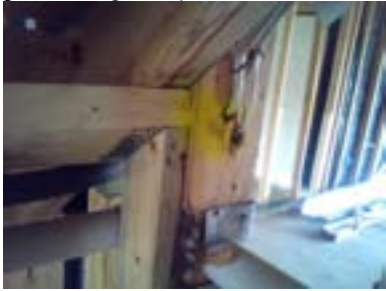
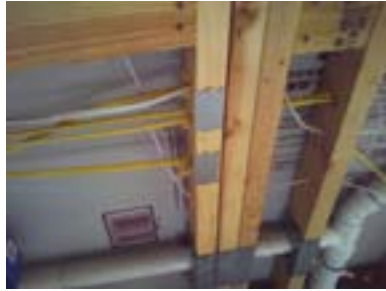
⌋ Missing nail plates over several electrical wires within 1 1/4 inches which were marked and should be like 2nd picture.

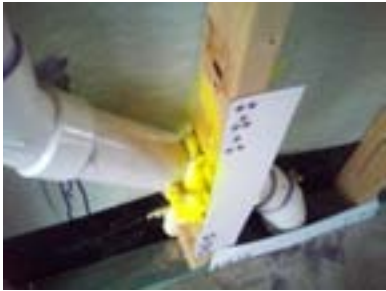
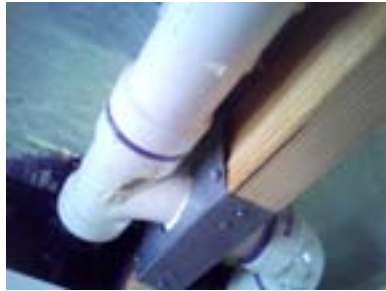
⌋ Missing shoes over notched plumbing pipes which will help bring back to full integrity; missing shoes over drain in living room wall and should be as others;

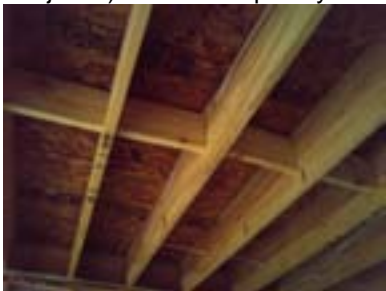
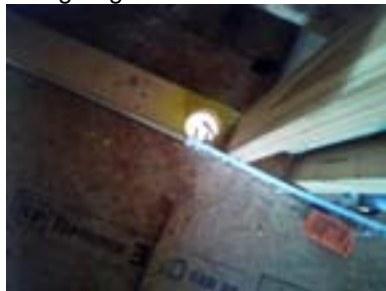
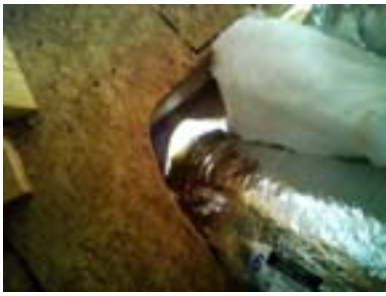
⌋ Missing in concealed spaces every 10 feet horizontal and vertical; blocks not as long, (ex. 2x8 block vs. 2x12 which would match the joists) so not completely blocked in garage horizontal and others marked.

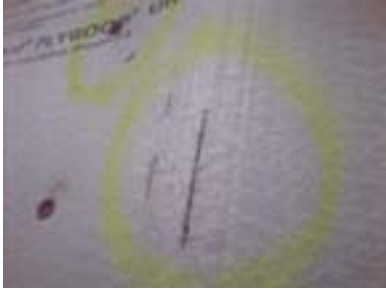
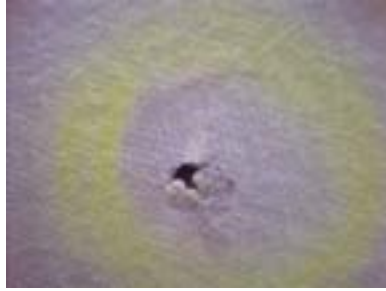
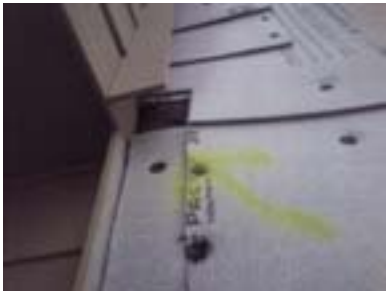
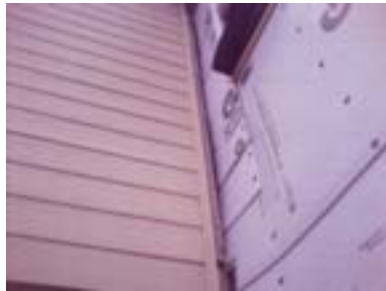
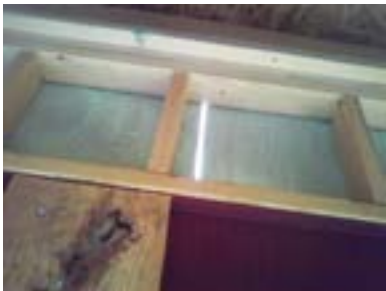
⌐ Sheathing is cracked, loose or needs sealing; split sheathing on side of living room to name some issues;

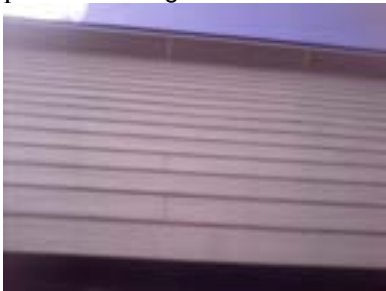
⌐ Some siding fasteners are backing out or overdriven all around which should have another nail driven beside and caulked/sealed;

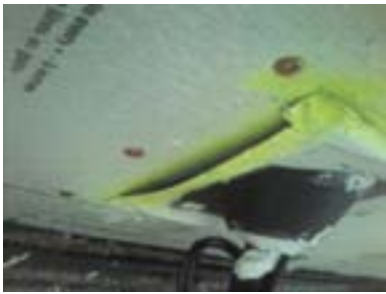
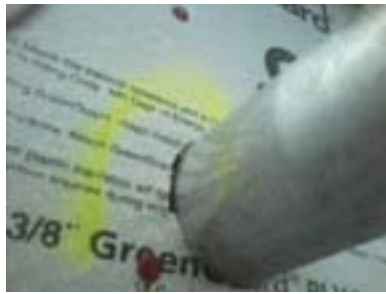
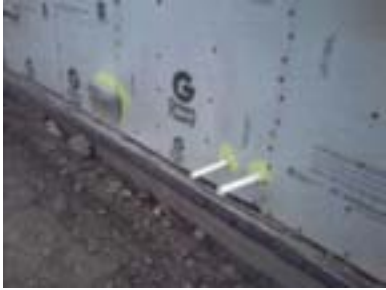
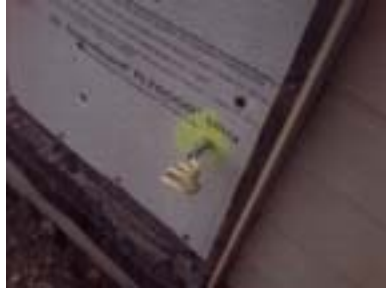
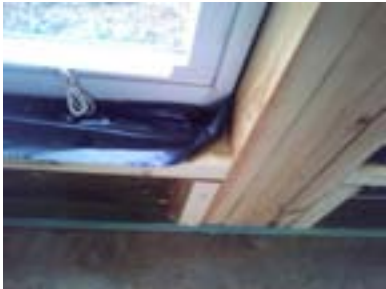
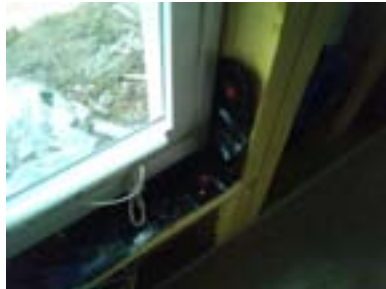
⌐ All openings and penetrations around the exterior should be examined and improved as needed to provide a solid seal (caulk) against water penetration. This includes all trim, plumbing water and gas pipes, electrical boxes and air conditioning flashings that break the wall which most were marked. Also noticed window in front not completely wrapped around corners; 5th picture and should be like 6th picture.

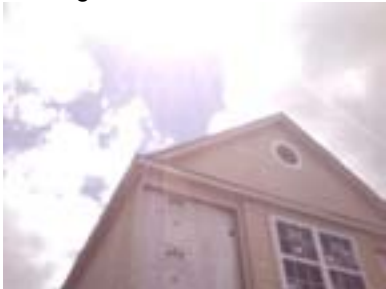
⌋ Trim, soffit, fascia boards are in need of repair; wood drip edge on rake noticed and is always better to have a metal as seen on side, some scuffs throughout and several shingles not completely sealed and should be by final inspection at all locations including the edges.

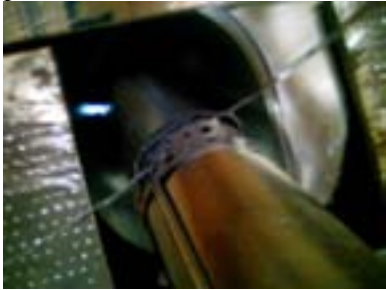
⌋ Storm collars are not caulked on furnace/**water heater flues**;

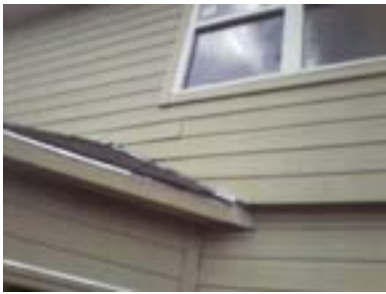
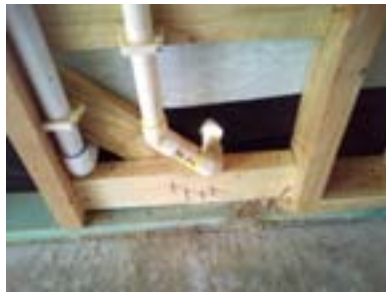
⌋ Missing step flashing where a roof intersects at exterior wall and only J or L flashing in use now;

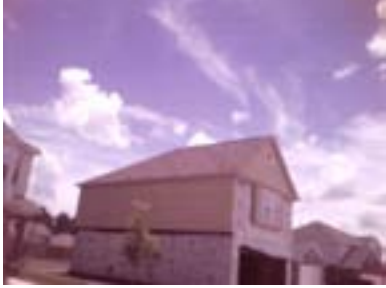
⌋ Drain,waste and vent roof jacks not yet painted;

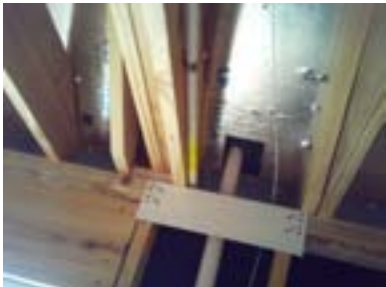
⌋ Secondary drain line is connected and secure,however not completely aligned properly and terminating over the back window.

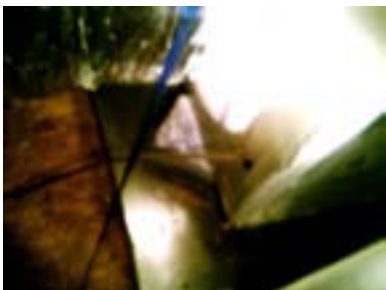
⌋ The bushing is missing in the furnace for the thermostat wires,the ground box cover is missing (laying in pan) and debris inside pan.

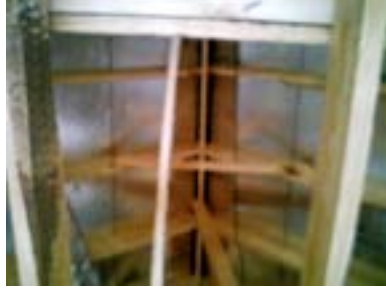
⌋ Insufficient attic ventilation or ridge not properly opened; one ridge over center access not cut open on back side and should be open on both sides like 2nd picture; **The total net free ventilating area shall not be less than 1 to 150 of the area of the space ventilated except that the total area is permitted to be reduced to 1 to 300 provided at least 50 percent and not more than 80 percent of the required ventilating.**

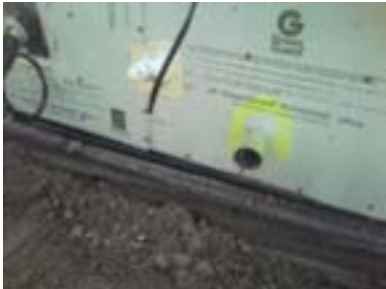
⌋ The dryer vent may terminate too close to condenser unit; should not terminate next to and easily within 4 to 6 ft. away from;

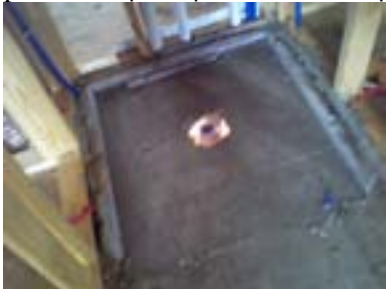
⌋ Shower pan upstairs is in the process of being re-installed and a tub was placed while on site.

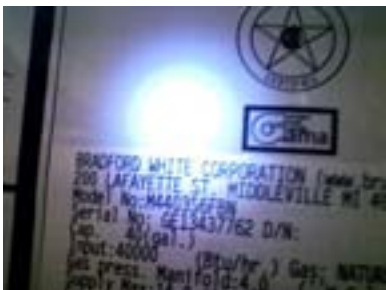
⌋ Unit drain pan has debris in pan and appears decking underneath is damaged/discolored from past leak.

Type: BRADFORD WHITE and the info in below picture and was manufactured this year per the data plate. **The TRP valve was NOT tested** and operated at the time of inspection and may not close properly leaving a constant water drip from the TRP line, however should always keep the pan clean and wiped down and test the TRP valve every 6 months as to keep the rust and sediment buildup to a minimum.
