**Sitting Empty in Neighborhood**

**December 7, 2009**

**This Limited, Visual Inspection Report is prepared exclusively for**

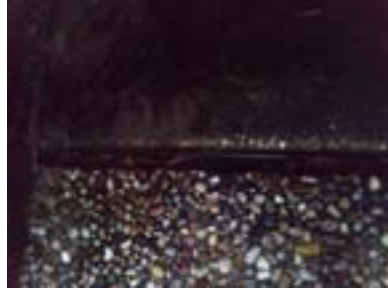
⌋ Structural movement and/or settling noted, however, the foundation is supporting the structure at this time;

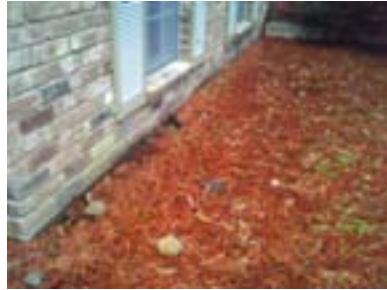
- .. Trees/heavy foliage too close to the structure
- .. A/C condensation line terminates too close to structure
- .. Planter(s) adjoining the structure
- ⌋ Inadequate grading clearance (high soil) to exterior wall surface;back is mud and high mulch in front,

- .. Observed the foundation elevation was less than 12 inches + 2% above the street drain.
  - ⌋ Could consider adding a gutter system in all locations to divert the water away;

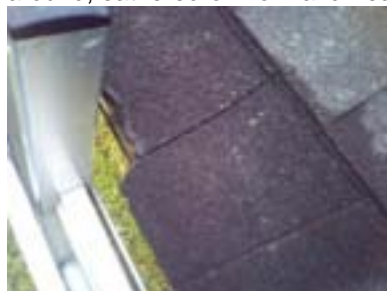
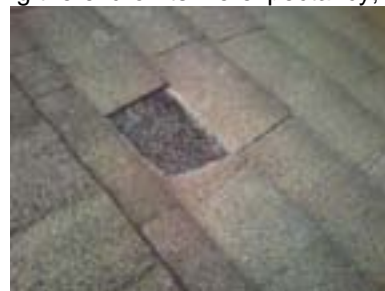
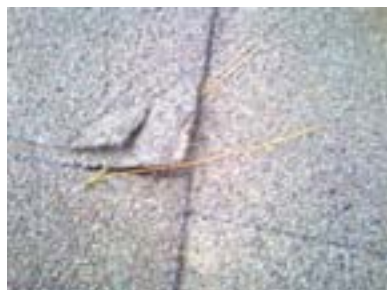
- ⌋ Some damaged,missing or raised shingles;1 or more missing shingles in front,a few tears around,feathered or worn and nearing the end of its life expectancy;

⌋ The roof covering is in need of replacement or extensive repairs, a Certified Roofing Company should be consulted

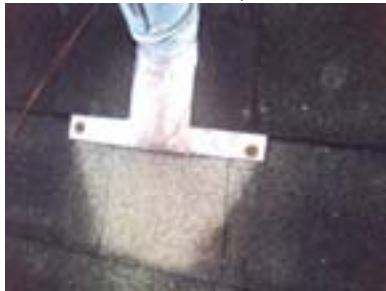
⌋ Observed some exposed nails and/or staples showing that should be covered or caulked as part of routine maintenance;

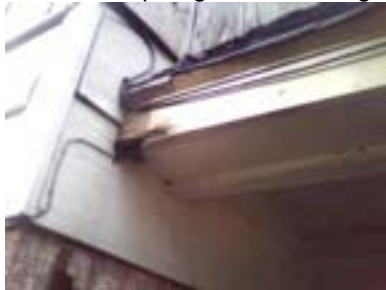
⌋ Trim, soffit, fascia boards are in need of repair; front fascia and some soffit damage, missing trim in front and drip edge loose over garage,

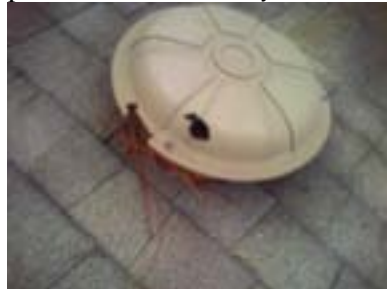
⌋ Roof ventilation system damaged and in need of repair;cracks on fan vent;

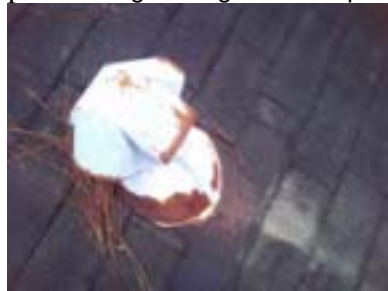
- .. Roof penetration(s) or flashing not properly secure, flashed/sealed;
- .. Brick chimney not properly flashed and counter-flashed;
- .. Skylight covers not secured and/or flashed properly
- .. Chimney cricket/saddle is missing if 30+ inches wide;
- .. Missing rain skirts on metal fireplace or furnace flues
- ⌋ Missing/damaged rain caps on furnace/water heater flues;all are rusted and not the proper type;

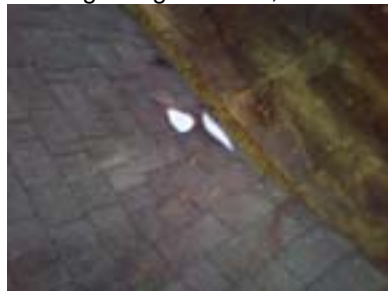
- ⌋ Valley/step or counter flashing in need of repair or replacement;some rusted around and some missing along roof/wall,

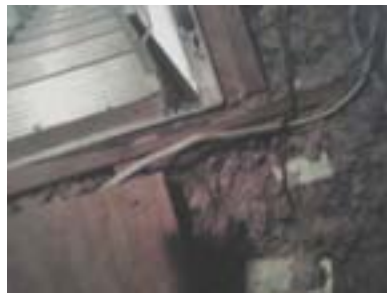
- Roof sag due to the decking should have more support. May try to add the h clips or fasteners
- Observed exposed and hot wires throughout the attic;
- Observed exposed gas or drain/water pipes that are loose or out in the walkway and should be blocked or strapped throughout;
- ↳ Observed debris,lumber,trash throughout the attic that should be removed.
- Observed an inadequate walkway or platform to mechanical equipment in the attic. Current code requires 30 inches of head clearance, a 24 inch solid walkway with no obstructions and a 30 inch deep solid platform in front of the equipment and must be flat flush secure surface;
- ↳ Current code requires all wires within 6 feet of the attic opening to be protected and observed unprotected electrical wires near the opening. This could lead to wire damage and possible electrical shock or potential fire hazard;should adjust and tuck in better.

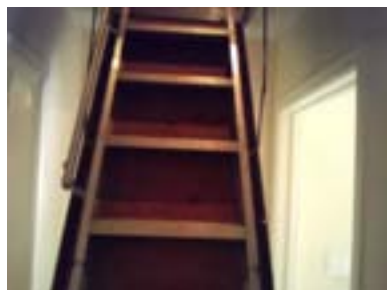
- ↳ Lack of foam board insulation inside the steps;needs in house,

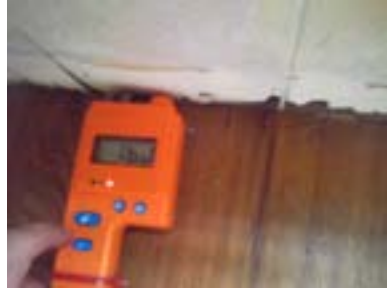
work and registered 16% moisture content which is damp and may want to repair the past damage at:some window sills may be from water sprinklers,next to chimney at bottom which may be wood rot on exterior,

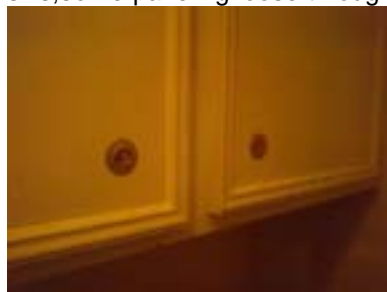
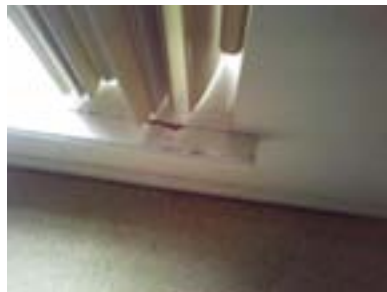
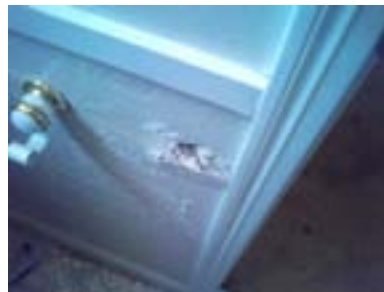
- .. Freshly Painted
- .. Holes in walls;may be behind doors because lack of door stops.
- ⌋ Observed walls or structure is out of square or bowed in areas:paneling is loose and bowed downstairs,
- .. Nail pops observed that could be repaired
- ⌋ Gaps or cracks underneath sinks around pipes,outlets, etc.;
- .. Past water damage underneath sinks
- .. Cabinets,counter or drawer issues:
- .. Caulking/sealant is separated or missing in some areas,;
- ⌋ Trim boards, shelves/racks or hardware is damaged/loose at several areas;many cabinet knobs,bath racks are missing,most baseboard is loose downstairs,pulling around front door,refinish some window sills,some paneling loose throughout,

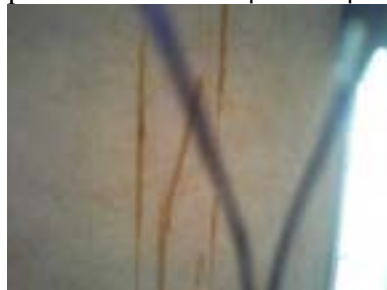
- ⌋ Observed several paint discolorations and scuff marks throughout the house;
- ⌋ Observed several paint chips or sheet rock cracks;

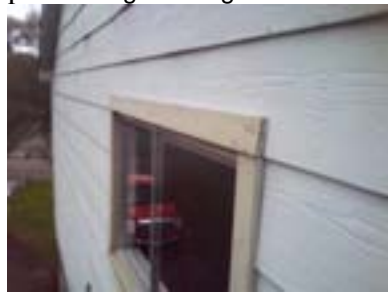
- .. Siding shingles are cracked, loose or missing
- ⌋ Observed walls or structure is out of square, bowed or warped in areas:all around.
- .. Some siding fasteners are backing out, overdriven nails or metal exposed around;
- .. Some above door and window lentils are rusted and should be sanded and painted.
- .. Weep holes not open and/or improper spacing of over 33" on center;
- ⌋ Flashing missing over windows or window trim;

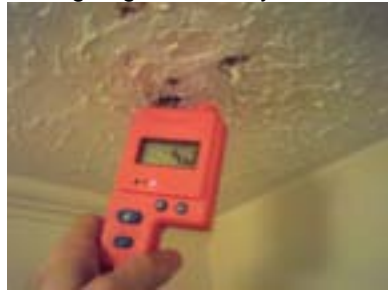
⌋ Water stains on ceiling - measured with a moisture meter set on gypsum for sheet rock and registered 5% to 3% moisture content which is wet and all past damage should be repaired; laundry room, garage over entry door,

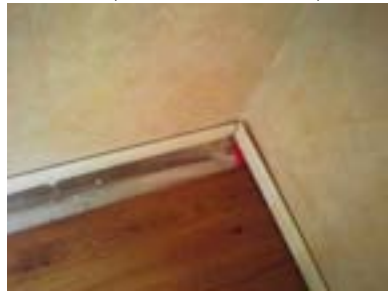
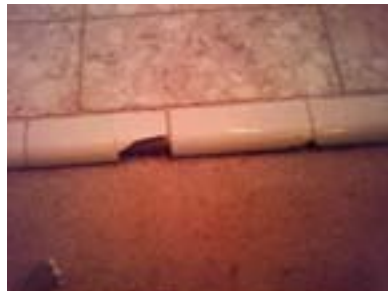
⌋ Floor cracks, scratches, or grout/seal openings in some areas which may have been marked;missing along wall in living room,front entry door gaps between tile and between door threshold,broken in master,

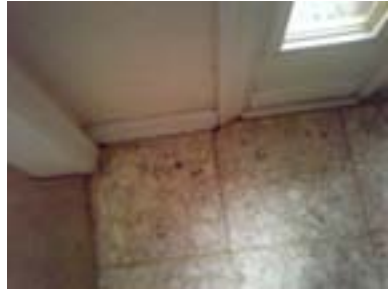
⌋ Observed tiles that sounded hollow when tapped with a hard object which is a result of lack of adhesive spread evenly underneath tile, loose tile, air pockets or water has penetrated underneath the tile. Discovered 2 or more in the front entry, 5 or more in the kitchen or more in bathroom and 2 or more in other open areas in kitchen eating area.

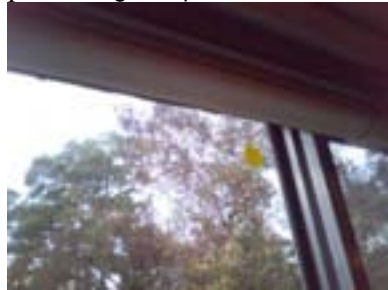
⌋ Some glass panes are loose, damaged/broken or missing at:chip/crack in west bedroom upstairs,

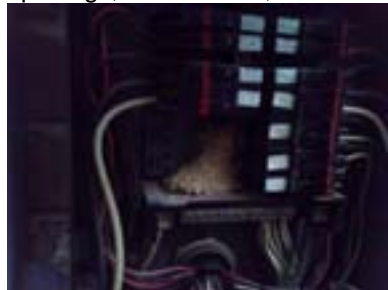
A/C condensing unit specifies a max amp breaker of 50 and a 50 amp breaker is in use  
⌋ Arc-Fault circuit breakers not observed or improperly installed for electrical receptacles in family rooms, dining rooms, living rooms, parlors, libraries, dens, bedrooms, sunrooms, recreation rooms, closets, hallways, or similar rooms or areas. This is a new regulation as of slab poured after September 2008 and homes built prior to this were not required to have arc fault protection except for bedrooms only and prior to mid 2,000's was not required at all and now current industry requires and most likely this panel could hold the proper amount needed;  
⌋ Panel(s) are not caulked and/or missing silicon around the outside of the Panel or inside the openings;debris inside,

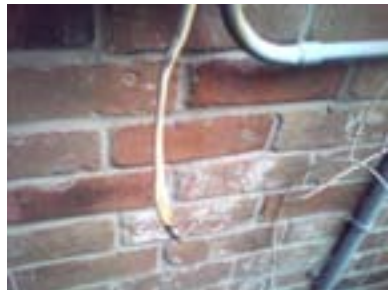
⌋ This is a Federal Pacific Stab breaker panel with wire hanging out and improperly terminated that should be evaluated by a professional electrician and please refer to the Federal Pacific clause below that is recommended to add by Inspector Association;

**Safety Warning\*\*\*** I have observed a Federal Pacific Electric "Stab-Lok" service panel in the house. This panel is a latent fire hazard: its circuit breakers may fail to trip in response to an over current or a short circuit. Failure of a circuit breaker to trip can result in a fire, property damage, or personal injury. A circuit breaker that may not trip does not afford the protection that is intended and required. Simply replacing the circuit breakers is not a reliable repair. The panel should be replaced, and significant expense may be involved. Additional information about the fire and shock hazards associated with this equipment can be read on the internet at <http://www.inspect-ny.com/fpe/fpepanel.htm>

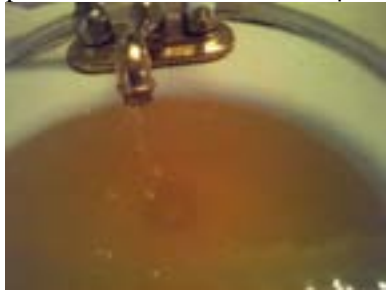
⌒ Faucets have low water pressure;cold in master;both in hall,

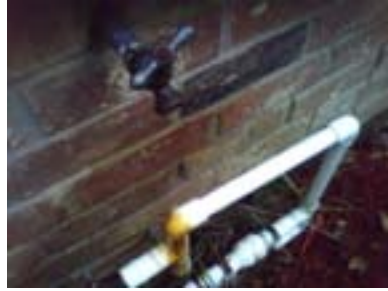
- ⌋ Leakage or corrosion observed at:side by ac,
- ⌋ Insulation missing and/or needs reattaching;all pvc including sprinkler pipes.
- ⌋ Sprinkler Anti-siphon is secure in ground or wall,however could/should be strapped to the wall or supported better.
- ⌋ Missing gas drip leg or sediment P-trap downstream of the equipment shut off valve as close to the inlet of the equipment on gas line, (G2419.4);both water heater and heat exchanger.
