Very established neighborhood

Houston, TX 77069

May 28, 2010

This Limited, Visual Inspection Report is prepared exclusively for

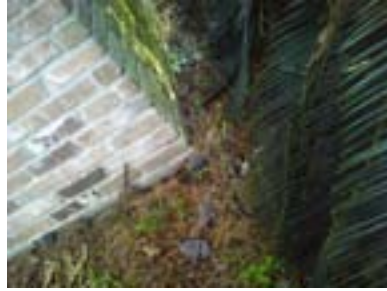
- Observed typical spalling (crumbling of slab) or honey combing. This can be epoxied or touched up and usually happens around the corner/edges of the slab because the stress will break the slab.
- Low spots around house allowing water to pond against the slab - recommend placing a gutter system with downspouts and splash pads if not present and repair the drainage issues
- Observed trees are very close to the structure in areas which tend to pull water from underneath the slab and may cause heaving or foundation issues:behind garage.

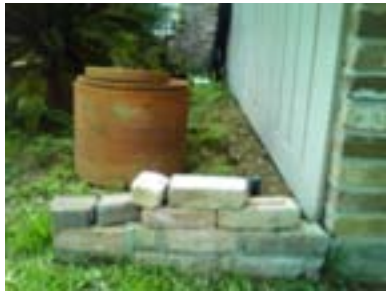
⌋ Improper drainage from foundation and not a decline at all locations away from slab and/or a 6 inch decline at 10 feet away;back,front,garage,

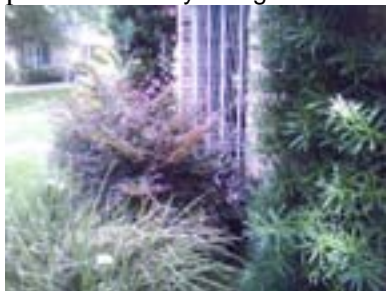
- ⋮ Gutters draining too close to the structure;
- ⋮ Plumbing/Hose Bibb(s)/Sprinkler System leakage
- ⌋ Trees/heavy foliage too close to the structure;

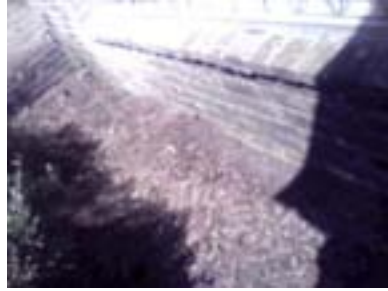
- French or corrugated drain system is clogged or blocked;
- Downspout is missing the splash blocks at several locations causing water to sit against the house;

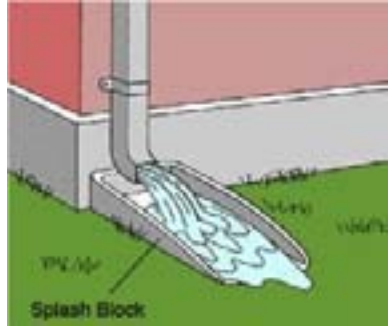
- Observed the foundation elevation was less than 12 inches + 2% above the street drain.
- Could consider adding a gutter system in all locations to divert the water away; French or corrugated drain system that should be monitored for leaks so that water does not seep into the ground and work under the slab;

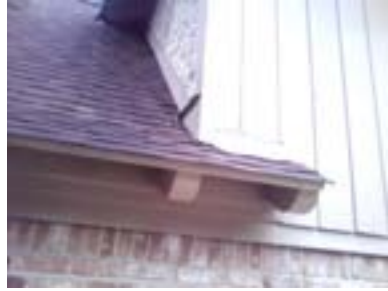
- ∴ Observed less than a 4 fastener minimum nailing pattern or staples in use if shingle could be lifted without damaging;
- ∴ Roof decking deflection, raised and/or sagging;
- ∴ Roofing covering installed over older roof covering
- ∴ Inappropriate roof covering for slope of the roof;
- ⌋ Observed some exposed nails and/or staples showing that should be covered or caulked as part of routine maintenance;

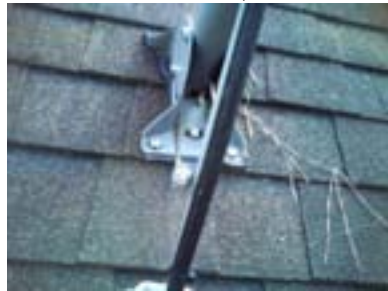
- ⌋ Trim, soffit, fascia boards are in need of repair; open trim under both walk in attic top intersections and squirrels have chewed on a few places;

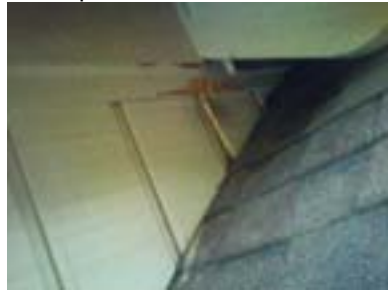
- ∴ Roof covering is in contact with siding;
- ⌋ Leaves/debris in the gutters and downspouts;

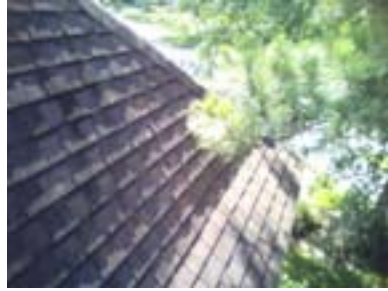
∞ Roof ventilation system damaged and in need of repair

⌋ Drain,waste vents beginning to deteriorate (some have been chewed) or improper installation (less than 6 inches above roof or 10ft horiz or 2ft above openings) or not protected with latex paint observed;upper roof has older roof jacks and lower were exchanged.

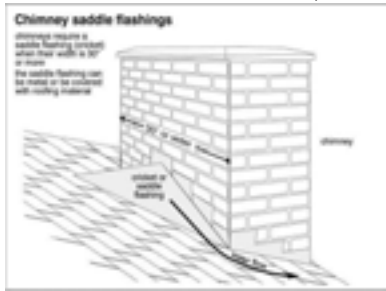
- .. Missing rain skirts on metal fireplace or furnace flues
- ⌋ Missing/damaged rain caps on furnace/water heater flues;old bonnet extensions are still in use which would be ok for bath fans,

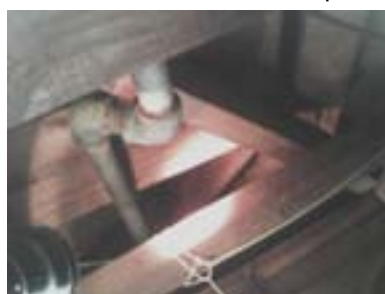
- Open chase should be fire blocked every 10 feet horizontally or vertically including around duct penetrations, between floors, and other openings and currently if a fire occurred could serve as a chimney.
- Roof sag due to the decking should have more support. May try to add the h clips or fasteners
- ⌋ Observed exposed and hot wires throughout the attic; covering off by water heater,

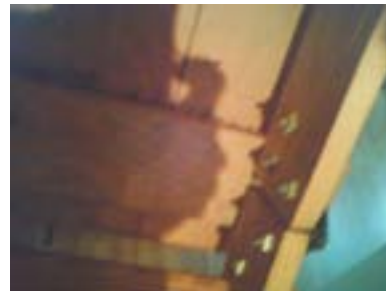
- ⊔ The attic door frame require 16D (penny) nails or 1/4 x 3" or equivalent screws through the hinges and around the frame and should have 16 fasteners attached unless the door manufacture lists or requires a different pattern. This door has only 8 fasteners now;
- ⊔ Lack of fasteners; missing on edge for proper support;

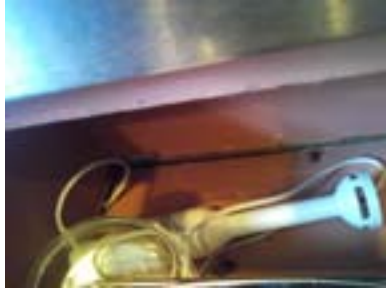
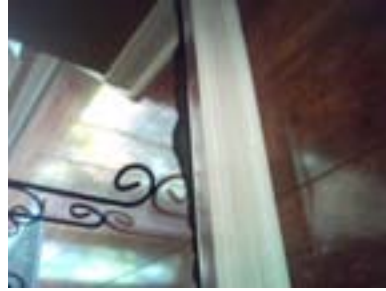
•• Caulking/sealant is separated or missing in some areas;,
⌋ Trim boards, shelves/racks or hardware is damaged/loose at several areas;laundry door trim,

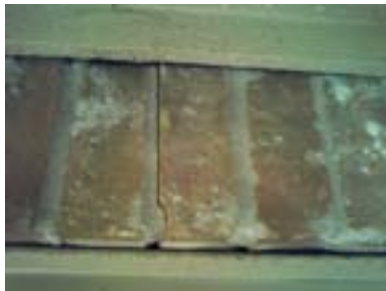
⌋ Caulking/sealant is separated or missing in some areas and should block/seal any and all openings between the wall and trim work,all expansion joints,

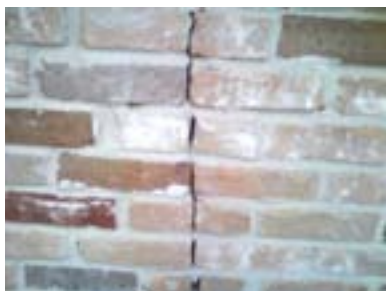
⌋ Some cracks at the brick, stone, or stucco siding;under kitchen window,

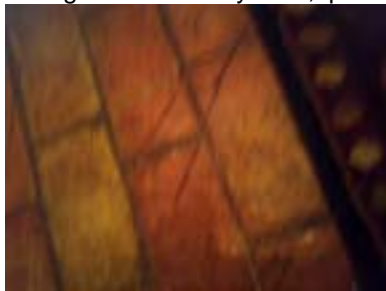
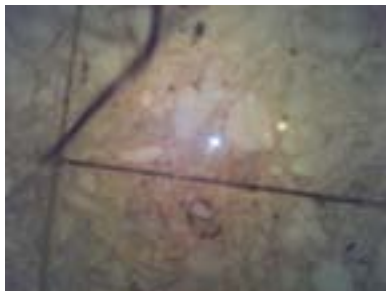
- ⌋ Stains on floor; breakfast area,

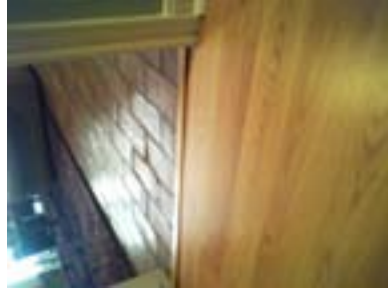
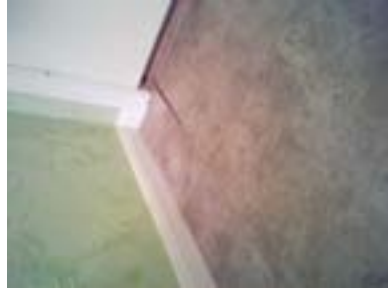
- .. Carpet and floor covering is stained and dirty throughout the house
- .. Freshly painted or stained floor
- .. Floors were uneven or creaked when walked across or warped/bowed in areas:

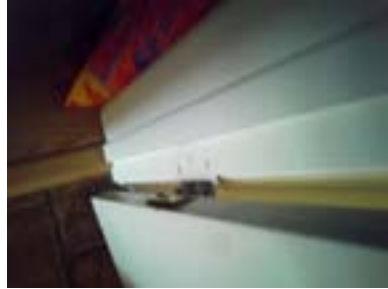
- Doors rub, stick, swing independently or hit the frames at:
- ↳ Closet doors slide poorly, off of their rails or missing at;missing to dining,

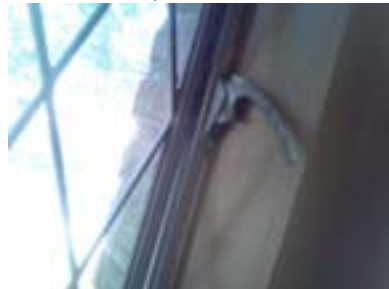
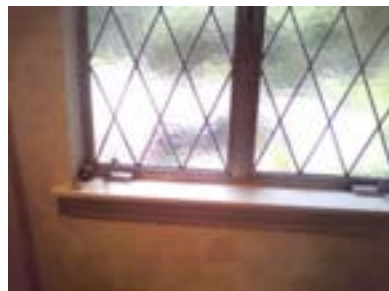
⌋ Some glass panes are loose, damaged/broken or missing at: front pool table room,

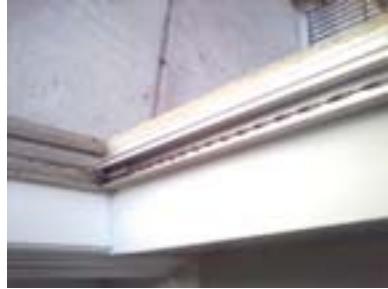
- ∴ Some missing or damaged trim or latches or out of alignment at:
 - ⌋ Some missing and/or damaged screens at:breakfast area,living room,master,and others throughout except kitchen and half bath.

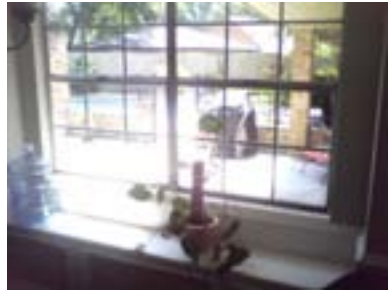
- ⌋ Windows in sleeping areas are of inadequate size or over 44" from ground for egress at: up bedrooms are 47 to 48" from floor.

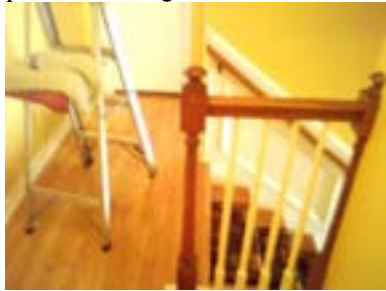
- ∴ Vertical railing spacing is greater than 4";
- ∴ Hand railing is not terminated properly;
- ⌋ Improper dimensions of stair raisers and over 7 3/4"; first 8 inches,

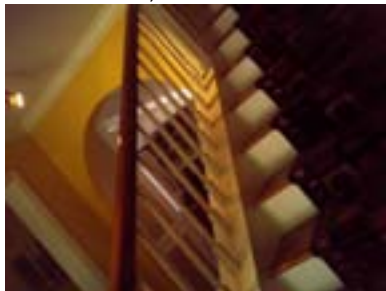
- ∴ Improper dimensions of stair treads and under 10";
- ⌋ Improper dimensions of stair treads or risers of more than 3/8 inch adjustment between;
- ∴ Head clearance less than 6 foot 8 inches at any part of stairway;

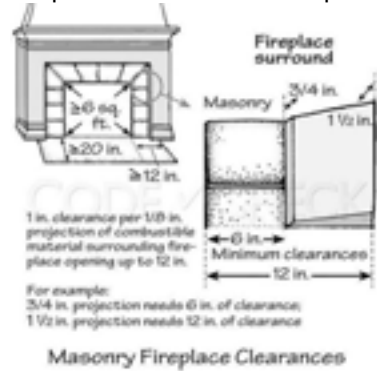
- " Firebox hearth extension is less than 2 inches thick and/or hearth less than 4 inches;
- ⌋ Some brick mortar is loose and/or has been patched, seems ok now,

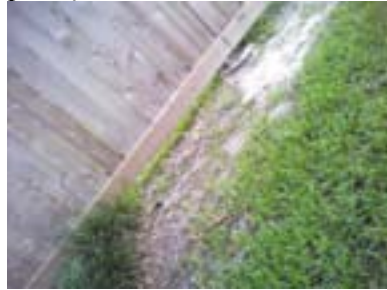
- .. Observed a dead tree which should be removed or monitored to ensure does not fall on house:
- .. Address not visible from the street or road:
- ⌋ Observed gate locks:rust on back gate,

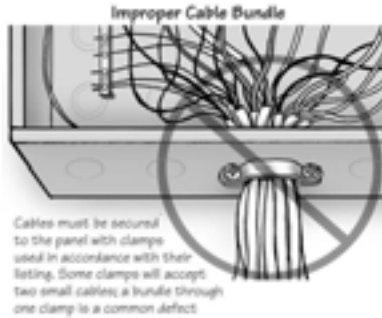
- ⌋ Panel inner safety cover is loose or missing
- ⌋ One or more knockouts are missing in front and at bottom/top or improper bonding locknut or connection in place with the use of clamps at connection from main and not secured outside panel; [2008 NEC 250.92 \(A\) and \(B\)](#);

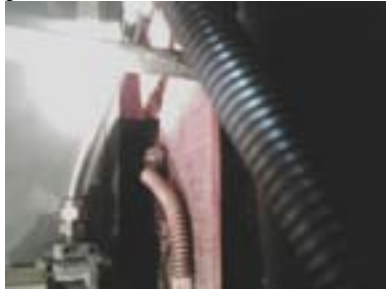
- o Rust at the burner and/or burner compartment;only slightly from underneath.
- o Improper clearance between door and unit
- o Combustible material under or touching the furnace
- o Unit's blower fan and/or motor assembly vibrates;
- o No separate shut-off switch located at filter door opening or post;
- o No data plate present or verified;
- o Flex gas line observed inside the unit
- o No gas cutoff valve and/or improper gas valve
- o Return air filter needs cleaning and/or replacement
- o Gas is turned off and/or no pilot flame,however attempted to ignite when turned on
- o Unit not properly grounded to outlet inside junction box(copper ground not connected properly);
- o Gas leaks detected at: _____
- o System(s) shows (show) signs of older unit and pilot housing outside the unit. Recommend cleaning, servicing, and further evaluation by a licensed professional.

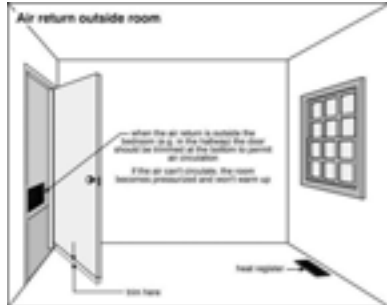
- Some supply registers have a heavy debris,rust or mildew buildup on the outside grates and/or very dirty return chase;
- Some registers are loose or not flush against the wall/ceiling;
- ⌋ Return air plenum is open inside and not sealed and/or wires, plumbing pipes which may be allowing air to escape and could be enclosed with duct board for increased efficiency and cover wires/pipes even when on an interior wall.

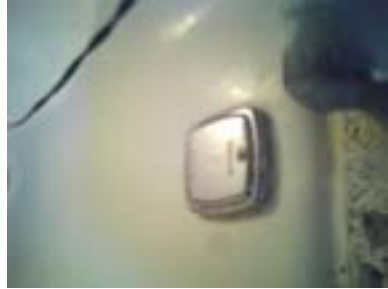
- Access panel is loose on the wall, screws are not holding panel snug to wall or not secured properly;
- Leakage from overflow or past leakage and a lot of extra caulk;

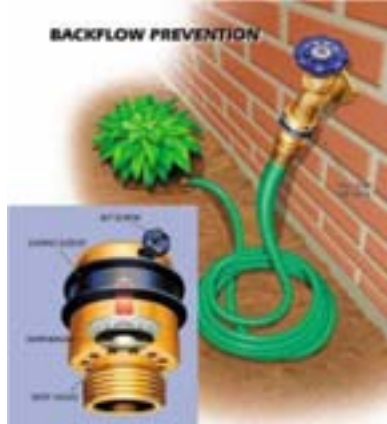
⌋ Faucet handles are loose, damaged, missing or just leak/drip at the nut or handle when the psi gauge is attached;back drips,side by ac damaged.

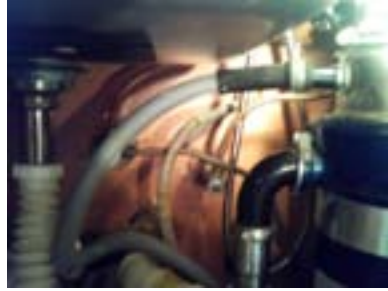
- .. Soap dispenser not functioning properly, missing rack rollers or sprayer parts missing.
- .. Unit is loose in cabinet and most likely needs screws added or tightened;
- ⌋ Rust present in interior of unit or racks,slightly,
