Local Lane

Houston, TX

February 24, 2010

This Limited, Visual Inspection Report is prepared exclusively for

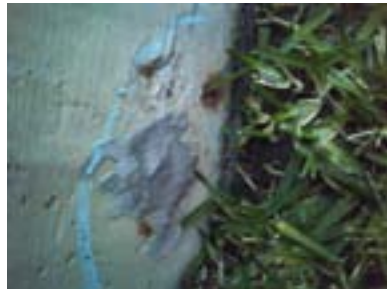
- ⌋ Cracks in slab on outside edge;
- ⌋ Beam/Rafter condition and/or Pier Condition which if rafters have pulled away from the ridge board or split should be blocked or repaired;
- ⌋ Excessive or improper shims
- ⌋ Wood form strips or other wood observed next to the slab which are conducive to wood destroying insects, which could be removed and replaced along with all cracks sealed with blown in foam covered with a thick layer of caulking;
- ⌋ Post tension live end tips are exposed and should be covered;
- ⌋ Nails or metal is exposed (only couple noticed) which could be removed and covered;

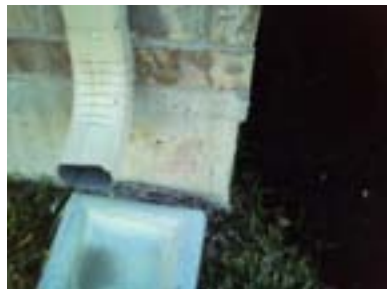
- ⌋ Soil is high and should be removed away from the brick so that there is a 6 inch decline at 10 feet away from the foundation which is a cause of foundation settlement;
- ⌋ Observed typical spalling (crumbling of slab) or honey combing. This can be epoxied or touched up and usually happens around the corner/edges of the slab because the stress will break the slab.

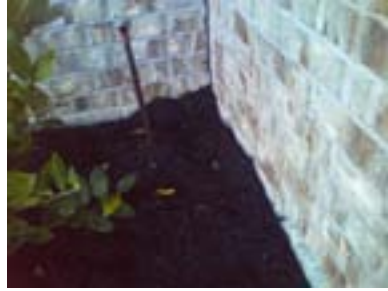
⌋ Inadequate grading clearance (high soil) to exterior wall surface;high mulch in front bed,

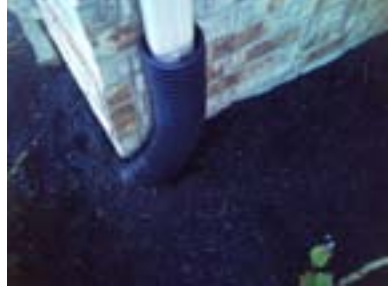
French or corrugated drain system that should be monitored for leaks so that water does not seep into the ground and work under the slab;

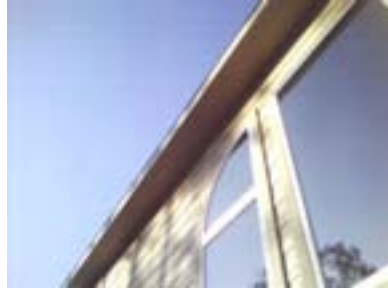
Downspout is missing the splash blocks at several locations causing water to sit against the house;

Could consider adding a gutter system in all locations to divert the water away;back and side,

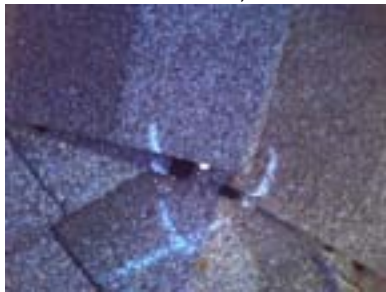
⌋ Observed an exposed nails and/or staples showing that should be covered or caulked as part of routine maintenance;

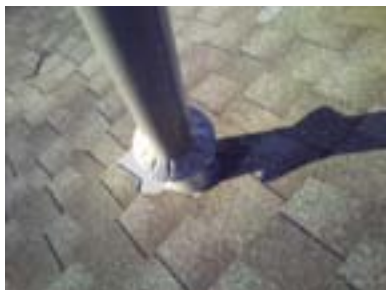
- .. Roof penetration(s) or flashing not properly secure, flashed/sealed;
- .. Brick chimney not properly flashed and counter-flashed;
- .. Skylight covers not secured and/or flashed properly
- .. Chimney cricket/saddle is missing if 30+ inches wide;
- .. Missing rain skirts on metal fireplace or furnace flues
- .. Missing/damaged rain caps on furnace/water heater flues
- ⌋ Storm collars are not caulked completely on furnace/water heater flues and/or could view daylight from attic access;left water heater and up furnace,

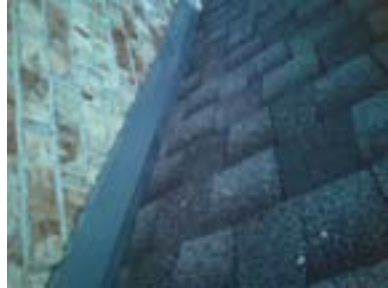
p Step flashing is not in use (about 10 inch sheets) where a roof intersects at exterior wall which is the type approved per most manufactures (GAF) and J or L-flashing (long continuous sheet, which if water enters could run continuous) is in use;

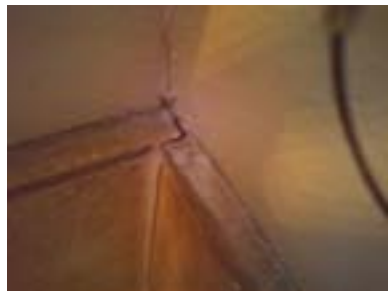
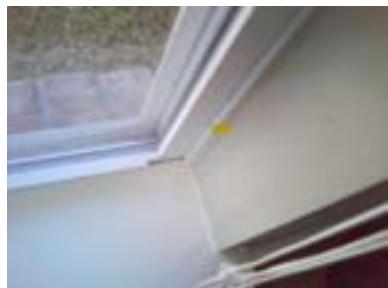
- ⌋ Caulking/sealant is separated or missing in some areas; around kitchen backsplash, minor, both sides of master tub, top of tub, corner wall over tub, master windows, bottom of stairs, office at trim, around game room sink to name some,

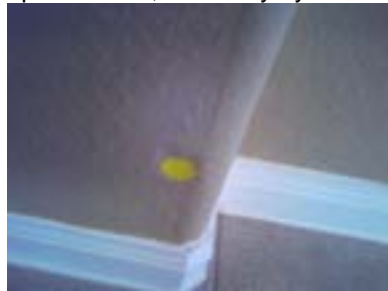
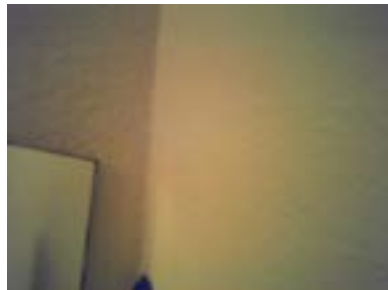
⌋ Trim boards, shelves/racks or **hardware is damaged/loose** at several areas;
⋮ Observed several paint discolorations and scuff marks throughout the house;
⌋ Observed several paint chips or sheet rock cracks throughout; some marked, over all tubs, corner of up bathroom, over entry by media room door to name some,

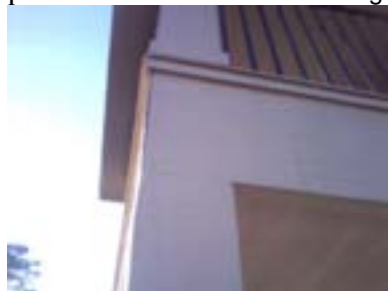
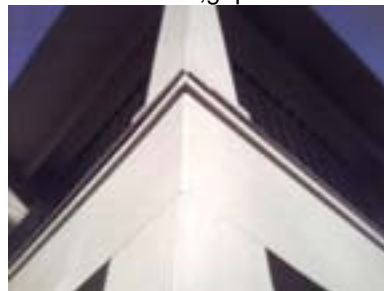
Type(s): ⌋ Brick ⌋ Cement Board ⋮ Wood ⋮ Stone ⋮ Portland Plaster Cement
⋮ May be asbestos siding;
⌋ Fascia/trim boards are damaged at several areas; gaps around balcony, 2 cracks around master trim,

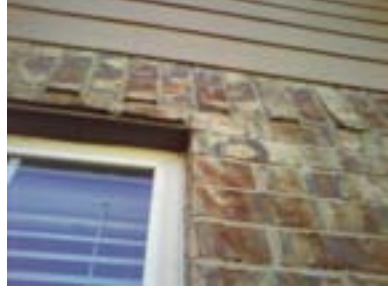
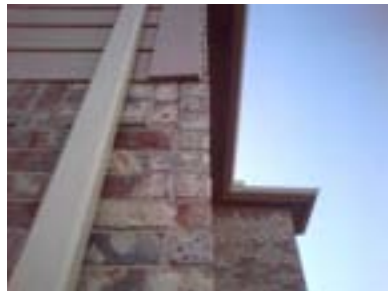
⌋ Mortar is separated or missing in some areas;between some bricks at corners,around windows,around east side windows,

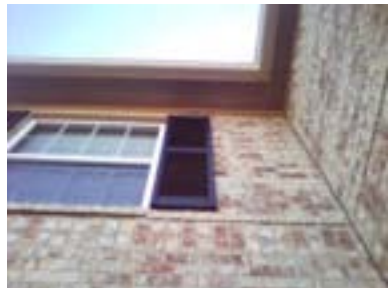
⌋ Caulking/sealant is separated or missing in some areas and should block/seal any and all openings between the wall and trim work, back corner,front corner,over garage and front room,

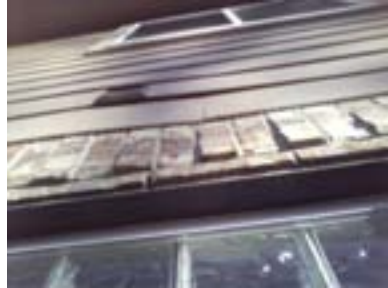
⌋ Observed walls or structure is out of square, bowed or warped in areas:over master bath window,

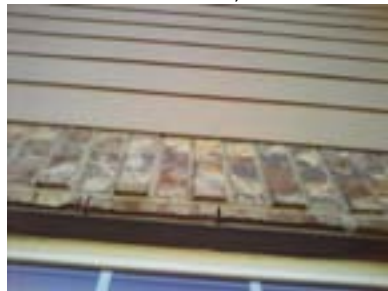
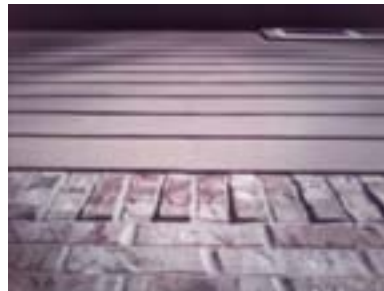
⌋ Some siding fasteners are backing out, overdriven nails or metal exposed around;high on east and west side at seems,

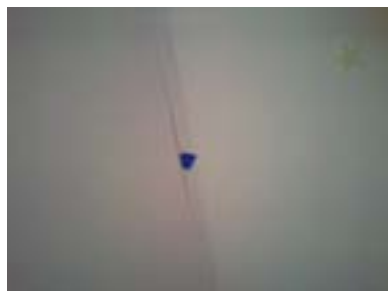
⌋ Ceiling cracks or imperfections in some areas(very common in vaulted ceilings) at;breakfast area, half bath, around front dining column, around girls detector, up girls room, up boys front room, couple of places game room, media room to name some,

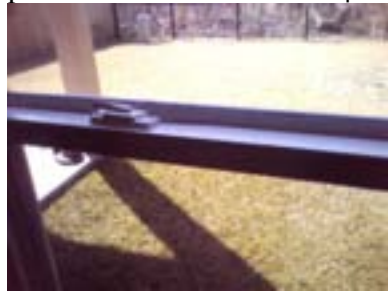
- Some glass panes are loose, damaged/broken or missing at:
- Some window lift supports are loose, damaged, (popped out) or missing at:
- Some latches at:left of fireplace out of square,however does latch,

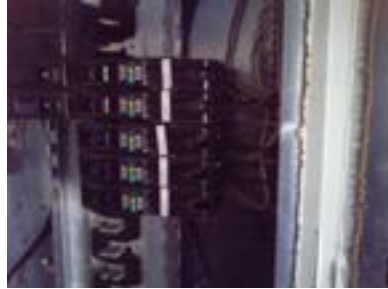
- .. Incorrect size of breakers/fuses
- ⌋ Grounds and neutrals on same bus bar or connected;remove silver connecting strap,

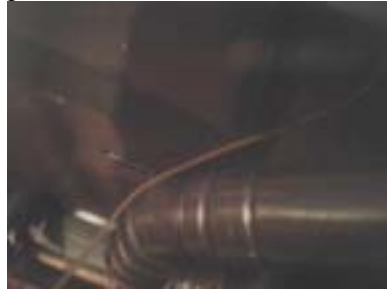
- ⋮ Floor or wall furnaces in use may be hazardous;
- ⋮ Flue is loose, not angled properly or not properly connected to the unit;not vented to exterior,
- Flue termination is an open cpvc pipe on roof vs. having a J cover to prevent water entry on high efficiency units;
- Inadequate ventilation for combustible air
- ⌋ Access panel not properly attached;BOTH were open on units and placed back,
- ⌋ Flue is in contact and/or too close to combustibles;wire on up unit,

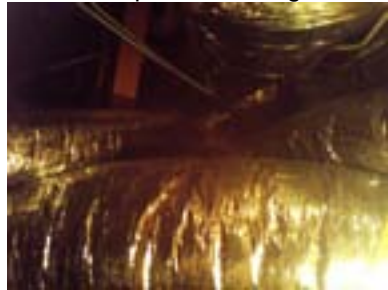
⌋ Ducting is lying on the attic floor or resting against each other throughout the attic which should be well suspended throughout the attic; should be separated by insulation or strapped apart,

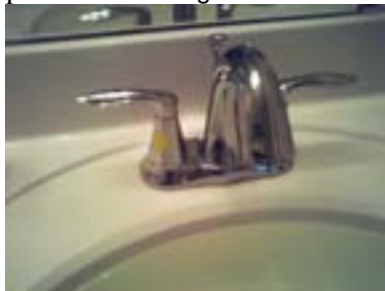
- Leakage around sink(s) at:
- Faucets have low water pressure
- ⋮ Drain stop inoperable, and not properly holding water or draining,
- Hot and Cold water reversed
- Loose/damaged faucet handles and/or a constant drip; hot faucet loose in up boys sink,

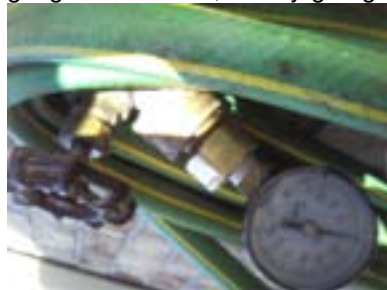
⌋ Faucet handles are loose, damaged, missing or just leak/drip at the nut or handle when the psi gauge is attached;side by garage. This could be as simple as tightening,however not certain.

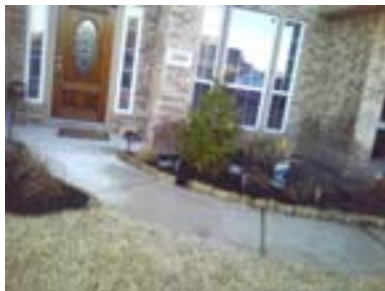
Observed about 12 total heads at; front beds and several spray the wall which should be adjusted;

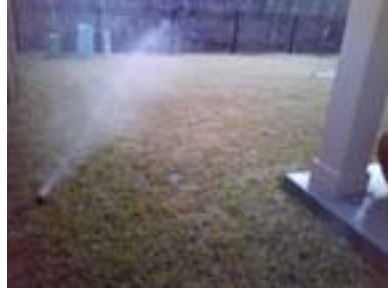
Observed about 4 total heads at; rotating heads in back center yard and 1 sprays the columns which should be adjusted;
