New Community Dr.

Kingwood, TX 77345

June 24, 2010

This Limited, Visual Inspection Report is prepared exclusively for

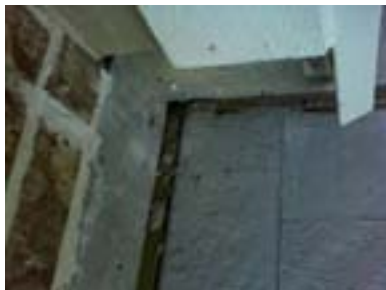
⌋ Wood form strips or other wood observed next to the slab which are conducive to wood destroying insects, which could be removed and replaced along with all cracks sealed with blown in foam covered with a thick layer of caulking; front patio area against wall.

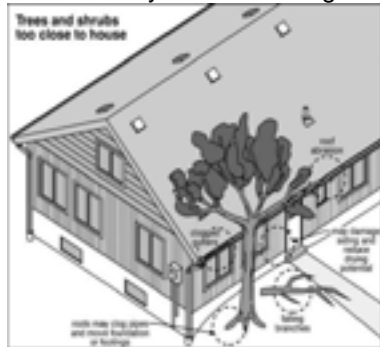
- Soil is high and should be removed away from the brick so that there is a 6 inch decline at 10 feet away from the foundation which is a cause of foundation settlement;
- Observed typical spalling (crumbling of slab) or honey combing. This can be epoxied or touched up and usually happens around the corner/edges of the slab because the stress will break the slab.
- Low spots around house allowing water to pond against the slab - recommend placing a gutter system with downspouts and splash pads if not present and repair the drainage issues
- Observed trees are very close to the structure in areas which tend to pull water from underneath the slab and may cause heaving or foundation issues:

Should always seal any opening between concrete sections with blown in foam covered with a thick layer of caulking;

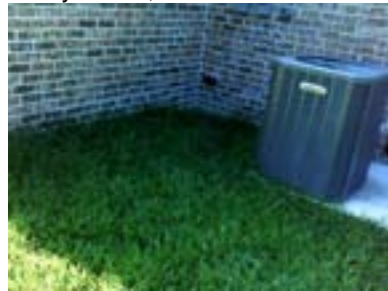
⌋ Erosion or ponding next to foundation/driveway or in yard; may adjust or monitor back corner, under valley runoff,

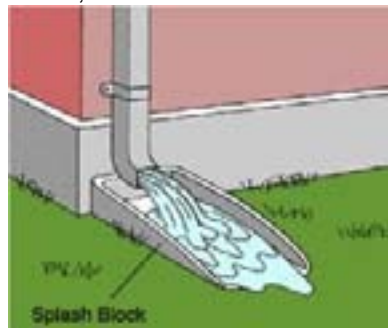
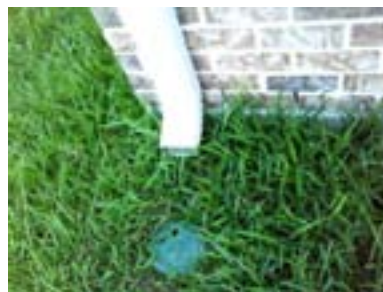
⌋ Downspout is missing the splash blocks at several locations causing water to sit against the house;

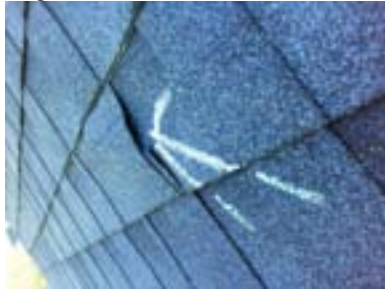
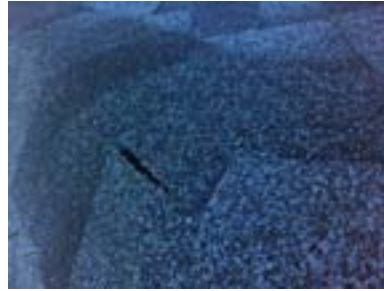
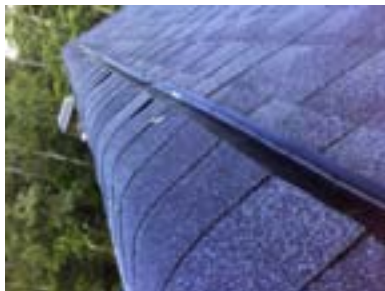
⌋ Some damaged or raised shingles throughout; 1 tear, a few raised on front over garage and ridge, several discolored/scuffed under front dormer and back noticed;

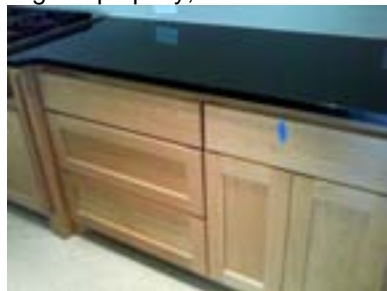
] Cabinets,counter,mirror or drawer issues:some chips marked,nail through peninsula,no hardware or bumpers inside,clean counter and scratches,seam in kitchen counter,cabinet doors by dishwasher not aligned properly,

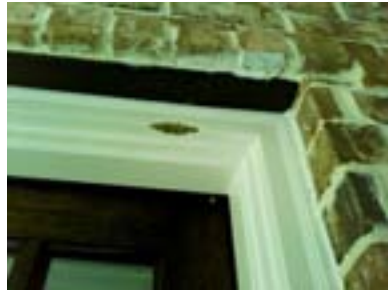
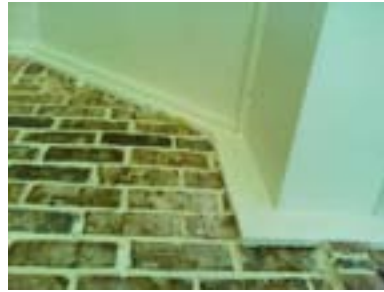
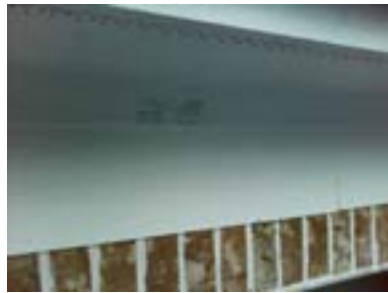
⌋ Mortar is separated or missing in some areas;between some bricks at corners,around windows,front or back porches,front fence.

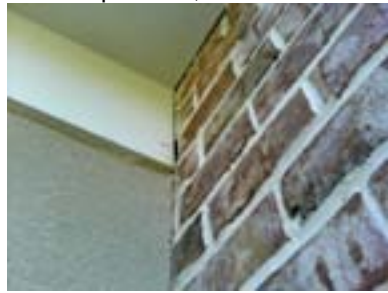
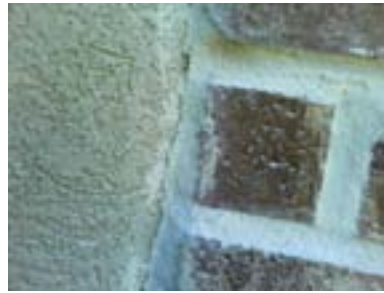
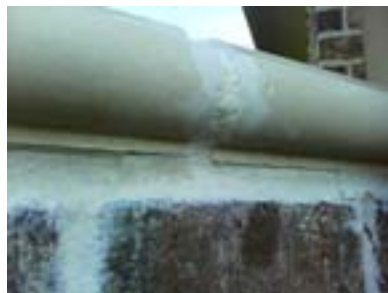
⌋ Caulking/sealant is separated or missing in some areas and should block/seal any and all openings between the wall and trim work,b/t brick and stucco,

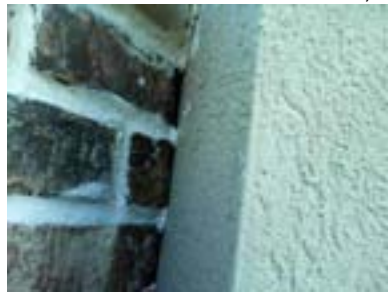
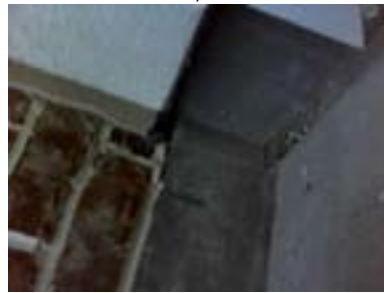
∴ Some cracks at the brick, stone, or stucco siding
∴ Wood siding is water damaged in several areas;
⌋ Siding shingles are cracked, loose or missing;plaster scrape on back patio,buckled on top of chimney,back of outside chimney to name some.

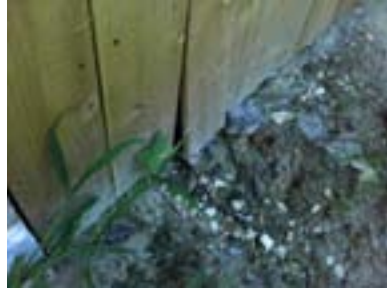
⌋ Fence;loose picket side of master to name one.

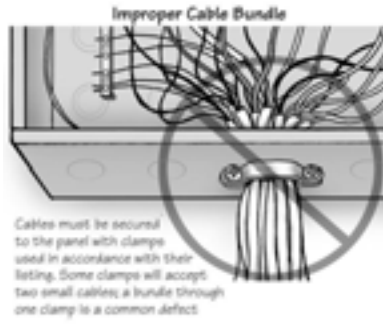
- .. Panel inner safety cover is loose or missing
- ⌋ Improper bonding locknut or connection; main strap not connected; [2008 NEC 250.92 \(A\) and \(B\)](#);

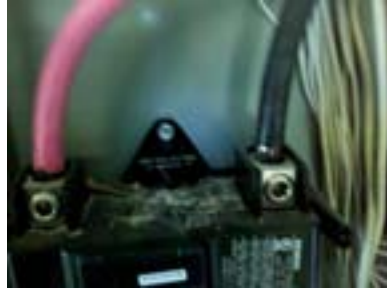
⌋ A/C living area condensing unit specifies a max amp breaker of 30 and a 40 amp breaker is in use;
⌋ A/C master condensing unit specifies a max amp breaker of 30 and a 40 amp breaker is in use;
Arc-Fault circuit breakers observed and properly installed for electrical receptacles in family rooms, dining rooms, living rooms, parlors, libraries, dens, bedrooms, sunrooms, recreation rooms, closets, hallways, or similar rooms or areas. This is a new regulation as of slab poured after September 2008 and homes built prior to this were not required to have arc fault protection except for bedrooms only and prior to mid 2,000's was not required at all and now current industry requires and cannot be sure this panel could hold the proper amount needed; Confirmed that 9 were in place and protected all of the above rooms except dining was gfci protected.
