Vacation Street

Galveston, TX

June 2, 2010

This Limited, Visual Inspection Report is prepared exclusively for

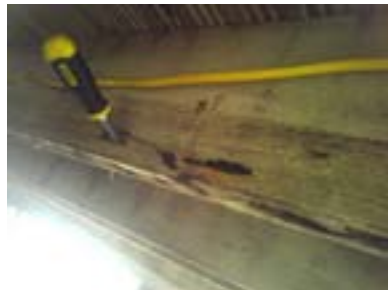
⌋ Beam/Rafter condition and/or Pier Condition which if rafters have pulled away from the ridge board or split should be blocked or repaired;noticed 1 in attic and some beams were removed under master bedroom,some rot on beams under kitchen and **front open area sides;3rd picture**,some holes under a few others were noticed.

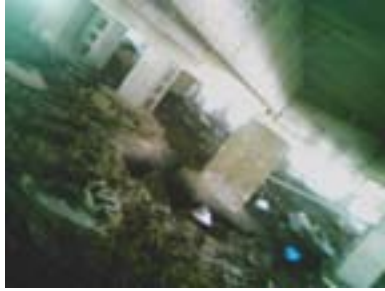
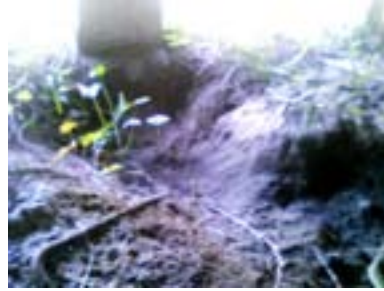
and usually happens around the corner/edges of the slab because the stress will break the slab.
⌋ Low spots under house (under kitchen and bath and 1 in front) allowing water to pond against the slab/piers - should all be leveled,

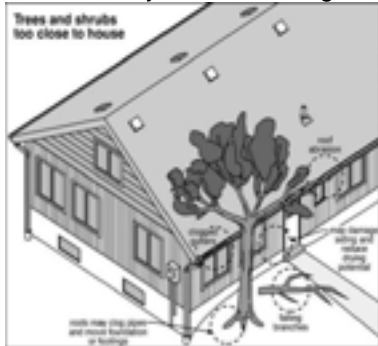
⌋ Observed trees are very close to the structure in areas which tend to pull water from underneath the slab and may cause heaving or foundation issues:

Should always seal any opening between concrete sections with blown in foam covered with a thick layer of caulking;

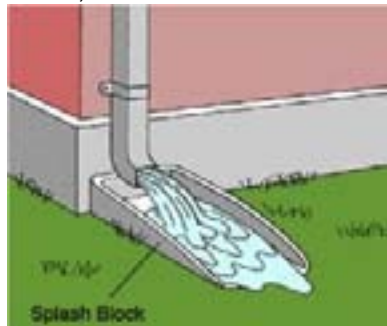
⌋ Erosion or ponding next to foundation/driveway or in yard; underneath as seen in foundation section, front under gas meter, corner of carport to name some,

- ⋮ Gutters draining too close to the structure;
- ⋮ Plumbing/Hose Bibb(s)/Sprinkler System leakage
- ⋮ Trees/heavy foliage too close to the structure
- ⋮ A/C condensation line terminates too close to structure;
- ⋮ Planter(s) adjoining the structure;
- ⋮ Inadequate grading clearance (high soil) to exterior wall surface;
- ⋮ French or corrugated drain system is clogged or blocked;
- ⋮ Downspout is missing the splash blocks at several locations causing water to sit against the house;

⌋ Could consider adding a gutter system in all locations to divert the water away;
 French or corrugated drain system that should be monitored for leaks so that water does not seep into the ground and work under the slab;

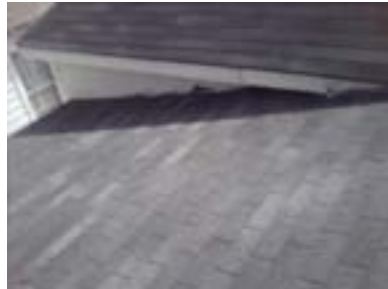
⌋ Roof covering for slope of the roof;appears under the min. slope however was 2.25:12 over master and is recommended for double felt under that section,

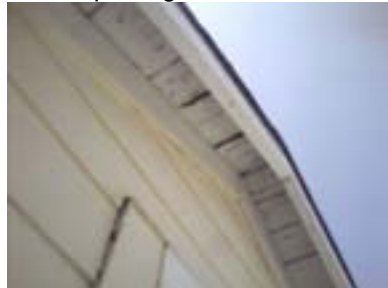
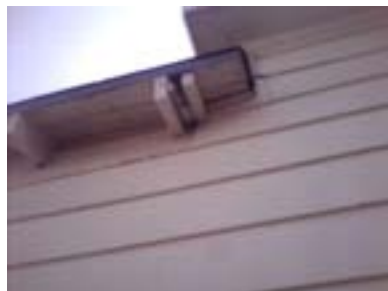
⌋ Trim, soffit, fascia boards are in need of repair;over back door,top outside fascia over bathroom has a crack and some soft rotted areas in back of bathroom along with fascia boards missing that need replacing,seal in front to name some,

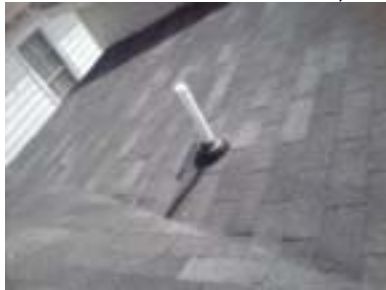
- ∴ Roof covering is in contact with siding;
 - ∴ Leaves/debris in the gutters and downspouts;
 - ∴ Tree branches are too close to the roof structure;
 - ∴ Roof ventilation system damaged and in need of repair
- ⌋ Drain,waste vents (some have been chewed and/or cracks around boot where water can enter around,however was caulked) and all are *not protected with latex paint observed*;

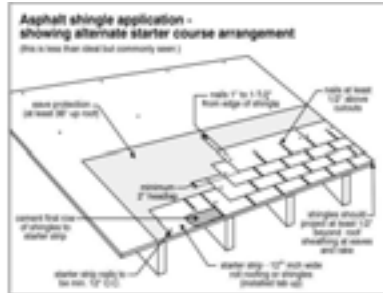
- Ⓟ Debris, nails, straw, and/or leaves on the roof that must be kept clean so that it does not damage the roof; loose 2x4 on front porch,
- .. Roof penetration(s) or flashing not properly secure, flashed/sealed;
- .. Brick chimney not properly flashed and counter-flashed;
- .. Skylight covers not secured and/or flashed properly
- .. Chimney cricket/saddle is missing if 30+ inches wide or not the proper height;

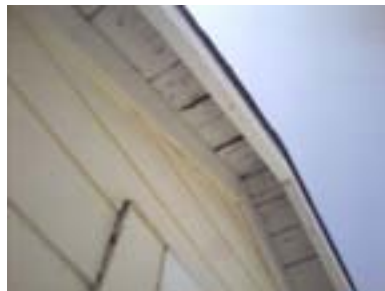
⌋ Damaged and/or missing roof sheathing;some open areas where felt is viewed and some discolored lumber,and wood rot around bathroom as seen from attic in below pictures and in roof pics.

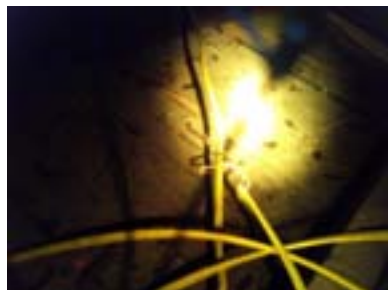
- ⌋ Bath/Kitchen vents terminating in attic or not properly sealed at roof decking;
- ⌋ Evidence of moisture penetration;over bathroom area gap,
- Open raceway from the garage to the house which should be blocked at the garage with a fire rated material. This creates an open chimney if a fire occurred and should be fire blocked;
- Open chase should be fire blocked every 10 feet horizontally or vertically including around duct penetrations, between floors, and other openings and currently if a fire occurred could serve as a chimney.
- Roof sag due to the decking should have more support. May try to add the h clips or fasteners
- ⌋ Observed exposed and hot wires throughout the attic;by access and older knob and tube still hanging around but not hot,

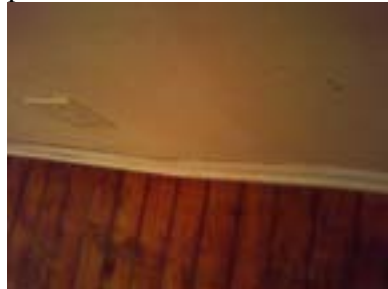
Ⓟ Observed walls or structure is out of square or bowed in areas:living room.

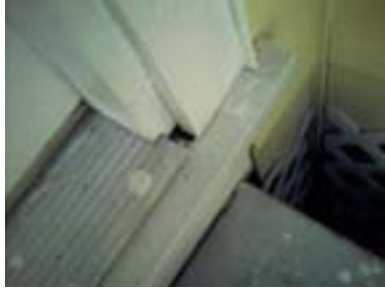
⌋ Caulking/sealant is separated or missing in some areas and should block/seal any and all openings between the wall and trim work,back door,panel.

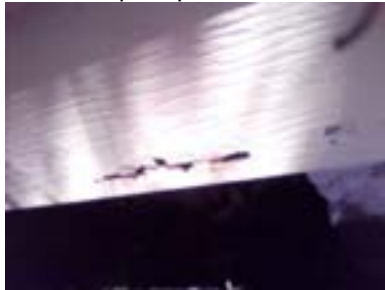
⌋ Siding shingles are cracked, loose or missing;all along bottom in back,corners and kitchen/living area side,past patch in back and hole in hardy on side was noticed,

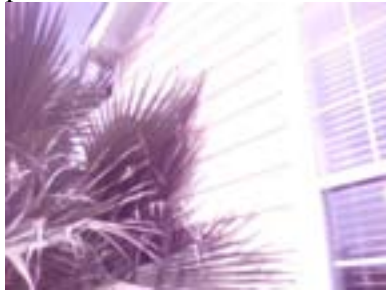
One or more areas were obstructed by foliage and/or other items;all around should be cut back,

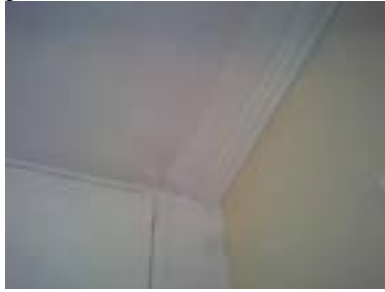
⌋ Paint discolorations;

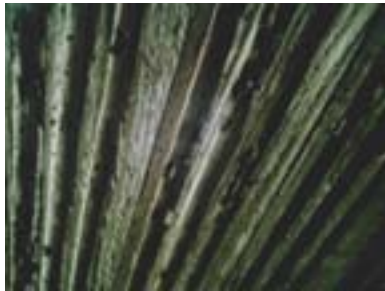
⌋ Floor cracks, scratches, or grout/seal openings in some areas;appears wall was removed in open room,some soft spots underneath around center,kitchen and bathroom noticed and may want to replace some damage.

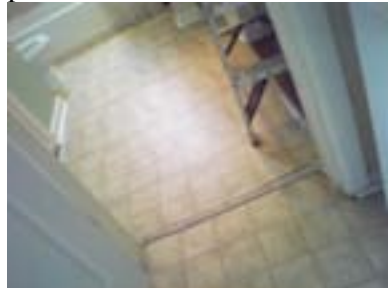
- .. Carpet and floor covering is stained and dirty throughout the house
- .. Freshly painted or stained floor
- ⌋ Floors were uneven or when walked across or warped/bowed in areas:bathroom,

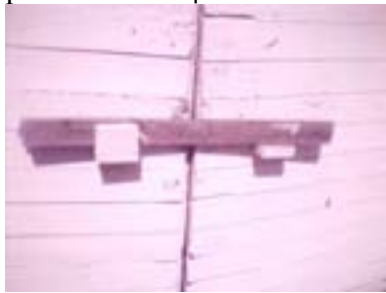
- .. Some fastening hardware loose;
- p Door locking hardware is loose and/or missing;
- p Doors and/or panels are bent or damaged;carport door not closing properly;

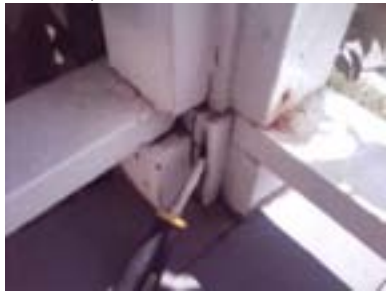
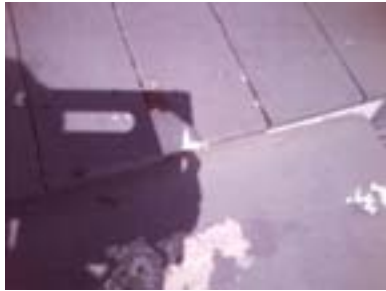
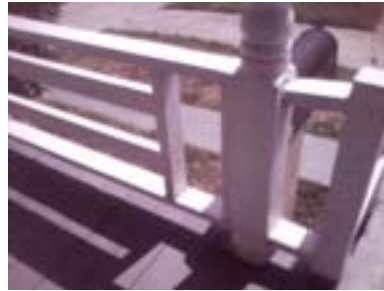
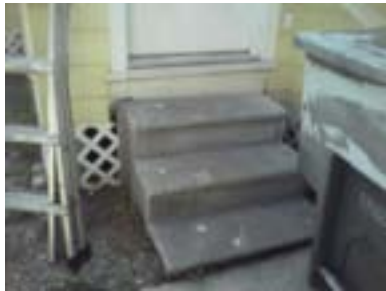
- .. Some decking fasteners are backing out
- .. Railing is loose or missing at one or more areas
- ⌋ Some decking boards are loose or damaged;front post rot damaged in corner,front etc,unevel steps in back,

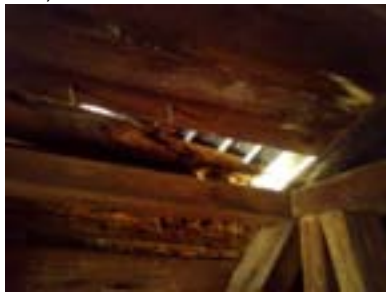
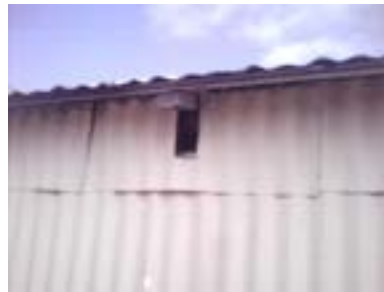
- ⌋ Inadequate structural support members;rot in back corner of garage and rafters ends rotted off on a few,

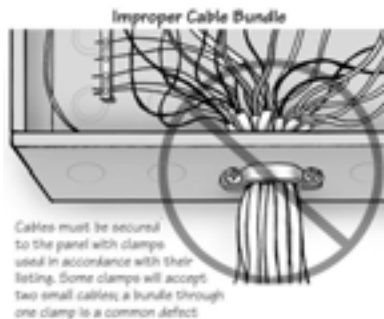
- ⌋ Panel(s), breakers and all equipment are not UL labeled;
- ⌋ Panel has more than 6 main disconnects;
- ⌋ Panel top switch must be less than 6 feet 7 inches from the ground in the up position;
- ⌋ Working space shall be 3 feet out from panel, 30 inches wide to 6 feet 1/4 inches high and 6 feet 6 inches head room with no more than 6 inches of shrubs/debris from the wall.
- ⌋ Panel(s) are loose at the wall, not flush mounted, missing screws or pointed screws.
- ⌋ Improper cable bundling; all wires are entering at the top through one hole which is not fire stopped vs. spread at the top which is considered fire stopped which is a new regulation;

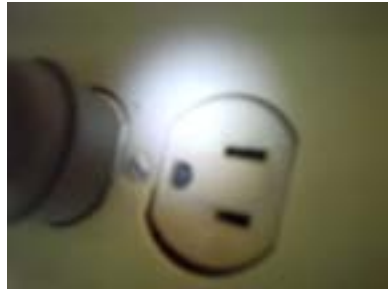
- .. Observed a receptacle more than 12 inches under Island counter.
- þ Observed and touched several loose outlets throughout the house that must be tightened- ([by removing the front cover if present and tightening the inside screws and replacing the covers](#)): some loose, broken, not flush to the wall or gaps around may have been marked;

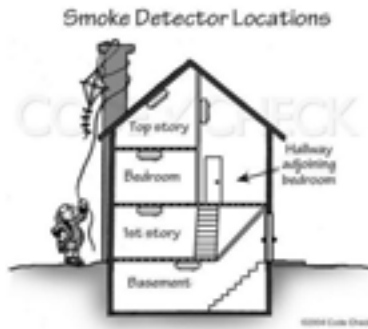
- Alarm(s) are loose at the ceiling/walls
- No alarms installed - Safety Hazard
- ⋄ Alarm(s) did not function - Safety Hazard;
- ⋄ No alarms installed in each bedroom
- ⋄ Alarm(s) are not hard-wired or connected
- No alarms in hallways
- ⌋ Batteries are chirping;
