Summerwood Community

Houston, TX 77044

March 12, 2010

This Limited, Visual Inspection Report is prepared exclusively for

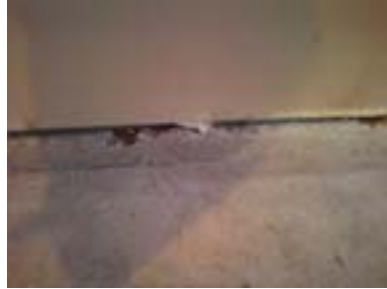
⌋ Chipped on side and step up in exposed concrete slab in garage; may patch around garage,

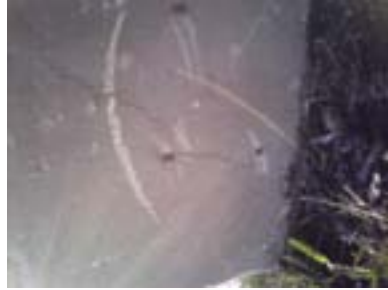
⌋ Observed typical spalling (crumbling of slab) or honey combing. This can be epoxied or touched up and usually happens around the corner/edges of the slab because the stress will break the slab.

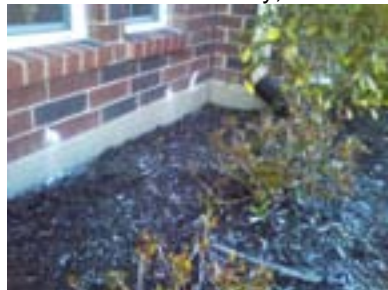
⌋ Improper drainage from foundation and not a decline at all locations away from slab and/or a 6 inch decline at 10 feet away; front needs adjusting and may look/address at sides;

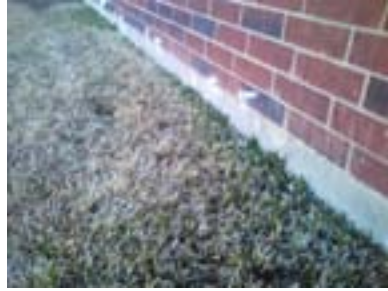
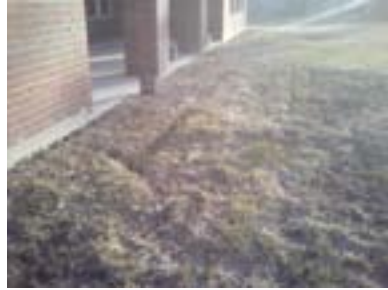
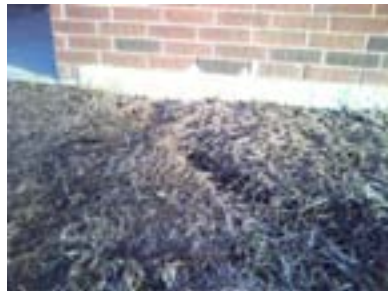
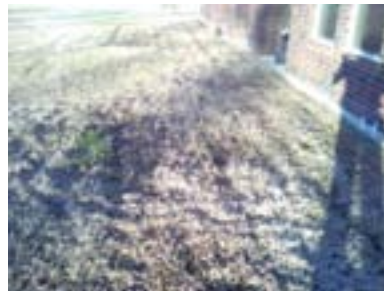
⌋ Erosion or ponding next to foundation/driveway or in yard;possibly front center corner and the back yard has holes,pomndng that must be addressed;

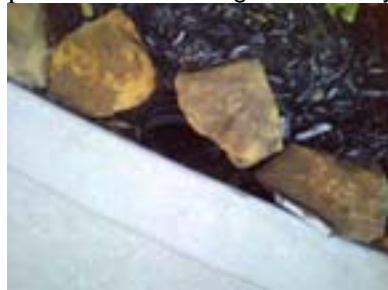
.. Downspout is missing the splash blocks at several locations causing water to sit against the house;

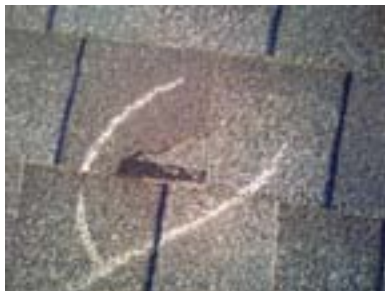
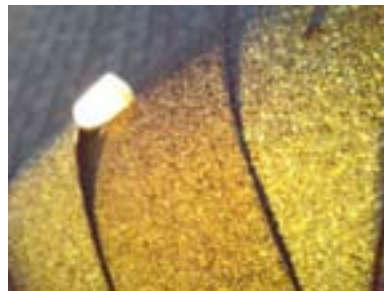
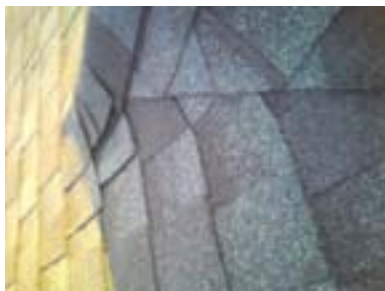
⌋ Some damaged,missing or raised shingles on ridges,valleys or throughout;a few lifts.

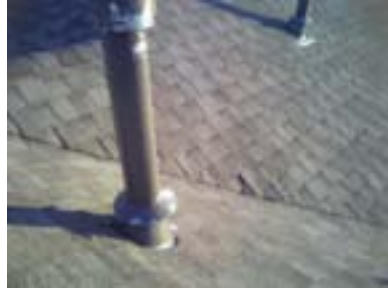
⌋ Flashing in need of repair or replacement; front over garage,

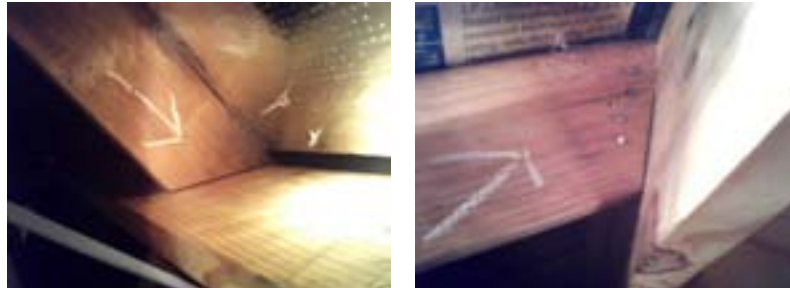
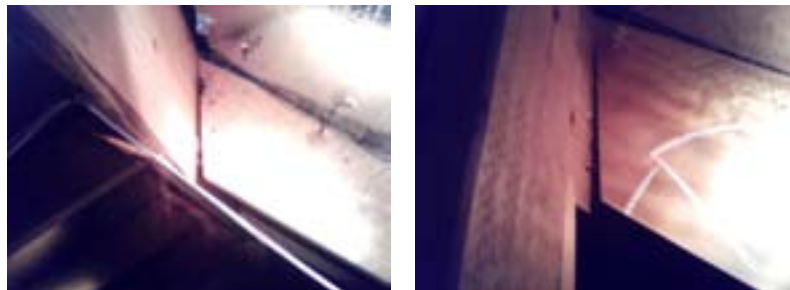
- .. Openings observed around corners of attic that should be blocked;
- ⌋ Roof support and/or failed members; observed 1 or more rafters that are not fully flush against the ridge board, split or that do not meet or align on both sides which could be blocked, metal joist hangers added, another rafter next too, other methods or just monitored; about 3/4 craftsmanship issues marked overhead that could be addressed,

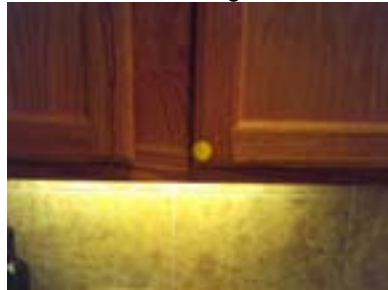
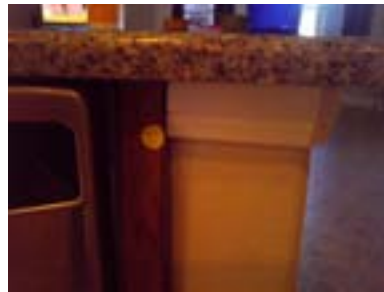
⌋ Caulking/sealant is separated or missing in some areas; shelves in pantry, right of dishwasher, top of backsplash around, end of cabinets, corners in kitchen, fireplace mantel and floor, molding trim all around to name some locations,

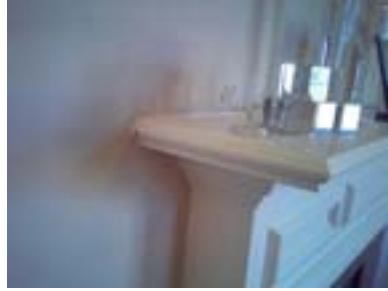
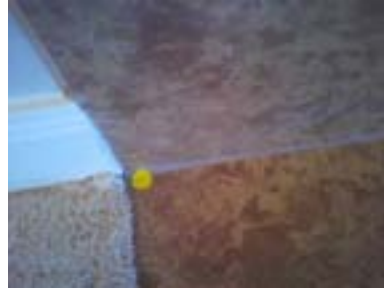
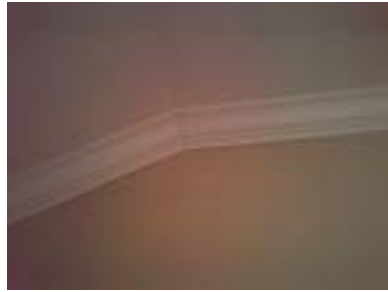
⌋ Trim boards, shelves/racks or hardware is damaged/loose at several areas;master pole is sagging,

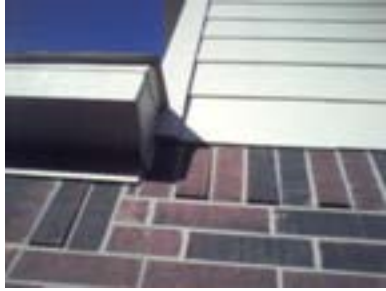
⌋ Mortar is separated or missing in some areas;between some bricks at corners,around windows,over garage,top,

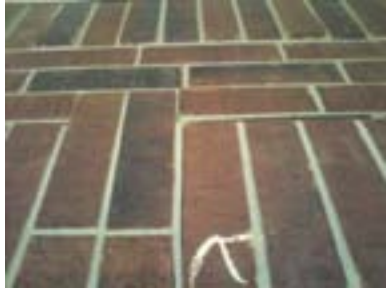
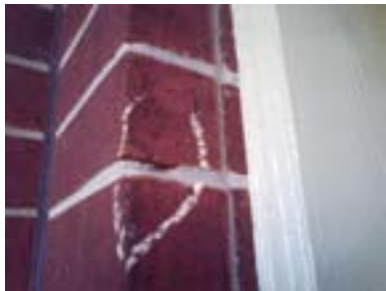
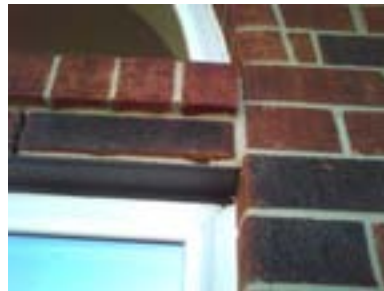
⌋ Caulking/sealant is separated or missing in some areas and should block/seal any and all openings between the wall and trim work;front,corners,back and trim,

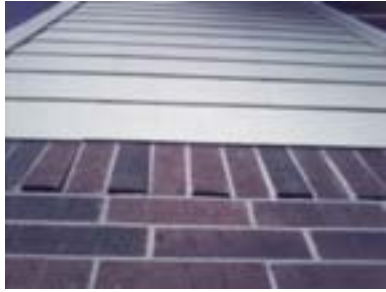
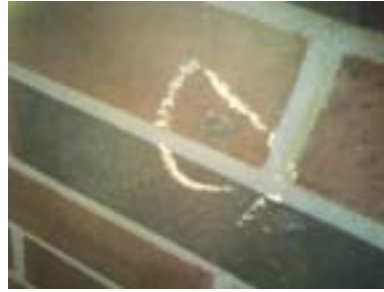
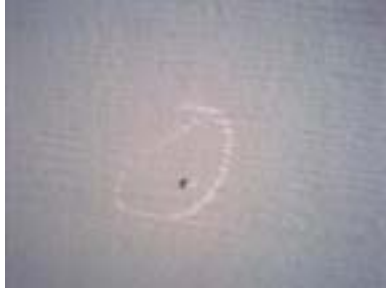
- ∴ Some cracks at the brick, stone, or stucco siding
 - ∴ Wood siding is water damaged in several areas;
 - ∴ Siding shingles are cracked, loose or missing
 - ∴ Observed walls or structure is out of square, bowed or warped in areas:
- ⌋ Some siding fasteners are backing out on both sides, overdriven nails on sides or metal exposed at

back column;

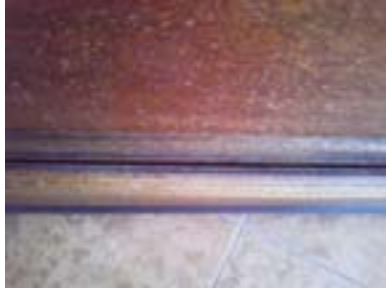
- ⌋ Observed that the automatic self closing device/hinge required by current IBC (International Building Code) on the door between the house and the garage needs adjustment to operate properly or is not present. [This is recommended to help prevent fumes in the garage from entering the living area and to ensure is always fire blocked.](#)

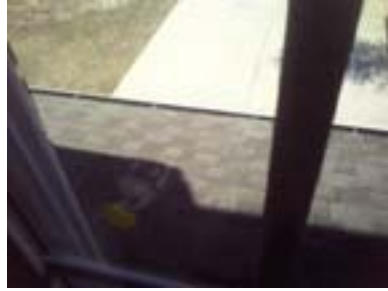
- Some window lift supports are loose, damaged, (popped out) or missing at:
- Some missing or damaged trim or latches at: trim turned in office, middle game room out of square,

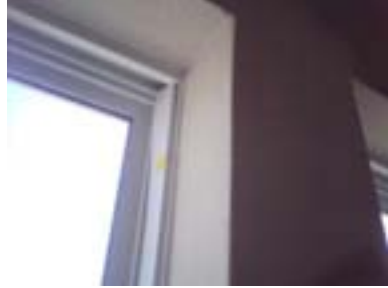
- Some missing and/or damaged screens at: top of laundry bedroom, up front bedroom on 2 screens and some screen pulls are not working properly in several rooms, 1 in living room pulled out when checked,

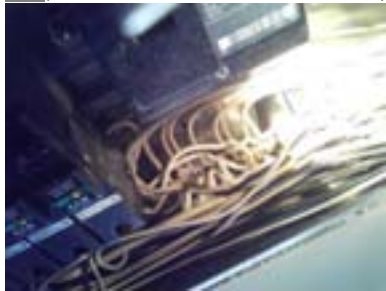
- ⌋ Ground rod less than 6ft apart from each other or less than #6 rod size on 8ft rod;
- ⌋ Double lugged wires of any kind under breakers **or neutral bus bar has several wires together and may be pigtailed from arc-fault, however technically may spread or add another bus bar**; several neutrals are doubled;

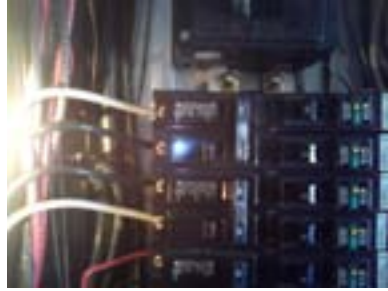
⌋ Lack of anti-oxidant grease on the aluminum service entrance conductors from the power company;both top and neutral lead.

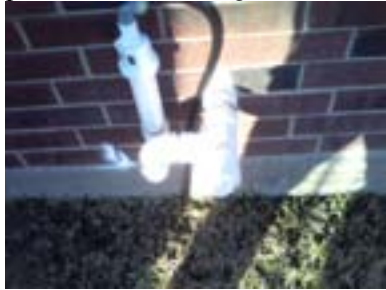
p Sprinkler Anti-siphon is secure in ground or wall,however could/should be strapped to the wall or supported better.
