Downtown townhouse

Houston, TX

December 3, 2009

This Limited, Visual Inspection Report is prepared exclusively for

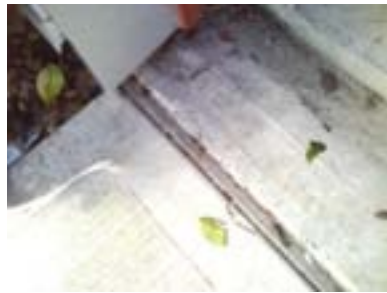
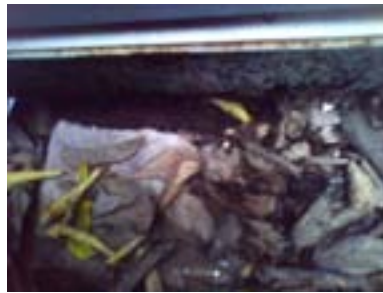
⌋ Wood form strips or other wood observed next to the slab which are conducive to wood destroying insects, which could be removed and replaced along with all cracks sealed with blown in foam covered with a thick layer of caulking;

- ⋆ Post tension live end tips are exposed and should be covered;
- ⋆ Nails or metal is exposed which could be a hazard and could be removed and covered;
- ⋆ Soil is high and should be removed away from the brick so that there is a 6 inch decline at 10 feet away from the foundation which is a cause of foundation settlement

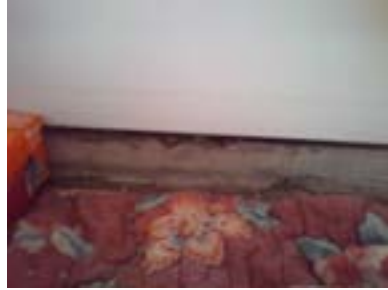
⌋ Observed typical spalling (crumbling of slab) or honey combing. This can be epoxied or touched up and usually happens around the corner/edges of the slab because the stress will break the slab;inside garage,

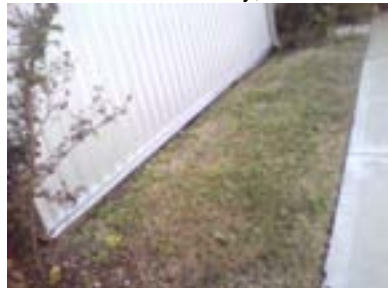
⌋ Improper drainage from foundation and not a decline at all locations away from slab and/or a 6 inch decline at 10 feet away;west side and back yard,

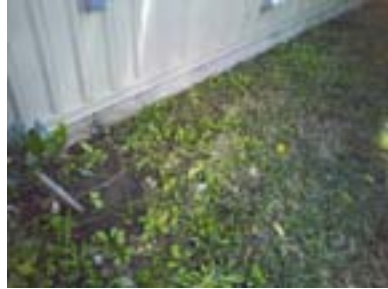
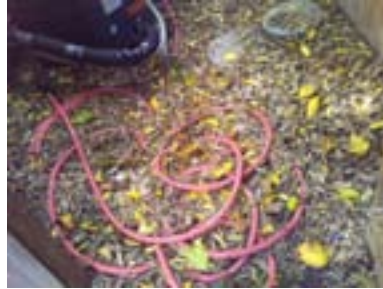
⌋ Erosion or ponding next to foundation/driveway or in yard;side and back has a hole,

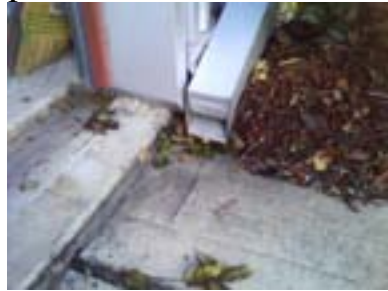
Ⓟ Gutters draining too close to the structure;garage,

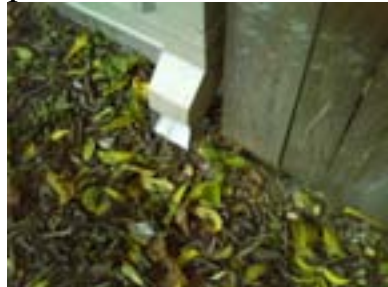
Ⓟ Downspout is missing the splash blocks at several locations causing water to sit against the house;

- .. Observed the foundation elevation was less than 12 inches + 2% above the street drain.
- .. Could consider adding a gutter system in all locations to divert the water away;

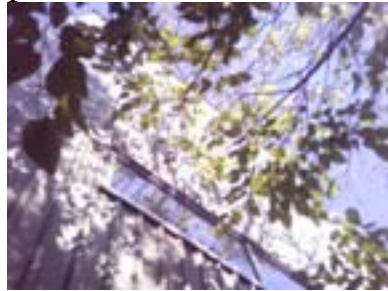
- .. Roof decking deflection, raised and/or sagging;
- .. Roofing covering installed over older roof covering
- .. Inappropriate roof covering for slope of the roof;
- b** Observed some exposed nails and/or staples showing that should be covered or caulked as part of routine maintenance; all screws need to be sealed;
- .. Trim, soffit, fascia boards are in need of repair
- .. Roof covering is in contact with siding;
- .. Leaves/debris in the gutters and downspouts;
- b** Tree branches are too close to the roof structure and wall,

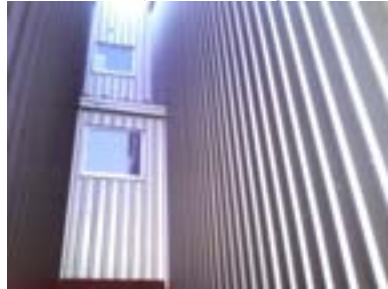
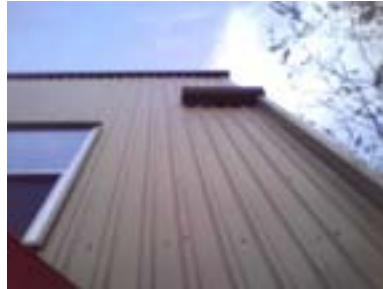
- .. Roof penetration(s) or flashing not properly secure, flashed/sealed;
- .. Brick chimney not properly flashed and counter-flashed;
- .. Skylight covers not secured and/or flashed properly
- .. Chimney cricket/saddle is missing if 30+ inches wide;
- .. Missing rain skirts on metal fireplace or furnace flues
- .. Missing/damaged rain caps on furnace/water heater flues
- .. Storm collars are not caulked completely on furnace/water heater flues and/or could view daylight from attic access;
- b** Valley/step or counter flashing in need of repair or replacement; could add a kick out plate over neighbors front door to direct water away so does not run down wall, may monitor gutters over porch because when full may be allowing water to bounce inside door trim or flash around balcony patio door better;

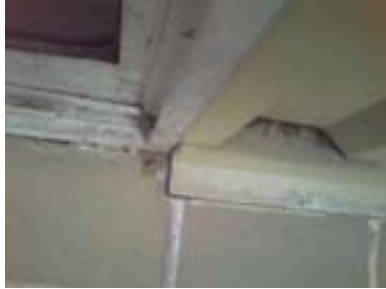
- .. Missing/damaged rain caps on metal fireplace flues
- .. Missing step flashing (about 8 inch sheets) where a roof intersects at exterior wall which is the type approved per most manufactures and/or J-flashing (long continuous sheet, which if water enters could run continuous) is in use;

.. The roof covering is in need of replacement or extensive repairs, a Certified Roofing Company should be consulted

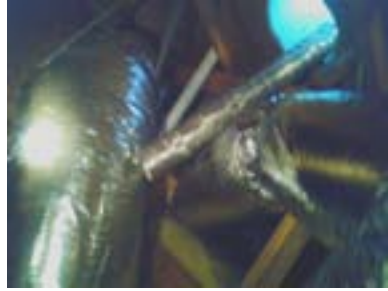
- Open raceway from the garage to the house which should be blocked at the garage with a fire rated material. This creates an open chimney if a fire occurred and should be fire blocked
- Open chase should be fire blocked every 10 feet horizontally or vertically including around duct penetrations, between floors, and other openings and currently if a fire occurred could serve as a chimney.
- Roof sag due to the decking should have more support. May try to add the h clips or fasteners
- Observed exposed and hot wires throughout the attic;
- Observed exposed gas or drain/water pipes that are loose or out in the walkway and should be blocked or strapped throughout;

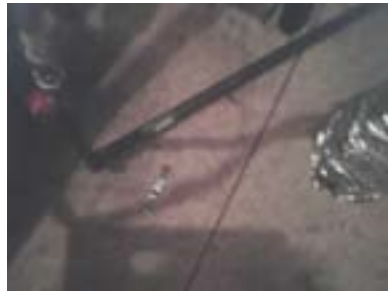
- Observed debris,lumber,trash throughout the attic that should be removed.
- Observed an inadequate walkway or platform to mechanical equipment in the attic. Current code requires 30 inches of head clearance, a 24 inch solid walkway with no obstructions and a 30 inch deep solid platform in front of the equipment and must be flat flush secure surface;
- Current code requires all wires within 6 feet of the attic opening to be protected and observed unprotected electrical wires near the opening. This could lead to wire damage and possible electrical shock or potential fire hazard;may tuck under better.

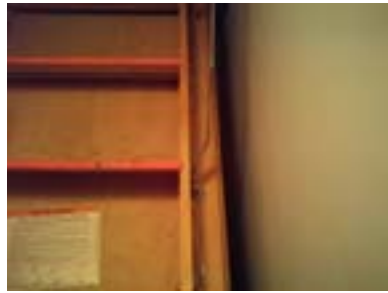
⌋ Lack of foam board insulation inside the steps along with weather-stripping on the outside edge;

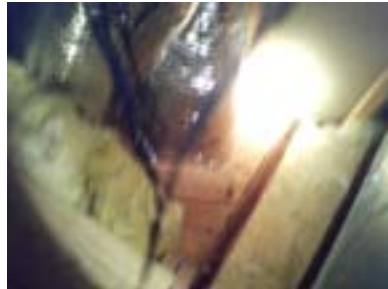
⌋ Noticed an area that should have insulation added or extra layers throughout;next to access and could have sheathing on the side walls;

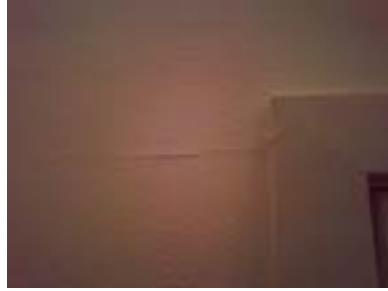
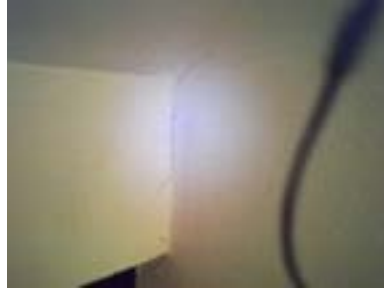
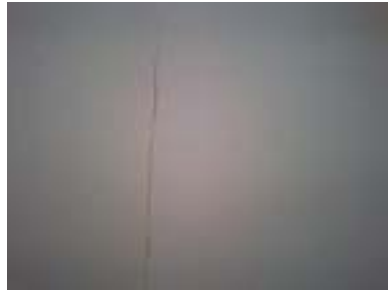
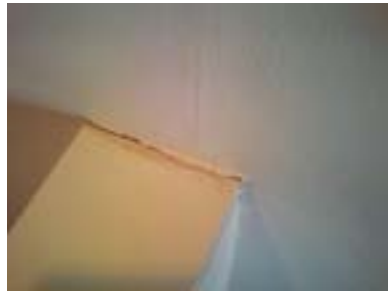
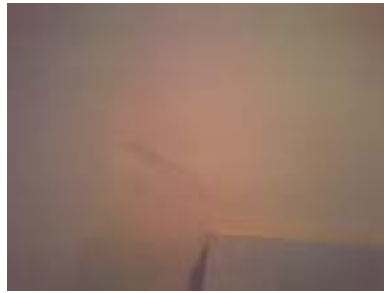
⌋ Signs of Structural Settling or past damage;above front door,under stairwell,all around down office window,above kitchen patio door,living room corner,upstairs over master door,master bedroom to name some,

⌋ Signs of water stains or water penetration - measured with a moisture meter set on gypsum for sheet rock and registered .2% moisture content which is dry and may want to repair past damage at:above areas;

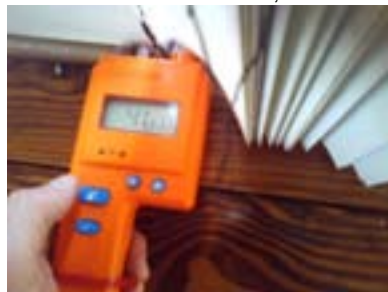
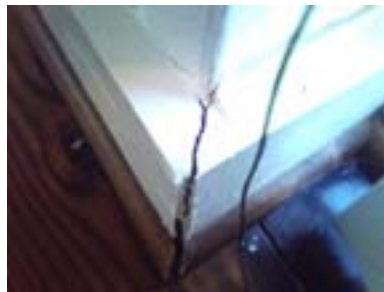
⌋ Signs of water stains or water penetration - measured with a moisture meter set on wood for trim work and registered 32 to 40% moisture content which is wet and should repair the past damage at:kitchen area patio baseboard trim and floor;

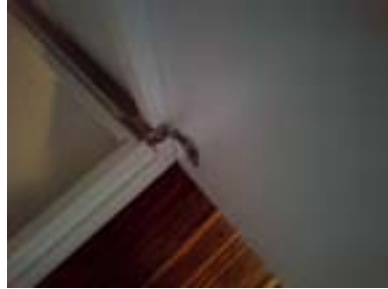
⌋ Cabinets,counter or drawer issues:right cabinet door on side of oven is very loose at hinge,

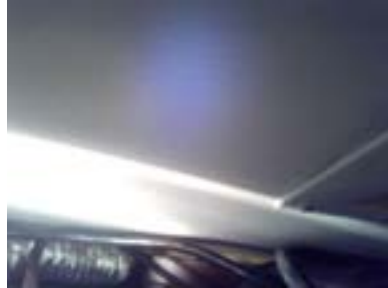
⌋ Trim boards, shelves/racks or hardware is damaged/loose at several areas;separated and moist behind washing machine and breakfast area,

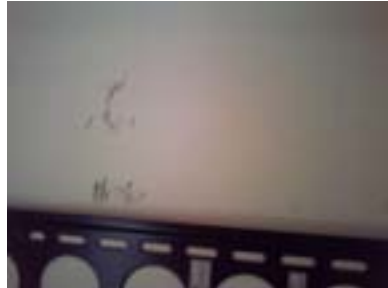
⌋ Observed several paint chips or sheet rock cracks and some where marked;all above,hole in master bedroom wall from tv and some corners are scuffed or peeling.

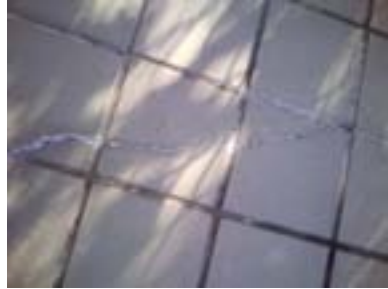
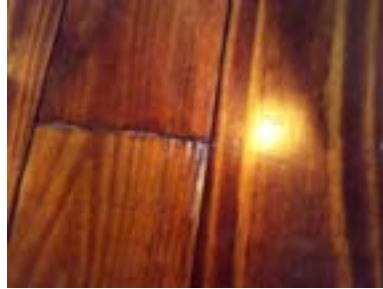
- ** Paint stains on floor;
- ** Linoleum or floor covering is torn
- ** Carpet and floor covering is stained and dirty throughout the house
- ** Freshly painted or stained floor

⌋ Floors were uneven or creaked when walked across or warped/bowed in areas:

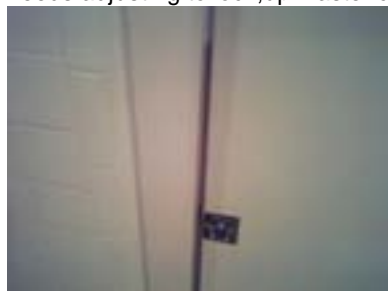
⌋ Closet doors slide poorly, off of their rails or missing at: down bath not latching because hits at top first and needs adjusting to lock, up master closet,

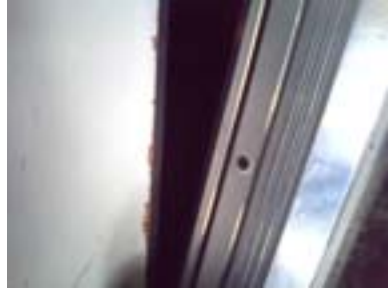
⌋ Damaged doors at: nick in bottom of garage door,

- Doors are loose at the hinges at:
- Doors rub, stick, swing independently or hit the frames at: _____
- Door locks or doorknobs are in need of repair at: garage knob is loose,

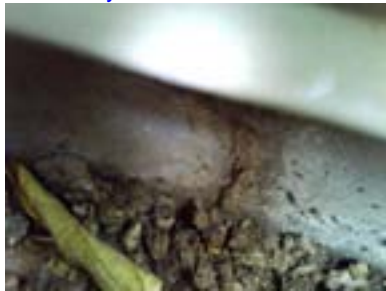
- .. Some mailbox or flag issues were observed:
- ⌋ Some other safety or tripping hazards exits around house:holes in back,

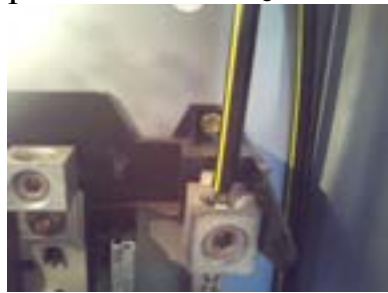
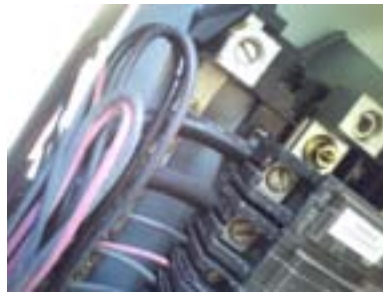
- .. Panel(s) are not labeled properly
- .. Panel has more than 6 main disconnects
- .. Panel(s) are loose at the wall, missing screws or pointed screws.
- .. Improper cable bundling;all wires are clamped together vs. spread which is a new regulation;
- .. Panel inner safety cover is loose or missing
- .. One or more knockouts are missing
- .. Ground wire/rod could not be verified or buried in ground;
- .. Double lugged breakers/fuses
- .. Ground wire not connected correctly to grounding rod or a loose clamp that should be tightened.
- .. Incorrect size of breakers/fuses
- .. Incorrect wire on breakers/fuses;observed white wires used for hot current attached to a breaker,green for other than a ground and/or red and black for other than hot current;
- Ⓟ Lack of anti-oxidant grease on the aluminum service entrance conductors from the power company;

- .. A/C condensing unit specifies a max amp breaker of 40 and a 40 amp breaker is in use
- Ⓟ Arc-Fault circuit breakers not observed or improperly installed for electrical receptacles in family rooms, dining rooms, living rooms, parlors, libraries, dens, sunrooms, recreation rooms, closets, hallways, or similar rooms or areas. This is a new regulation as of slab poured after September 2008 and homes built prior to this were not required to have arc fault protection except for bedrooms only and prior to mid 2,000's was not required at all and now current industry requires and not sure this panel could hold the proper amount needed; Confirmed 2 breakers must have protected all the bedrooms and not turned off since occupied.

- Ⓟ Panel(s) are not caulked and/or missing silicon around the outside of the Panel or inside the openings;
- .. This is a Federal Pacific Stab breaker panel that should be evaluated by a professional electrician and please refer to the Federal Pacific clause below that is recommended to add by Inspector Association;

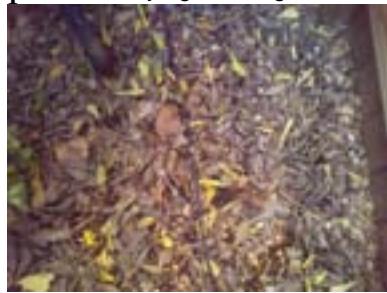
⌋ Wires lying on the ground in back of house;low voltage cable wire in back,

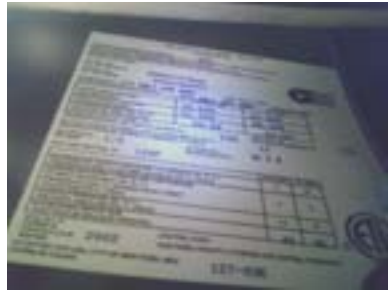
This unit is a Split level GOODMAN brand model # and serial # and determined it was manufactured in 2005 by analyzing the data plate.

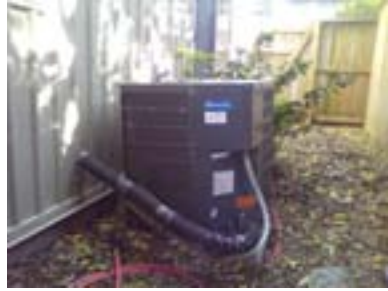
- Freon lines not properly insulated at: Condenser(s) Air Handler(s) In Attic
- Condenser unit(s) coils dirty
- ⌋ Condenser unit(s) are not level;

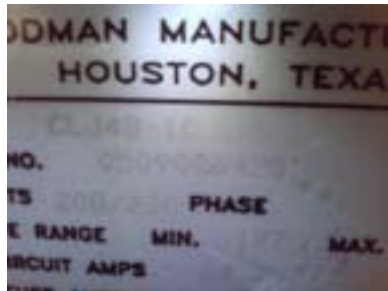
Type: GOODMAN - Model # and Serial # is below with a min of 25 AMPS and max circuit breaker of 40 AMPS. This is a 4 ton unit and was manufactured in 2005 by analyzing this data plate.

One ton should cool 550 to 600 square feet of house and if a newer energy efficient house between 600 to 700 and this **4 ton** unit should cool between **2,200 to 2,400** square feet or more without any issues.

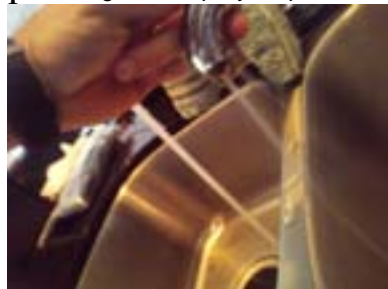
Overflow not working;left upstairs master sink;

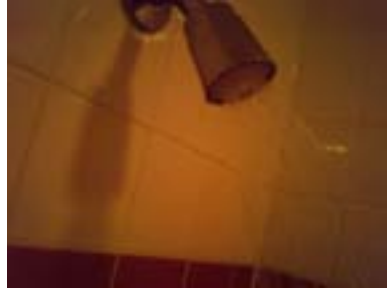
- Leakage around tub(s)
- Faucets have low water pressure
- Water hammering noted
- Leakage around shower(s)
- Absence of safety glass enclosure
- Shower head is leaking;downstairs,

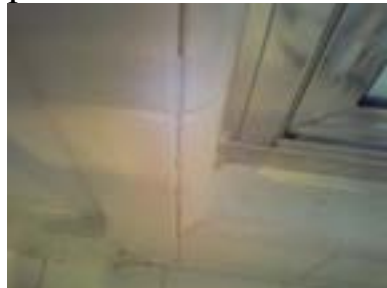
- Shower head is loose;
- Hot and cold water reversed;could not get hot water on shower head on master back/outside wall,
- Loose/damaged faucet handles
- Improper slope of shower floor
- Tile loose and/or needs sealing;outside master tub,

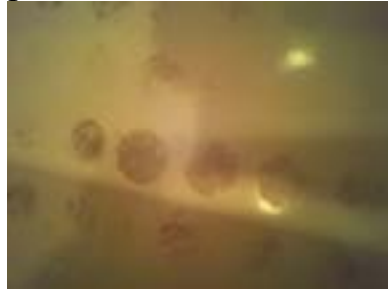
- Drain stop inoperable or missing
- Soap dish missing
- Porcelain scuffs or scratches in tub;downstairs; may can be cleaned,

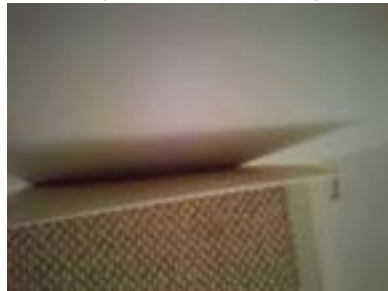
- Access panel is missing behind tub overflow and faucets;all are missing and up master has a cover,however no cut out;

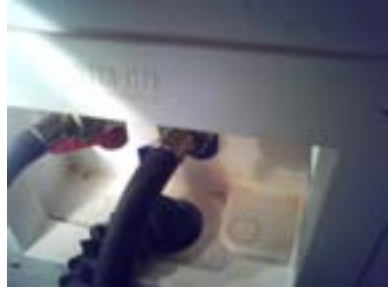
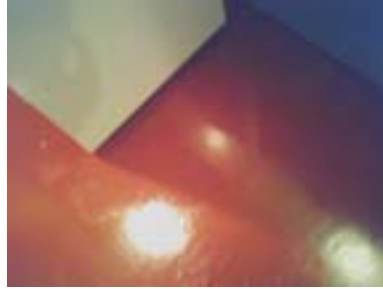
⌋ Leakage at plumbing connections; hot valve appears to have been dripping for a while and a puddle on the floor;

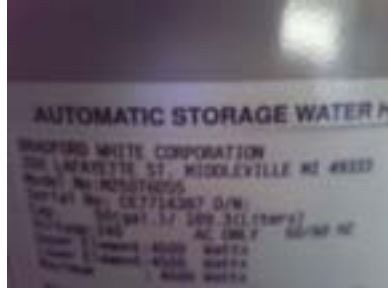
Type: BRADFORD WHITE and the info in below picture. The TRP valve is NOT tested (except for new construction and warranty) or operated at the time of inspection due to sometimes if has not been tested in the past year or so may not close properly leaving a constant water drip from the TRP line, however should always keep the pan clean and wiped down and test the TRP valve each year as to keep the rust and sediment buildup to a minimum.

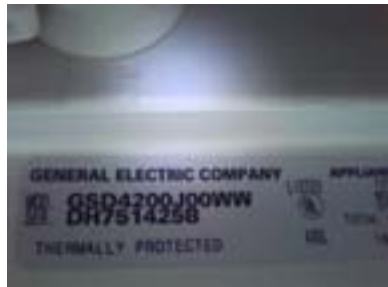
Note: Operated the dishwasher through all cycles and checked for leaks around outside and underneath. This unit is a GE brand and model/serial # is below.

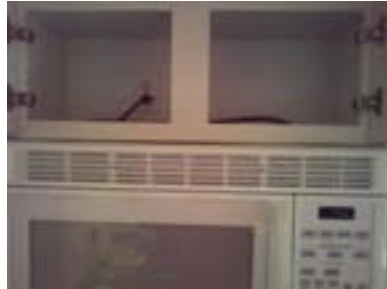
- .. Filter is dirty/greasy
 - .. Light not functioning
- ⌋ Vent pipe terminates improperly or does not completely vent all air to the exterior. The range is not the best system because it circulates the air back into the kitchen vs. to the exterior, however appeared to function at the time of inspection. Prefer the type system that takes the air to the exterior vs. recycling inside the house.
