**Local Neighborhood**

**Humble, TX**

**November 2009**

**Mr. and Mrs. Typical home**

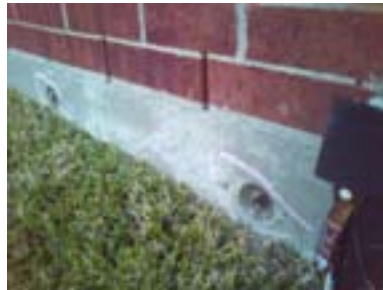
⌋ Post tension live end tips are exposed and should be covered;just starting to break through on kitchen corner,however all must be covered on front east side,

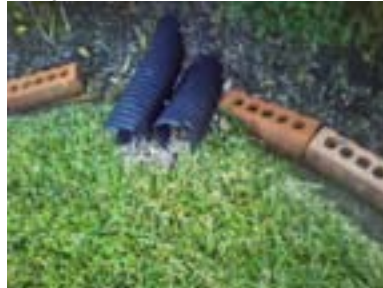
⌋ French drain system that should be monitored for leaks so that water does not seep into the ground and work under the slab;should be free flowing at ends and not blocked;

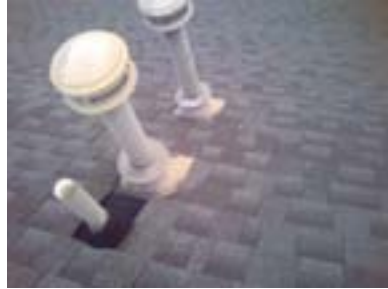
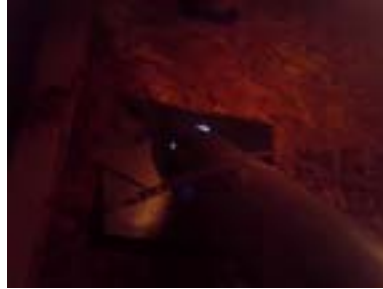
⌋ Valley/step or counter flashing in need of repair or replacement;this roof does not have a metal drip edge and only a wood edge,must secure all raised flashing,

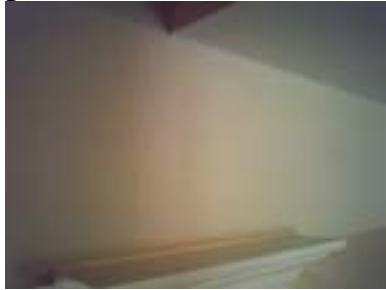
- .. Trim boards, shelves/racks or hardware is damaged/loose at several areas
- .. Observed several paint discolorations and scuff marks throughout the house which some were marked;
- ⌋ Observed several paint chips or sheet rock cracks and some where marked; over stairwell column,

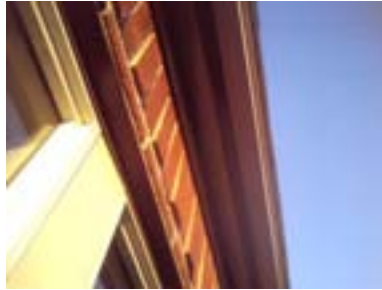
between the wall and trim work and at brick intersections, some windows, picture in front.

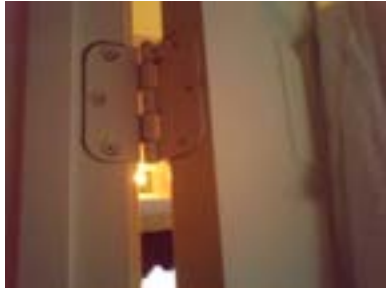
⌋ Doors are loose at the hinges at: master center hinge a little loose, top master commode door, top hall bathroom, 1 in a closet.

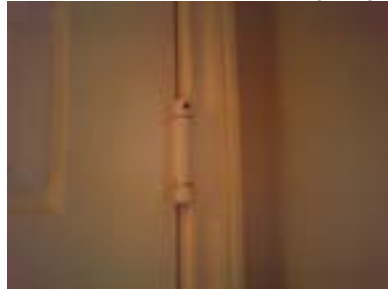
**p** Observed that the automatic self closing device/hinge required by current IBC (International Building Code) on the door between the house and the garage needs adjustment to operate properly which is recommended to help prevent fumes in the garage from entering the living area.

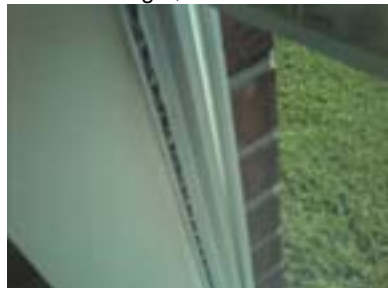
**p** Some window lift supports are loose, damaged, (popped out) or missing at: extended kitchen back left, living room back right,

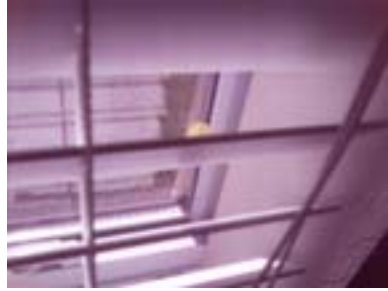
**p** Some missing or damaged trim or latches at: some trim turned in living room and a few others,

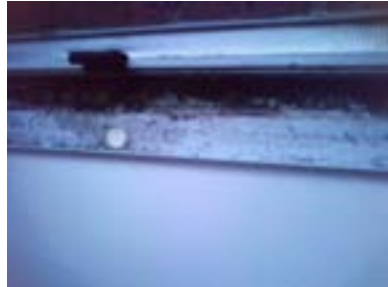
Ⓟ Some windows have been drilled through for alarm sensors which will void the manufacturer's warranty unless the builder received approval and has the approval on file. These drill holes must have a good caulk seal so that water will not penetrate into the wood and some need sealing;

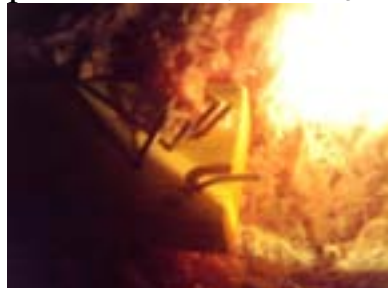
⌋ Some other safety or tripping hazards exits around house:Nails in attic turned upward,

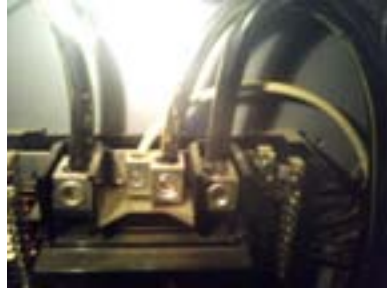
⌋ Lack of anti-oxidant grease on the aluminum service entrance conductors from the power company;

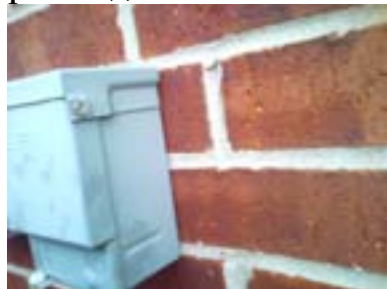
⌋ Panel(s) are not caulked and/or missing silicon around the outside of the Panel or inside the openings;

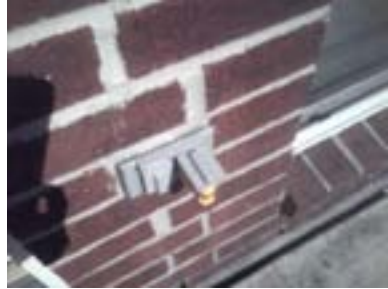
One or more junction boxes do not have covers or rain protective/weather resistant boxes for exterior locations in all damp or wet receptacle areas;(2008 NEC 406.8),

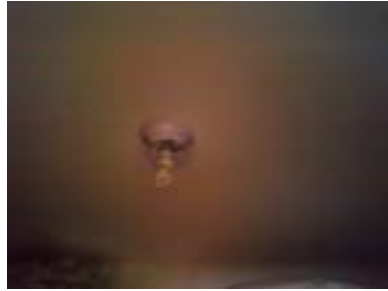
- Some light fixtures and/or bulbs did not function;1 over front furnace in attic,
- Closet light fixture does not have proper clearance
- \*\* Some light fixture covers are damaged/missing;
- Some light fixture globes are missing from the clothes closets which must be present per NEC standards;master fixture is missing.

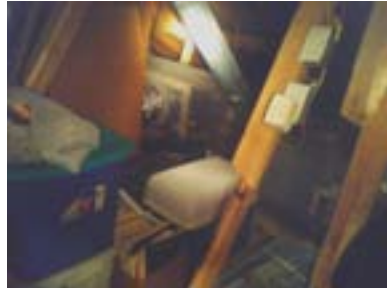
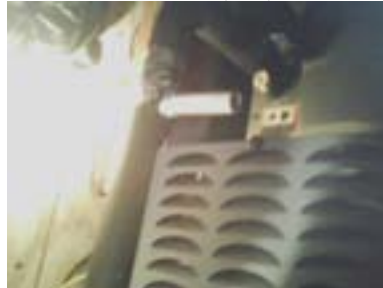
- Flue is loose or not properly connected to the unit
- Inadequate ventilation for combustible air
- Access panel bent, not properly attached or openings allowing debris to enter;
- Flue is in contact and/or too close to combustibles
- Rust at the burner and/or burner compartment
- Improper clearance between storage and unit and the primary drain line is really in the way of removing the access which should reroute or adjust, removed anyway.

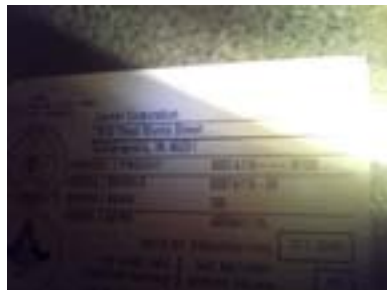
This unit is a Split level CARRIER brand model # and serial # and determined it was manufactured in OCT 2002 by analyzing the data plate. This is the BACK unit and HEATS THE DOWNSTAIRS.

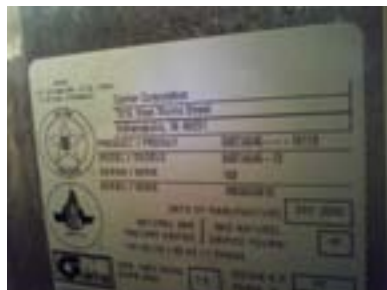
This unit is a Split level CARRIER brand model # and serial # and determined it was manufactured in DEC 2002 by analyzing the data plate. This is the FRONT unit from the attic entrance and HEATS THE UPSTAIRS.

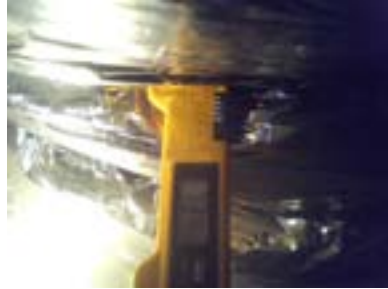
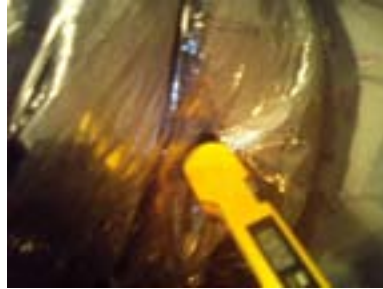
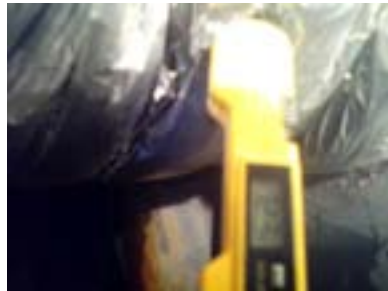
Attic check with Duct thermometer - Supply Air Temp: 49.6 /51.2 on down unit and 62.4 on upstairs Return Air Temp: 73.4 on down unit and 76.4 upstairs Temp. Differential: 22 to 24 on down and 5.6 up 1st read and 14 2nd read Degrees F; by checking in the duct or plenum with a duct thermometer in the attic. This is referred to as a Delta T.

␣ Temperature differential is not within range of 15-20 degrees Fahrenheit); inconsistent readings and were checked several times.

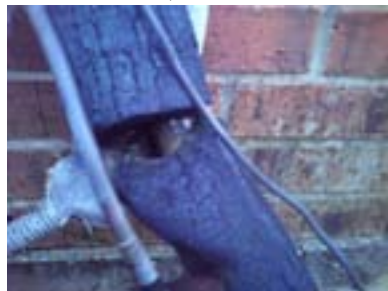
␣ Freon lines not properly insulated at: ␣ Condenser(s)-small piece not covered    ○ Air Handler(s)  
 ○ In Attic;

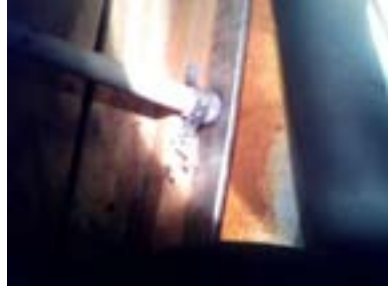
- Condenser unit(s) coils dirty
- Condenser unit(s) are not level
- No data plate present or verified;
- No electrical cut-off within view of condenser unit
- Condenser coil(s) fins are damaged
- Air handler plenum is not properly sealed
- Condenser airflow is restricted by foliage
- No drain pan and/or drain line under the air handler
- Rust, debris was found in the overflow pan like it may have overflowed in the past and should be cleaned or replaced to ensure it does not leak;

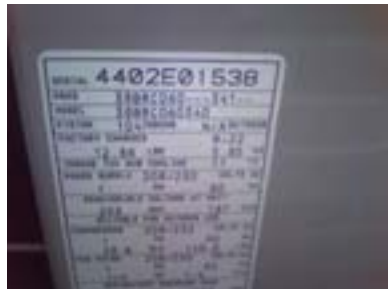
Type: CARRIER- Model # and Serial # is below with a min of 40 AMPS and max circuit breaker of 60 AMPS. This is a 5 ton unit and was manufactured in 44TH WEEK OF 2002 by analyzing this data plate and COOLS the DOWNSTAIRS.

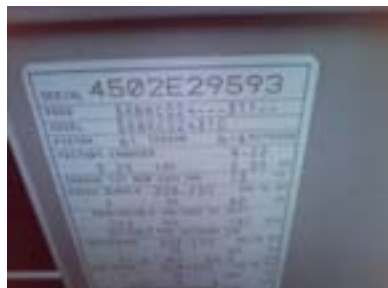
Type: CARRIER- Model # and Serial # is below with a min of 15 AMPS and max circuit breaker of 25 AMPS. This is a 2 ton unit and was manufactured in 45TH WEEK OF 2002 by analyzing this data plate and COOLS the UPSTAIRS.

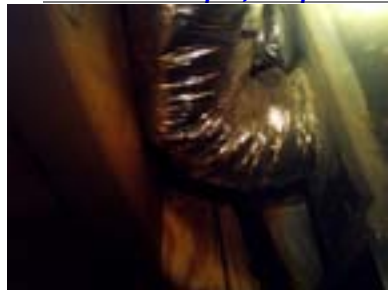
⌋ Ducting is kinked or restricted in one or more places which may be affecting airflow or found a heat differential less than 8 degrees per room at: up unit return duct is crimped, **108 in front 2 rooms (may be closed or damper, crimped issue) and 126 to 130F other rooms and upstairs would not ignite**

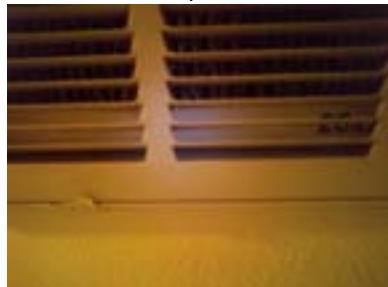
- Ducting is lying on the attic floor or resting against each other throughout the attic which should be well suspended throughout the attic
- ⌋ Return air filters are present throughout the house and should be replaced because are dirty or torn at:

- 12x12x1     12x24x1     16x25x1    ⌋ 20x25x1-master hall, upstairs and front hall and register is difficult to open in front,    " 20x30x1;

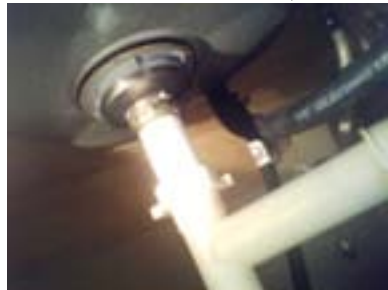
Leakage around sink(s) at:left sink top of stand pipe connection (may be seal is dry rotted) and possibly in center at connection,

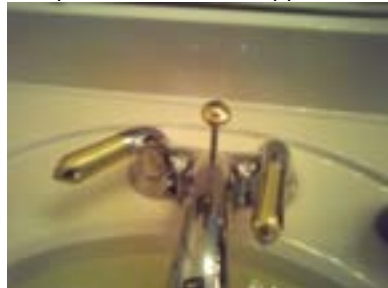
Loose/damaged faucet handles and or constant drip; kitchen ok if in center position,left hot handle firm to open in master and appeared to be dripping,

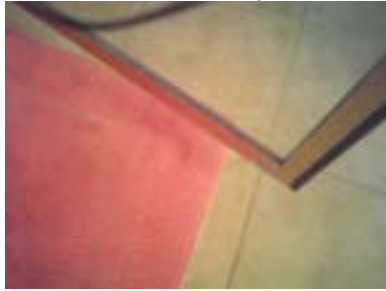
- Absence of safety glass enclosure
- Shower head is leaking;
- b** Shower head is loose;master slightly,
- .. Hot and cold water reversed;
- Loose/damaged faucet handles
- Improper slope of shower floor
- Tile loose and/or missing
- Shower diverter valve not operating
- .. Shower diverter valve allowing water from tub faucet when shower is in operation;
- b** Enclosure needs to be sealed;or bottom drip guard missing and allowing water to drip on floor when turned toward back glass corner;

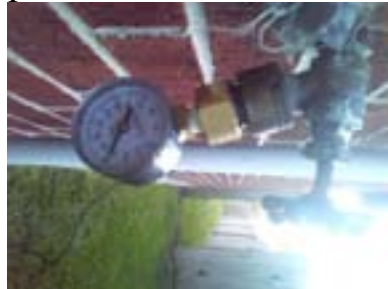
- .. No backflow prevention at hose bibb(s):
- .. Faucet handles are loose, damaged or missing:
- b Leakage at: all drip slightly from the nut on faucet, most likely needs tightening,

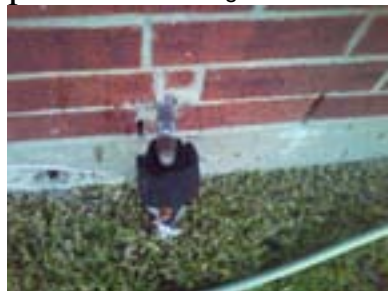
- b Insulation missing and/or needs reattaching; shut off valve,

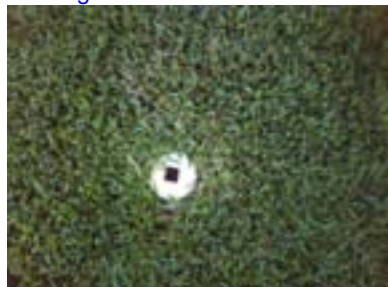
The main water pipes are copper, and the sewer clean out is located in front corner of garage and cap is missing or broken.

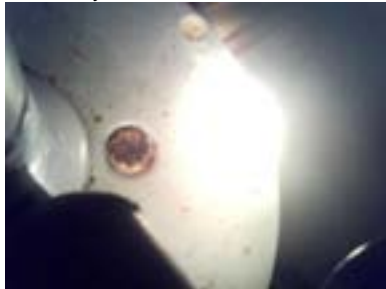
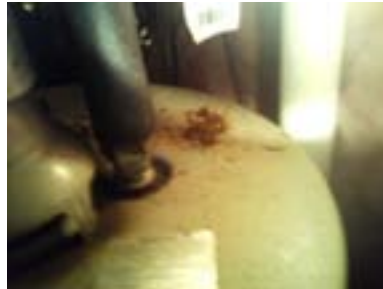
␣ Corrosion and/or signs of an intermittent leak at isolation valve, and/or plumbing connections;from around flue entry and anodes,

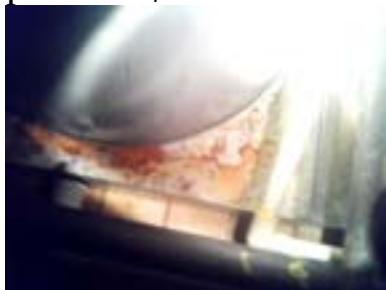
␣ Unit drain pan has debris and/or rust in pan,

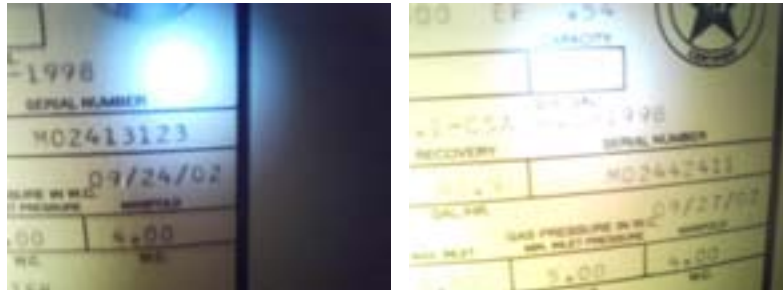
Type: STATE INDUSTRIES-STATE SELECT and the info in below picture. The TRP valve is NOT tested (except for new construction and warranty) or operated at the time of inspection due to sometimes if has not been tested in the past year or so may not close properly leaving a constant water drip from the TRP line, however should always keep the pan clean and wiped down and test the TRP valve each year as to keep the rust and sediment buildup to a minimum.

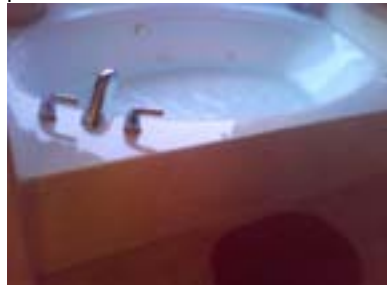
⌋ The motor for the hydrotherapy tub was not accessible which is common, thus not visible for inspection. Proper grounding/bonding could not be verified. Ideally a readily operable inspection door should be provided in order to access the whirlpool motor.
