New Builder Community

Humble, TX

June 29, 2010

This Limited, Visual Inspection Report is prepared exclusively for

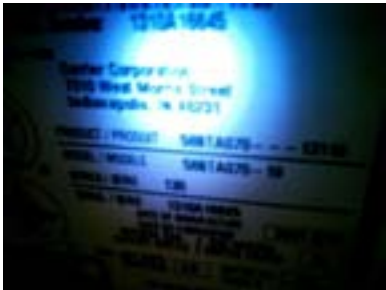
This unit is a Split level CARRIER brand model # and serial # and determined it was manufactured in March 2010 by analyzing the data plate.

⌋ Secondary drain line is connected and secure,however not completely aligned properly and terminating over the back window.
