**Sitting Empty in Neighborhood**

**December 7, 2009**

**This Limited, Visual Inspection Report is prepared exclusively for**

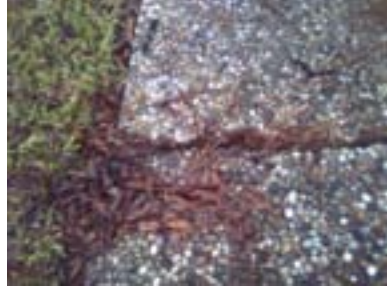
⌋ Door and/or window frames out of square, did observe a sag over garage door;

⌋ Cracks in sidewalks, driveway, patio or garage which is very common; if large uneven areas in driveway could cause tripping hazards;

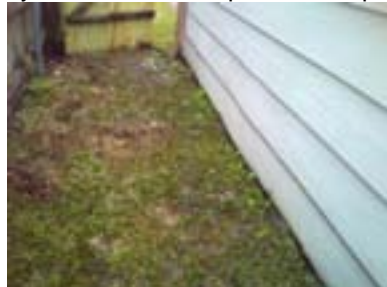
⌋ Low spots around house allowing water to pond against the slab - recommend placing a gutter system with downspouts and splash pads if not present and repair the drainage issues;

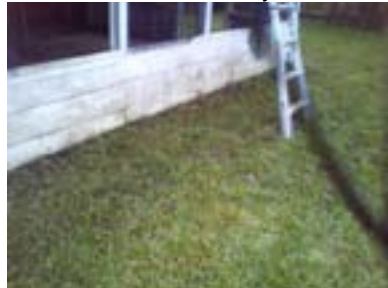
⌋ Improper drainage from foundation and not a decline at all locations away from slab and/or a 6 inch decline at 10 feet away;all around;

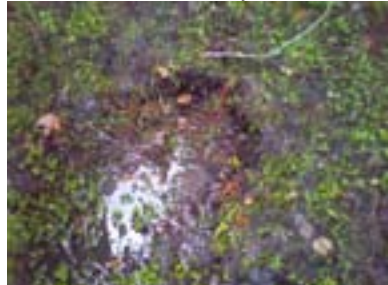
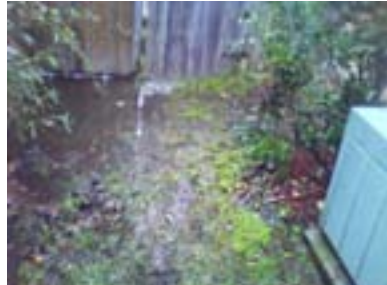
⌋ Erosion or ponding next to foundation/driveway or in yard;very muddy all around the back and should add a drain system on the sides and back because a lot of water is standing;

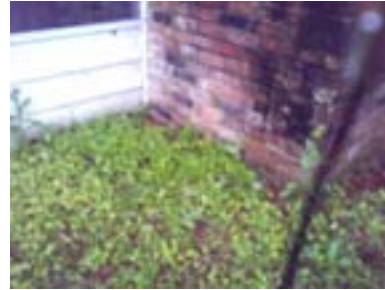
- .. Trees/heavy foliage too close to the structure
- .. A/C condensation line terminates too close to structure
- .. Planter(s) adjoining the structure
- ⌋ Inadequate grading clearance (high soil) to exterior wall surface;back is mud and high mulch in front,

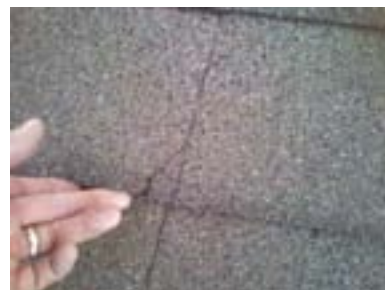
- ⌋ Some damaged,missing or raised shingles;1 or more missing shingles in front,a few tears around,feathered or worn and nearing the end of its life expectancy;

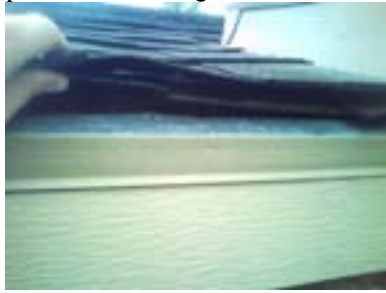
⌋ Roof decking deflection, raised and/or sagging; back at edge,

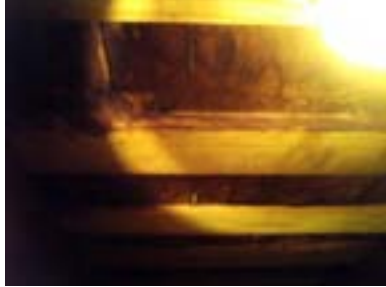
⌋ Roofing covering installed over older roof covering; cedar shakes on bottom,

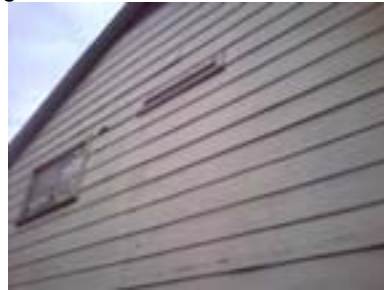
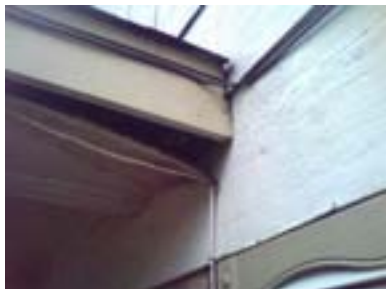
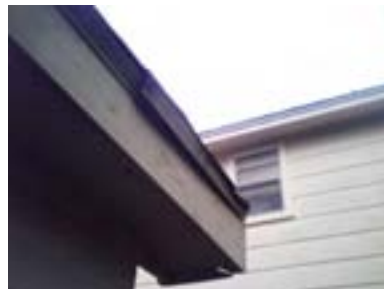
⌋ Trim, soffit, fascia boards are in need of repair; front fascia and some soffit damage, missing trim in front and drip edge loose over garage,

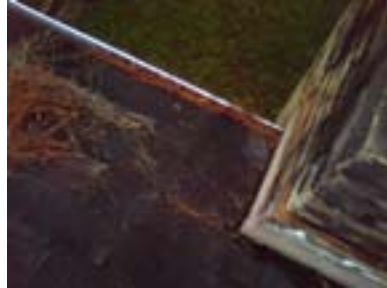
⌋ Leaves/debris in the gutters and downspouts;

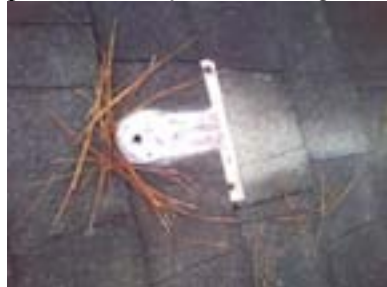
⌋ Vent roof jacks missing, deteriorated or improper installation observed.

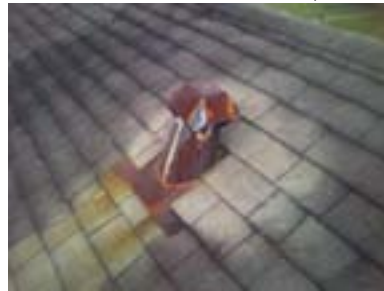
- .. Roof penetration(s) or flashing not properly secure, flashed/sealed;
- .. Brick chimney not properly flashed and counter-flashed;
- .. Skylight covers not secured and/or flashed properly
- .. Chimney cricket/saddle is missing if 30+ inches wide;
- .. Missing rain skirts on metal fireplace or furnace flues
- ⌋ Missing/damaged rain caps on furnace/water heater flues;all are rusted and not the proper type;

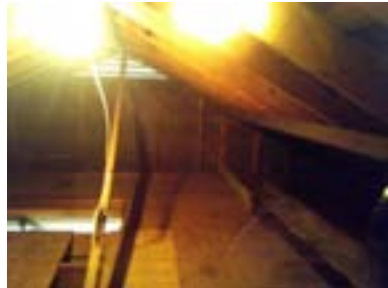
⌋ Roof support from rafters, bracing, purlins, ties may not be adequate;missing braces under purlins in back east and far west side overhead in house and garage, and collar ties over garage and front of house,

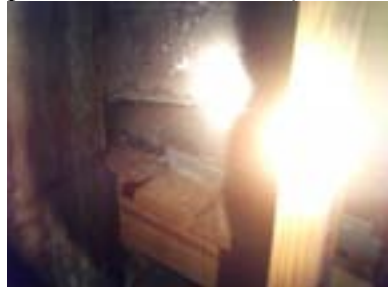
⌋ Evidence of moisture penetration;where lack of flashing at front wall intersection,

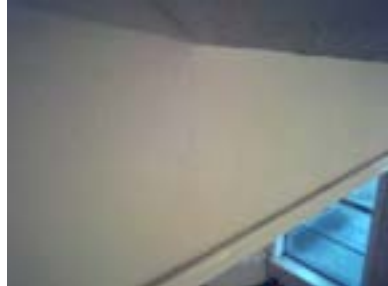
⌋ Signs of Structural Settling;stairwell,

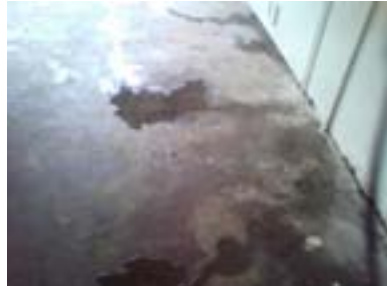
⌋ Signs of water stains or water penetration - measured with a moisture meter set on gypsum for sheet rock and registered 1% moisture content which is damp and may want to repair past damage at:between garage and laundry wall under substance area and 1.5% at bottom which may be from water coming in from roof, leaking at shut off under kitchen sink,laundry drip and water heater and back wall of garage is wet,

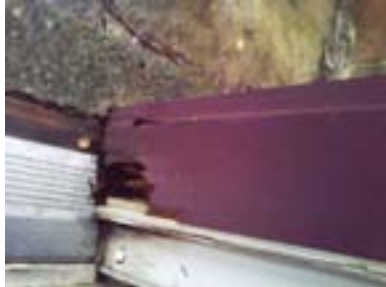
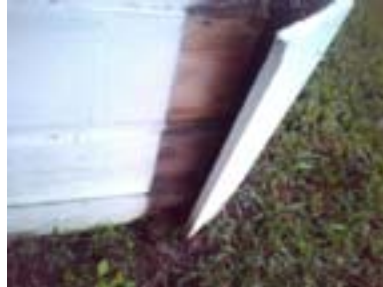
⊆ Fascia/trim boards are damaged at several areas;front door,back porch trim,

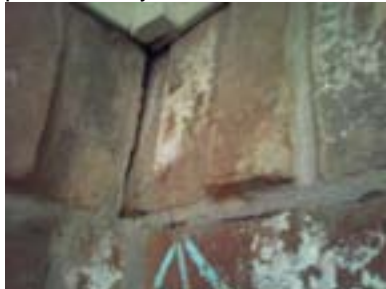
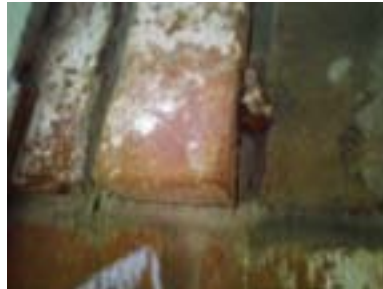
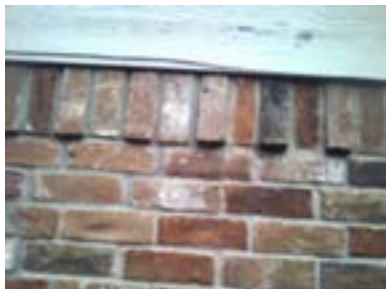
⊆ Mortar is separated or missing in some areas;between some bricks at corners,around windows,front porch is very loose and a few more corners;

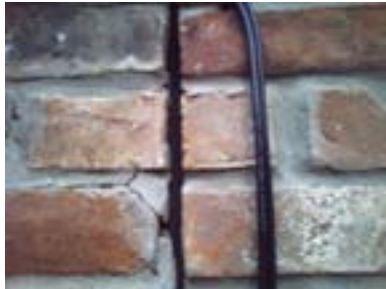
⊆ Caulking/sealant is separated or missing in some areas and should block/seal any and all openings between the wall and trim work;expansion joints;

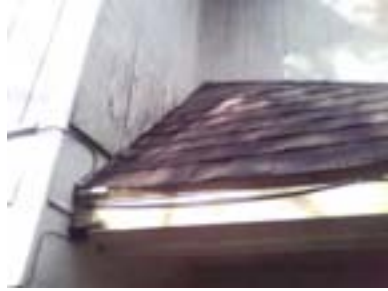
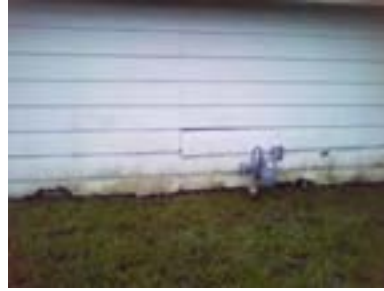
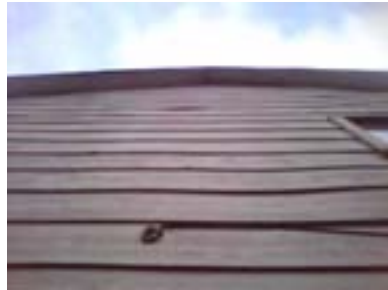
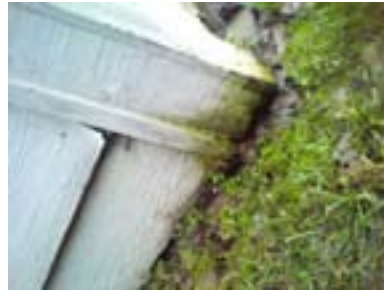
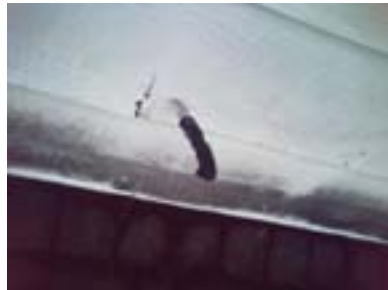
○ Some cracks at the brick, stone, or stucco siding  
⊆ Wood siding is water damaged in several areas;front wall,back and both sides. Should consider replacing all and salvage any that's not totally wood rot.

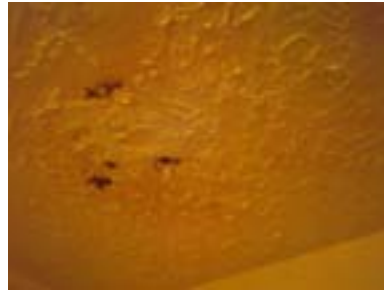
⌋ Water stains on ceiling - measured with a moisture meter set on gypsum for sheet rock and registered 5% to 3% moisture content which is wet and all past damage should be repaired; laundry room, garage over entry door,

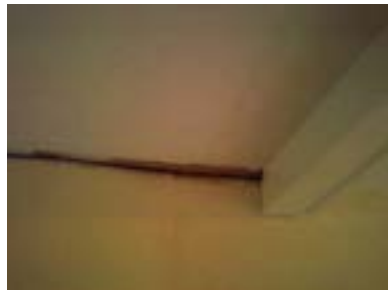
⌋ Caulk or trim pull away from the ceiling which should be addressed; living room,

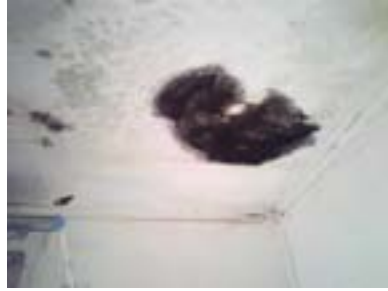
⌋ Observed ceilings are out of square or bowed in areas:bowed in up hallway,

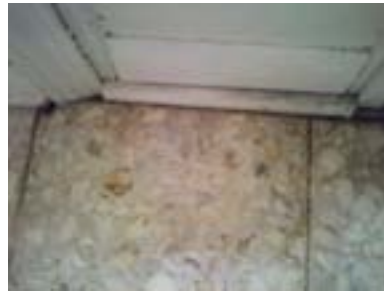
⌋ Floor cracks, scratches, or grout/seal openings in some areas which may have been marked;missing along wall in living room,front entry door gaps between tile and between door threshold,broken in master,

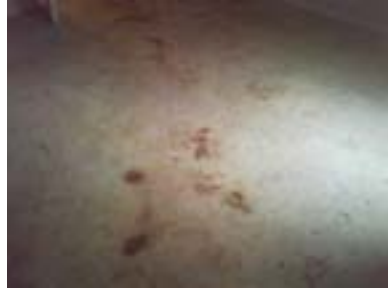
⌋ Floors were uneven or creaked when walked across or warped/bowed in areas:up slopes a little toward front west room,

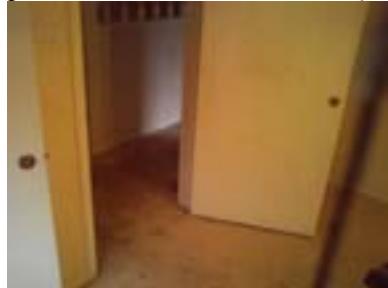
⌋ Doorknobs are in need or repair at:loose and missing knobs throughout,

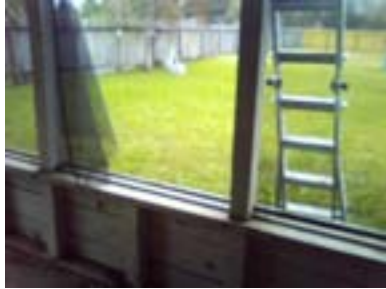
⌋ Sliding or other screen door is missing/damaged at:back spring is broken and porch screens are damaged;

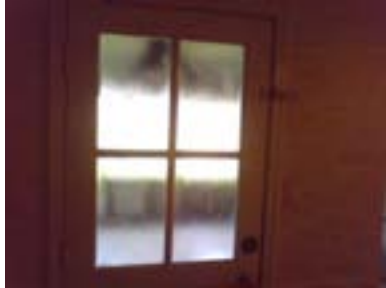
- ⌋ Damaged doors at:front door trim and threshold is loose from the mortar and loose in frame;
- ⌋ Safety glass logo not present at:back door,

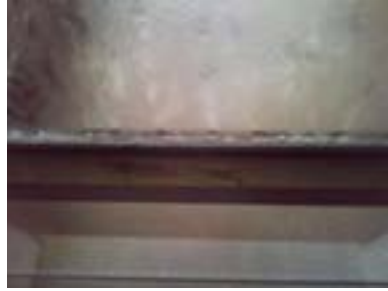
- ⌋ Some windows are difficult to open or close at:right of fireplace is bent in frame and catching;

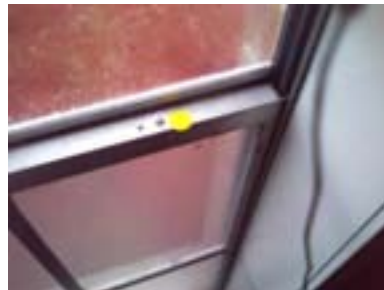
⌋ Some missing or damaged trim or latches at:some hanging trim,broken latch in front living room and formal,

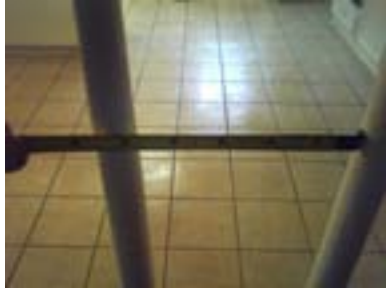
- ⋮ Hand railing is loose/missing at one or more locations;
- ⌋ Vertical railing spacing is greater than 4";about 5,however low to ground;

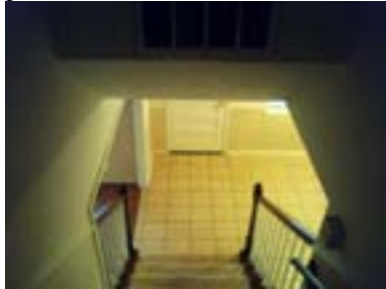
- ⋮ Hand railing is not terminated properly;
- ⋮ Improper dimensions of stair raisers and over 7 3/4";
- ⋮ Hand railing or guardrail not at proper height between 34" to 38" or guardrail less than 36";
- ⋮ Improper dimensions of stair treads and under 10";
- ⌋ Improper dimensions of stair treads or risers of more than 3/8 inch adjustment between;
- ⌋ Head clearance less than 6 foot 8 inches at any part of stairway;about 6 feet 1 inch at bottom,

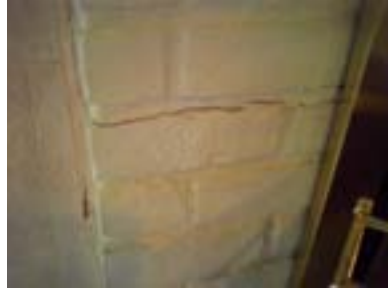
- ⌋ **Brick/Stone**      ⋮ **Factory or Gas**      ⋮ **Free Standing**
- ⋮ Mantle is loose
- ⋮ Firebox hearth inadequate size of less than 16" deep and 8 in to sides if opening <6sq ft or 20 in deep and 12 in to sides if opening >6sq ft;
- ⋮ Firebox hearth extension is less than 2 inches thick and/or hearth less than 4 inches;
- ⌋ Some brick mortar is loose and/or missing;front,

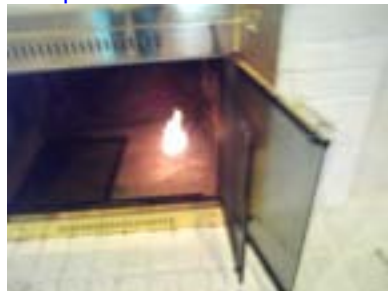
- ⌋ Improper installation of gas log system
- ⌋ Damper is missing a clamp or bolt or is not blocked open and should be present in case of a gas leak, the damper must not be completely closed when a gas starter valve is present.
- ⌋ Starter wand is missing the air-mixer valve;
- .. Currently the chimney flue is inaccessible. Building insulation in contact with a metal chimney can cause hot spots that can burn out over time. Contact the chimney manufacturer for exact requirements. In the absence of the manufacturer's requirements, a free space of at least 2" is recommended to all construction materials and insulation should be remedied for safety against the possibility of damage that can lead to a fire if determined the chimney is in contact.
- ⌋ No gas key located

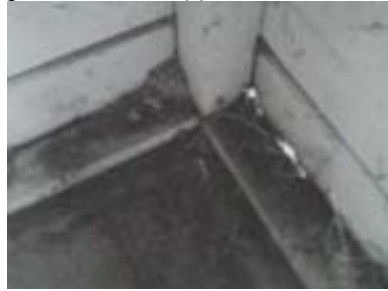
- .. Some decking fasteners are backing out
- .. Railing is loose or missing at one or more areas
- .. Some decking boards are loose or damaged
- ⌋ Structural support members;some wood rot and debris at bottom;

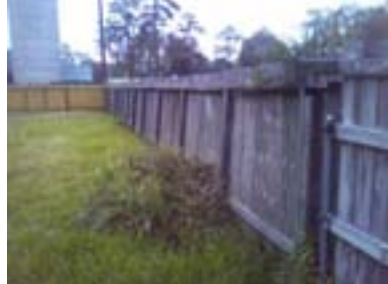
- ⌋ Fence is showing signs of wood rot or pickets are warped, leaning or falling off:leaning in back;

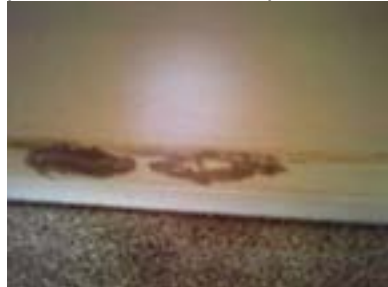
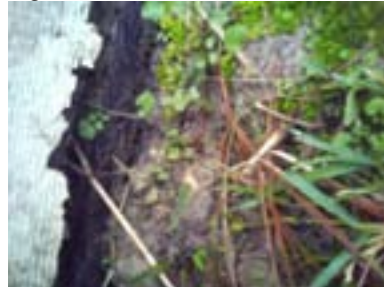
- ⌋ Some wasps nests, insects or ant beds were observed at:appears to be wdi tunnels in master and possible wood rot and past wdi damage in back,

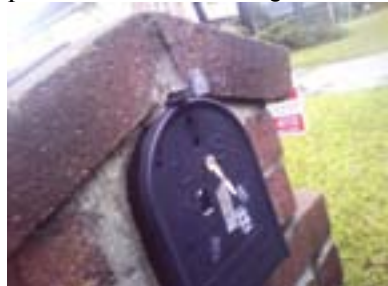
- ⌋ Some mailbox or flag issues were observed:missing latch,

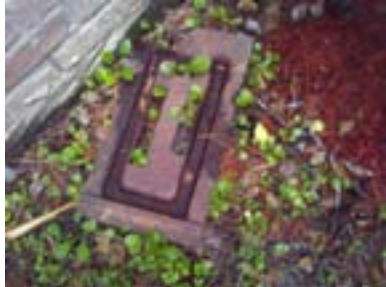
- ⌋ Panel(s) are not labeled properly
- ⌋ Panel has more than 6 main disconnects
- ⌋ Panel(s) are loose at the wall, missing screws or pointed screws.
- ⌋ Improper cable bundling;all wires are clamped together vs. spread which is a new regulation;
- ⌋ Panel inner safety cover is loose or missing;on ground and entire panel is rusted;

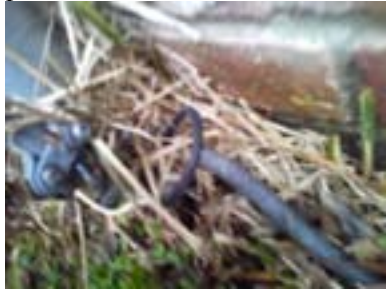
- ⌋ One or more knockouts are missing
- ⌋ Ground wire/rod could not be verified or buried in ground;
- ⌋ Double lugged breakers/fuses
- ⌋ Ground wire not connected correctly to grounding rod or a loose clamp that should be tightened.

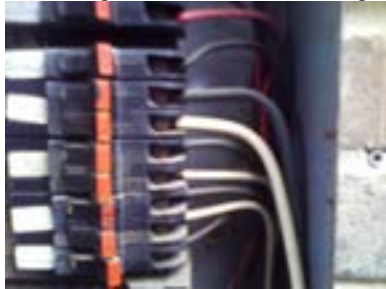
- ⌋ Incorrect size of breakers/fuses
- ⌋ Incorrect wire on breakers/fuses;observed white wires used for hot current attached to a breaker,green for other than a ground and/or red and black for other than hot current;

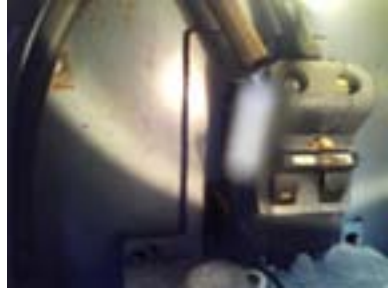
- ⌋ Lack of anti-oxidant grease on the aluminum service entrance conductors from the power company;

⌋ This is a Federal Pacific Stab breaker panel with wire hanging out and improperly terminated that should be evaluated by a professional electrician and please refer to the Federal Pacific clause below that is recommended to add by Inspector Association;

**Safety Warning\*\*\*** I have observed a Federal Pacific Electric "Stab-Lok" service panel in the house. This panel is a latent fire hazard: its circuit breakers may fail to trip in response to an over current or a short circuit. Failure of a circuit breaker to trip can result in a fire, property damage, or personal injury. A circuit breaker that may not trip does not afford the protection that is intended and required. Simply replacing the circuit breakers is not a reliable repair. The panel should be replaced, and significant expense may be involved. Additional information about the fire and shock hazards associated with this equipment can be read on the internet at <http://www.inspect-ny.com/fpe/fpepanel.htm>

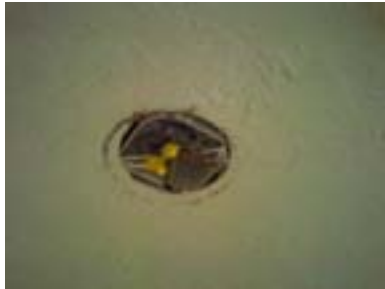
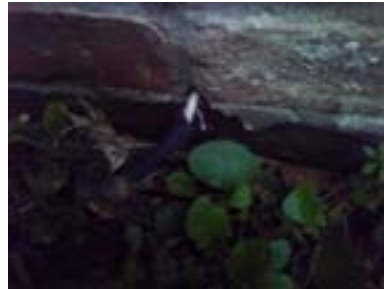
Ⓟ One or more wiring connections or wire splices are not in junction boxes or fully enclosed conduit;front rooms where missing fixtures,attic,ac wire outside not in conduit,

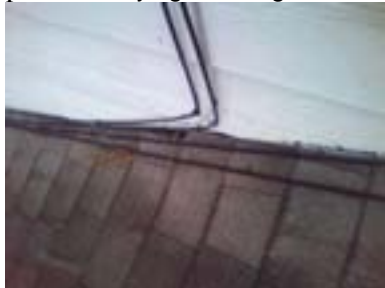
Ⓟ Wires lying on the ground, roof, under or around house;low voltage wires all over,

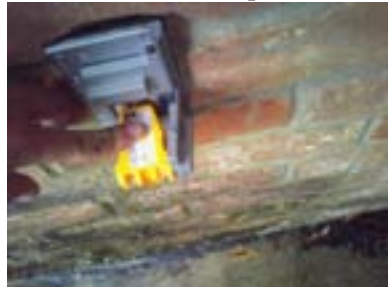
Kitchen: ⊔ Yes ⊔ No ○ N/A 3 trip and reset to 2 locations,and current regulation may require desk area to be protected since part of same counter,2 trip in front formal as well,  
 Bathrooms: ⊔ Yes ○ No ○ N/A all trip and reset independently,and turn off lights in that room,along with 1 in front east bedroom and 3 or so in master trip into the master bath reset,all in front west room,  
 Exterior: .. Yes ⊔ No ○ N/A all 3 should trip and reset and are not protected,

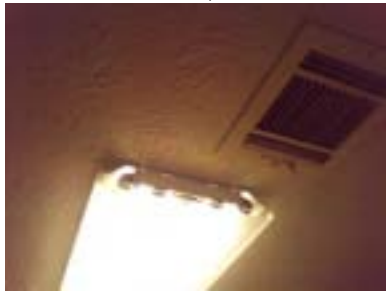
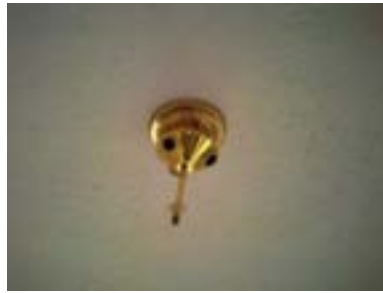
- ⌋ Some light fixtures and/or bulbs did not function;throughout interior and exterior,
- Closet light fixture does not have proper clearance
- ⌋ Some light fixture covers are damaged/missing;kitchen is loose,missing in front entry,formal room to name some,

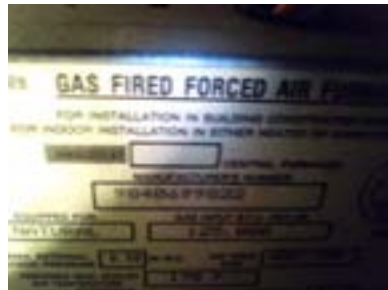
- Gas leaks detected at: \_\_\_\_\_
- ⌋ System(s) shows (show) signs of unit not working or gas is turned off and/or no pilot flame. Recommend cleaning, servicing, and further evaluation by a licensed professional.

This unit is a Split level DUNCAN brand model # and serial # and determined it was manufactured in 1998 by analyzing the data plate. Replaced batteries in thermostat to set on heat and allowed display to come on.

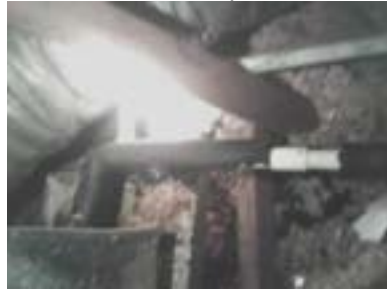
⌋ Rust and debris was found in the overflow pan like it may have overflowed in the past and should be cleaned or replaced to ensure it does not leak;

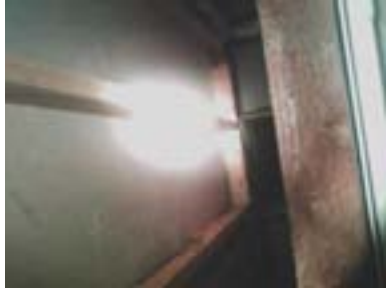
- ⌒ Some ducting moisture barrier or plenum is damaged, missing and/or deteriorated or not sealed properly at the connections or unit.
- There is no central airflow to the room addition(s) and/or garage conversions
- Some supply registers have a heavy soot buildup on the outside grates;
- Some registers are loose or not flush against the wall/ceiling;
- ⌒ Return air plenum is open inside and/or wires, plumbing pipes which may be allowing air to escape and could be enclosed with duct board for increased efficiency and cover wires/pipes even when on an interior wall.

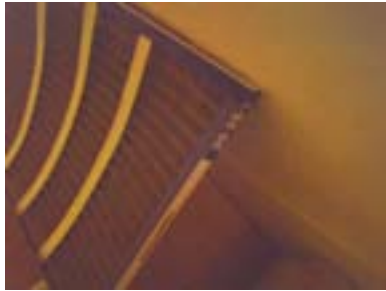
- ⌒ Ducting is lying on the attic floor throughout the attic which should be well suspended throughout the attic
- ⌒ Return air filters are present throughout the house and should be replaced because are dirty or torn at:
  - 12x12x1 ○ 12x24x1 ○ 16x25x1 ⌒ 20x25x1 " 20x30x1;

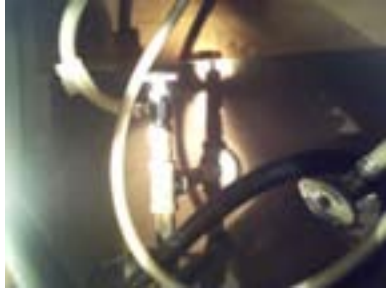
⌒ Faucets have low water pressure;cold in master;both in hall,

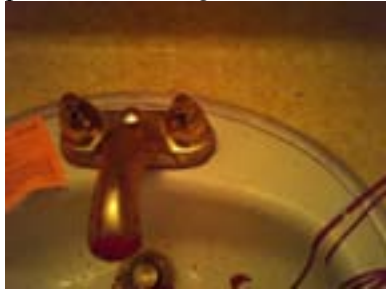
⌒ Drain stop inoperable, needs adjusting to hold water or missing in upstairs hall,  
○ Hot and Cold water reversed  
⌒ Loose/damaged faucet handles and or constant drip;half missing,

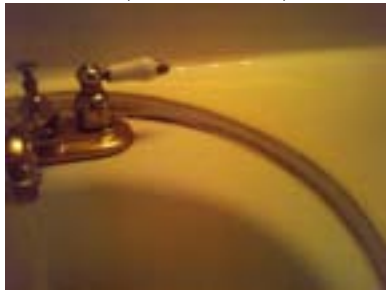
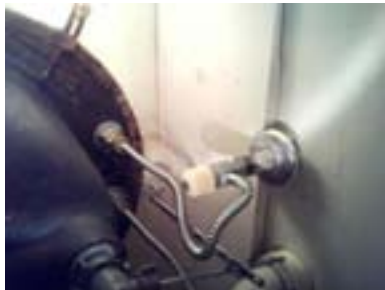
⌒ Finish on sink is damaged;underneath in master very rusted and not aligned properly in cabinet,some on hall,

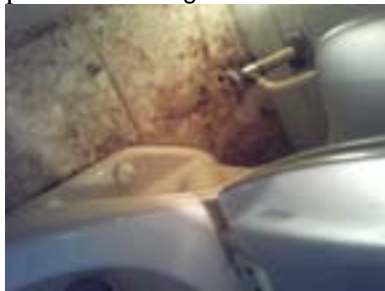
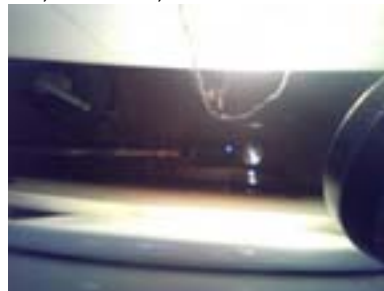
- ⌋ Leakage around commodes
- ⌋ Seal leaking between tank & bowl;in master,

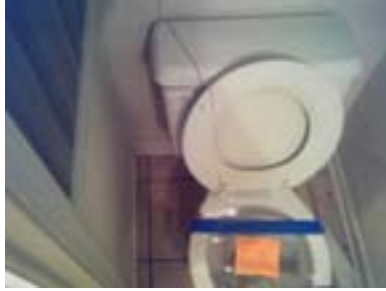
- ⌋ Loose at floor mounting and may need reseating;half bath,very loose in master,up hall slightly loose;
- ⌋ Bowl or tank is loose,leaning against wall in half,

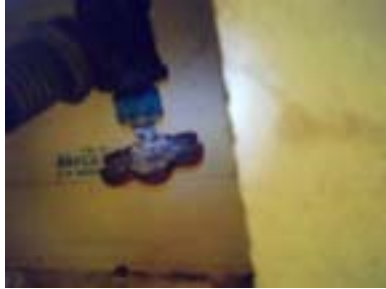
- o Washing machine connected at this time - faucets, drains not tested for proper operation
- o Leakage/corrosion at plumbing connections; may replace both,

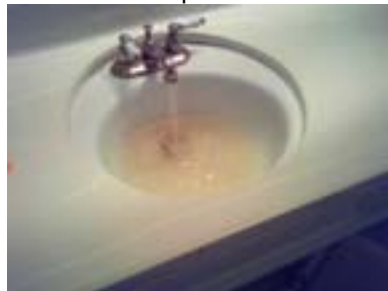
- ⌋ Drain not draining quickly or takes a while for sink or tub to drain and may be clogged or blocked at: backs up a little when running in master and tub a little slow,

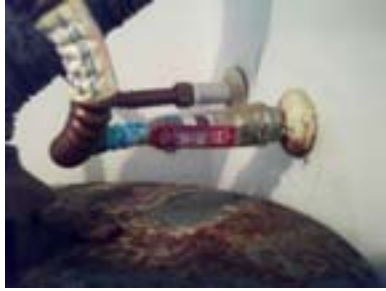
- ⌋ Corrosion and/or signs of an intermittent leak at isolation valve, and/or plumbing connections or underneath unit;top,some corrosion inside,

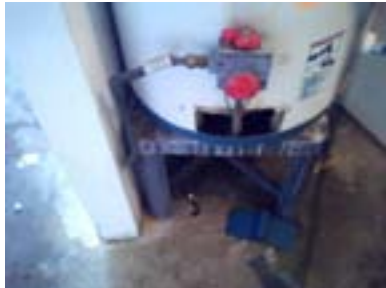
- .. Unit is located in a Garage or adjacent area and is not elevated so that its ignition source is 18" above the floor
- .. Unit was not in operation at the time of inspection. Hot water temperature was not checked, inspection limited
- ⌋ Unit has no drain pan and/or drain line installed under the unit if on second floor, attic or next to an inside wall;

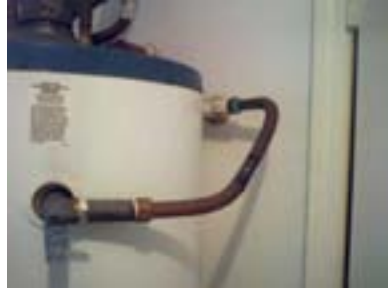
- .. T/P valve has no drain line and/or less than 3/4 inches
  - .. Drain line is not plumbed to exterior
  - .. T/P valve not installed at designated location
- ⌋ Drain line runs uphill at some point;

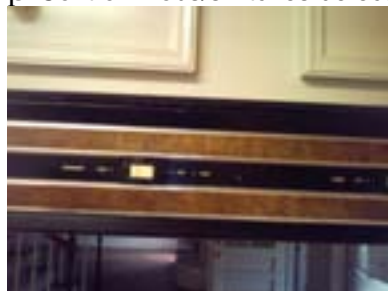
- ⌋ Filter is dirty/greasy
- ⌋ Light not functioning
- ⌋ Vent pipe terminates improperly or does not completely vent all air to the exterior. The range is not the best system because it circulates the air back into the kitchen vs. to the exterior, however appeared to function at the time of inspection. Prefer the type system that takes the air to the exterior vs. recycling inside the house.
- ⌋ Fan/Motor assembly vibrates and/or is noisy
- ⌋ Control knobs/switches defective and not working,turning on,

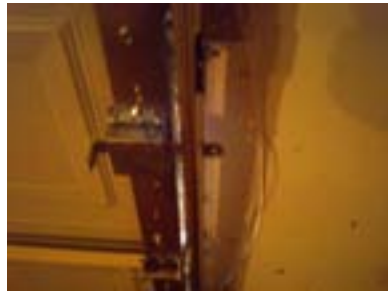
⌋ Latch device is not secured properly so that cannot be latched which is a must with automatic door openers;

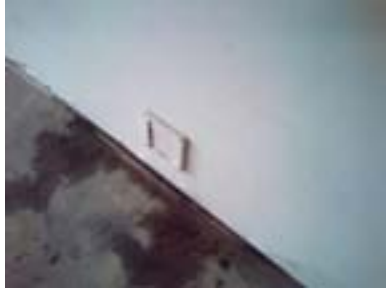
- .. Dryer vent cover is loose, damaged and/or missing
- ⌋ Dryer vent is not vented to the exterior wall or roof;in garage,
