Very established neighborhood

Houston, TX 77069

May 28, 2010

This Limited, Visual Inspection Report is prepared exclusively for

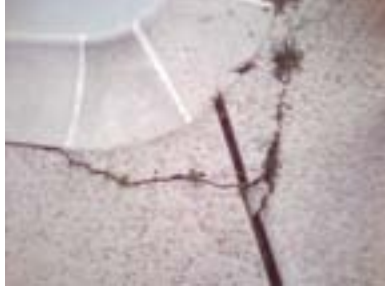
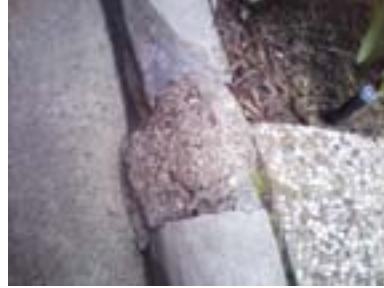
- ⋮ Cracks in wall(s) and/or ceiling;
- ⋮ Floors visibly not level
- ⋮ Cracks in brick, stone, or stucco;
- ⋮ Cracks in exposed concrete floors
- ⋮ Door and/or window frames out of square
- ⌋ Cracks in sidewalks, driveway, patio or garage which is very common; pool, front curb;

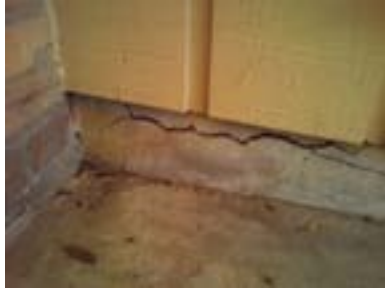
- ⌋ Cracks in slab on outside edge; by back door and may just be outer covering,

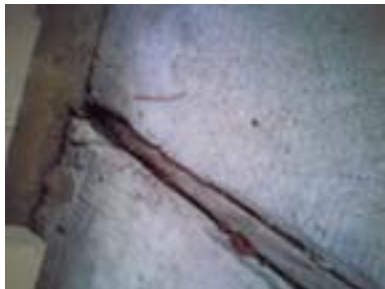
- ⋮ Beam/Rafter condition and/or Pier Condition which if rafters have pulled away from the ridge board or split should be blocked or repaired;
- ⋮ Excessive or improper shims
- ⌋ Wood form strips or other wood observed next to the slab which are conducive to wood destroying insects, which could be removed and replaced along with all cracks sealed with blown in foam covered with a thick layer of caulking;

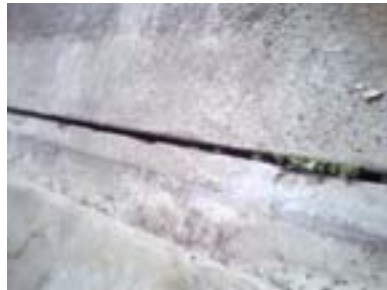
Should always seal any opening between concrete sections with blown in foam covered with a thick layer of caulking;

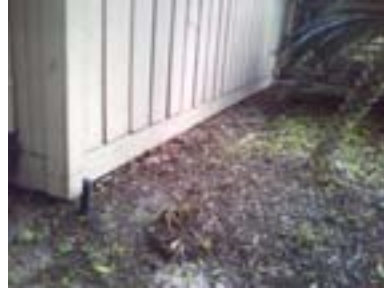
⌋ Improper drainage from foundation and not a decline at all locations away from slab and/or a 6 inch decline at 10 feet away;back,front,garage,

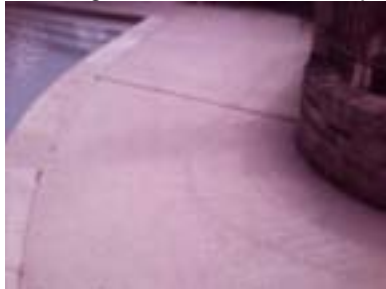
⌋ Erosion or ponding next to foundation/driveway or in yard;front corner has algae on brick as may be standing at times and back slopes toward slab,

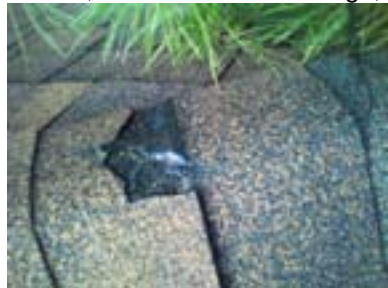
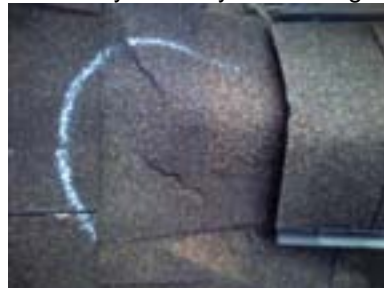
- Some damaged or raised shingles on ridges, valleys or throughout; missing a shingle on ridge over master, few minor tears on ridge, few raised by chimney and front game room wall.

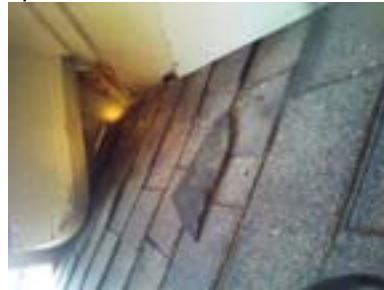
- ⌋ Trim, soffit, fascia boards are in need of repair; open trim under both walk in attic top intersections and squirrels have chewed on a few places;

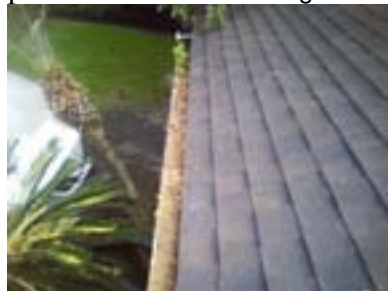
- ∴ Roof covering is in contact with siding;
- ⌋ Leaves/debris in the gutters and downspouts;

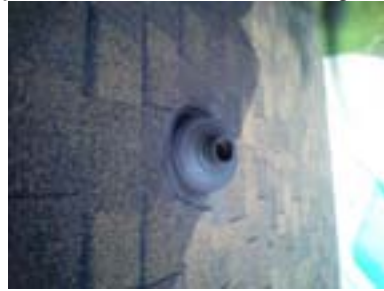
⌋ Drain,waste vents beginning to deteriorate (some have been chewed) or improper installation (less than 6 inches above roof or 10ft horiz or 2ft above openings) or not protected with latex paint observed;upper roof has older roof jacks and lower were exchanged.

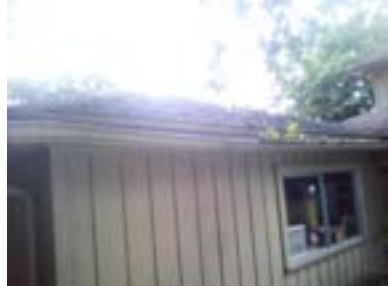
⌋ Loose, missing and/or damaged gutters or downspouts;garage,

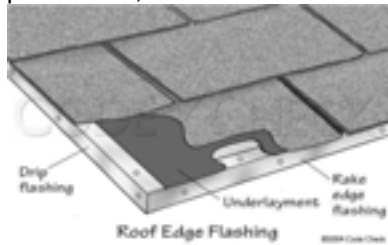
∞ Underlayment should be over the rake edge flashing at the front and back eaves and be tucked under at the sides so rain water will not get between the flashing and wood and cause water penetration;

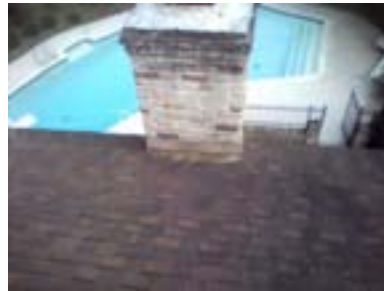
- .. Skylight covers not secured and/or flashed properly
- ⌋ Chimney cricket/saddle is missing if 30+ inches wide or not the proper height;about 35 to 36 inches wide and no cricket,

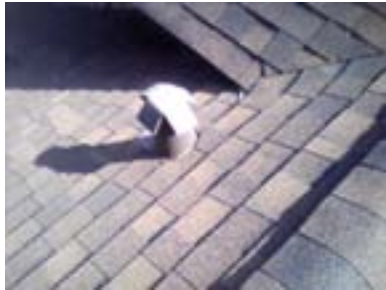
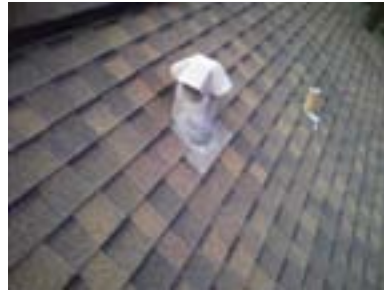
- .. Missing rain skirts on metal fireplace or furnace flues
- ⌋ Missing/damaged rain caps on furnace/water heater flues;old bonnet extensions are still in use which would be ok for bath fans,

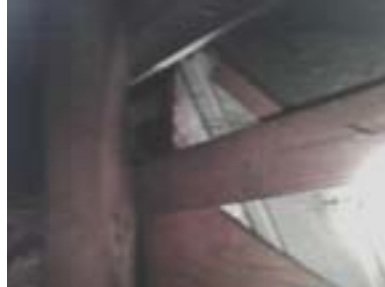
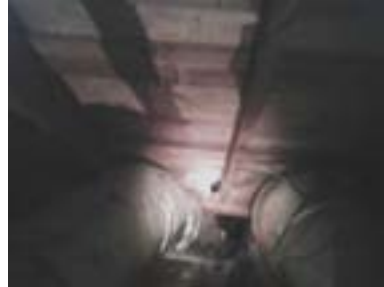
- ⌋ Openings observed around corners of attic that should be blocked;
- ⌋ Roof support and/or failed members; observed 1 or more rafters that are not fully flush against the ridge board, split or that do not meet or align on both sides which could be blocked, metal joist hangers added, another rafter next too, other methods or just monitored; only a few gaps and 1 split noticed over furnace,

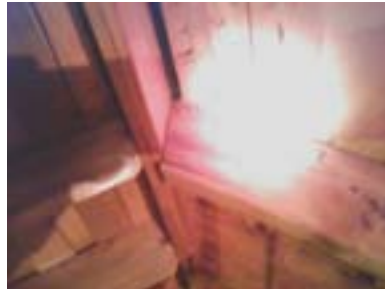
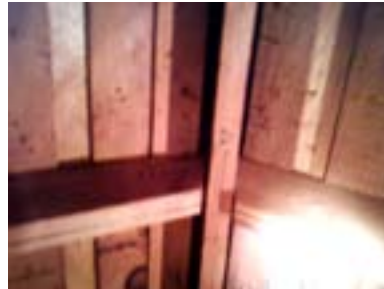
- ⌋ Roof support from rafters, bracing, purlins, collar ties may not adequate;
- ⌋ Bath/Kitchen vents terminating in attic or not properly sealed at roof decking;
- ⌋ Evidence of moisture penetration
- ⌋ Open raceway from the garage to the house which should be blocked at the garage with a fire rated material. This creates an open chimney if a fire occurred and should be fire blocked; small opening,

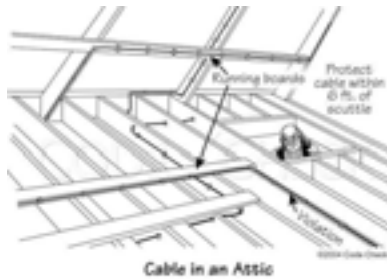
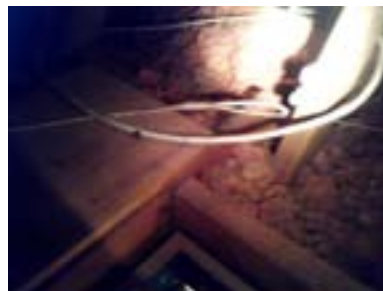
- ⊢ Current regulation requires all wires within 6 feet of the attic opening to be protected and observed unprotected electrical wires near the opening. This could lead to wire damage and possible electrical shock or potential fire hazard.

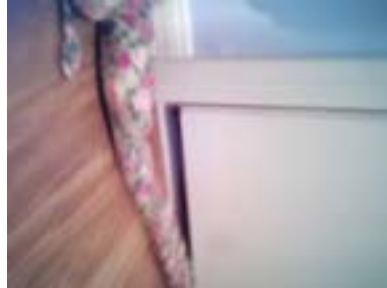
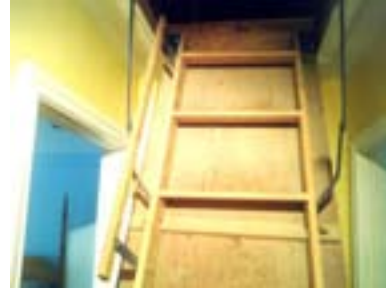
- ∩ Lack of insulation around the edge of the attic trim;
- ⊔ Lack of or did not appear to be a fire rated door;
- ∩ Gap in door when closed that should be adjusted so air does not escape
- ⊔ Stairs should be trimmed so that it rests flush against the floor. The strain could eventually break the steps;broken at bottom,

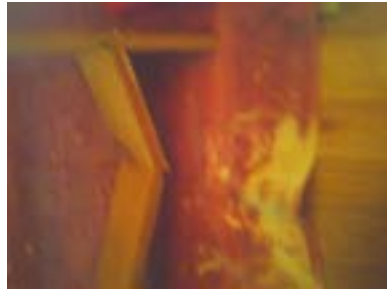
- ⊔ The attic door frame require 16D (penny) nails or 1/4 x 3" or equivalent screws through the hinges and around the frame and should have 16 fasteners attached unless the door manufacture lists or requires a different pattern. This door has only 8 fasteners now;
- ⊔ Lack of fasteners; missing on edge for proper support;

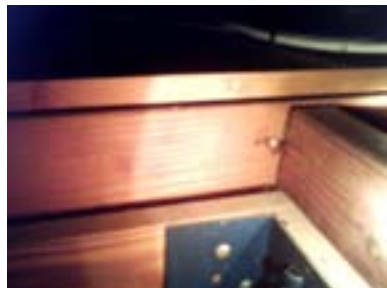
- Type: ⊔ Batts ⊔ Blown-in-measured about 2 inches by access opening.
- ⊔ Noticed an area that should have insulation added or extra layers throughout;vertical in walk in access,

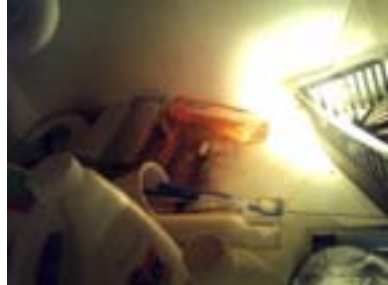
⌋ Past water damage underneath sinks;master right sink,minor repairs needed under some others;

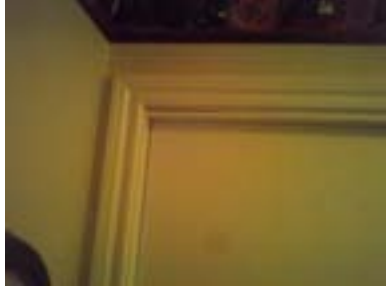
•• Caulking/sealant is separated or missing in some areas;,
⌋ Trim boards, shelves/racks or hardware is damaged/loose at several areas;laundry door trim,

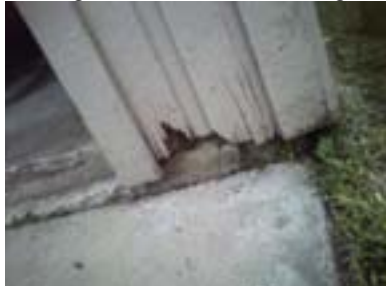
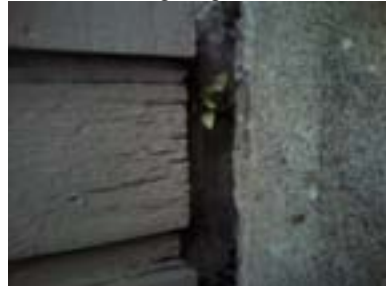
⌋ Fascia/trim boards are damaged at several areas;back door and breakfast area window needs sealing,wood rot under front game room window,garage trim,

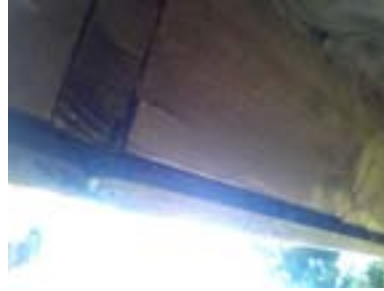
⌋ Mortar is separated or missing in some areas;between some bricks at corners,around windows,front or back porches,front porch is loose at top,

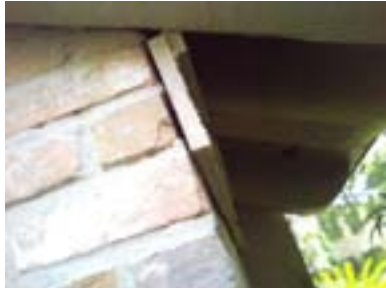
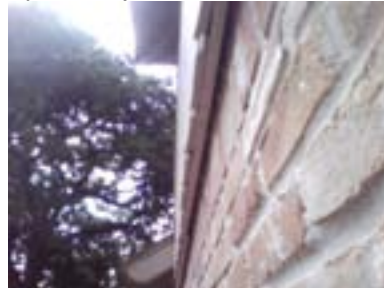
⌋ Caulking/sealant is separated or missing in some areas and should block/seal any and all openings between the wall and trim work,all expansion joints,

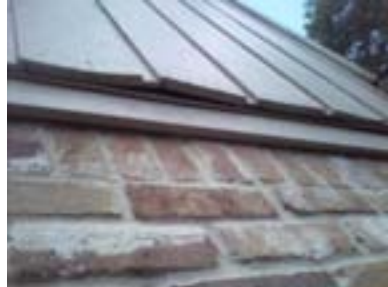
- ∴ Wood siding is water damaged in several areas;
- ∴ Siding shingles are cracked, loose or missing
- ⌋ Observed walls or structure is out of square, bowed or warped in areas:garage and side of kitchen,

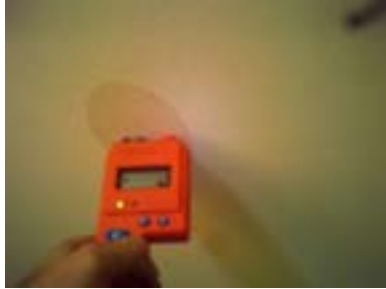
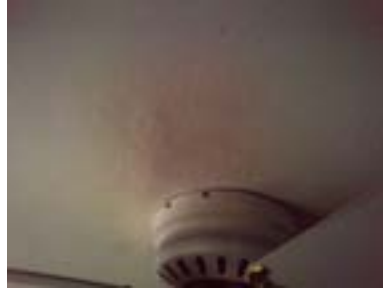
- ⌋ Water stains on ceiling - measured with a moisture meter set on gypsum for sheet rock and registered .0 to.1% moisture content which is dry and past damage could be repaired;master bath,up gym room,up center bathroom,

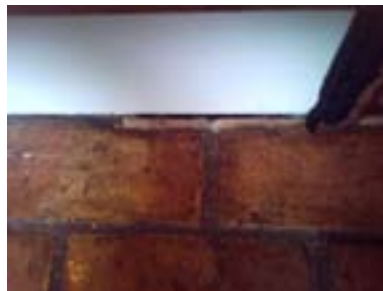
- ⌋ Floor cracks, scratches, or grout/seal openings in some areas; scratch in front entry, some chips throughout taverestry area, up center bathroom, by stairwell and walls.

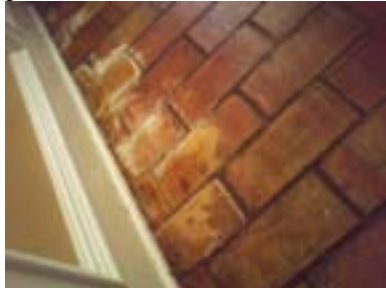
- ⌋ Stains on floor; breakfast area,

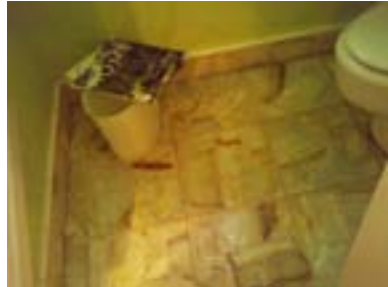
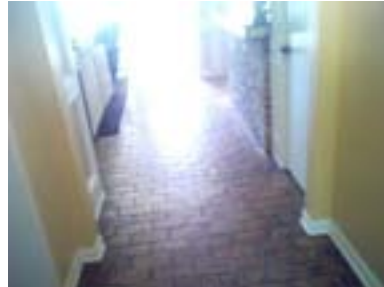
⌋ Observed tiles that sounded hollow when tapped with a hard object which is a result of lack of adhesive spread evenly underneath tile, loose tile, air pockets or water has penetrated underneath the tile. Discovered most in the front entry, 0 or more in the kitchen, 0 or more in laundry, 3 or more in master water closet bathroom and most in all brick floor locations in other open areas (unless this is a floor type linoleum covering).

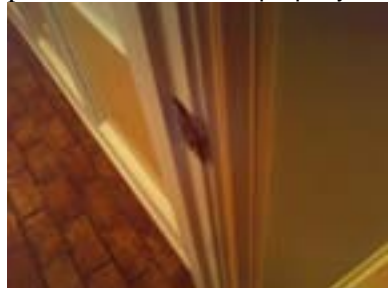
⌋ Doors do not latch properly and/or striker plates need adjusting at:master striker bent,

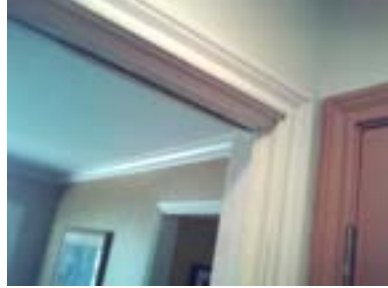
- Doors rub, stick, swing independently or hit the frames at:
- ↳ Closet doors slide poorly, off of their rails or missing at;missing to dining,

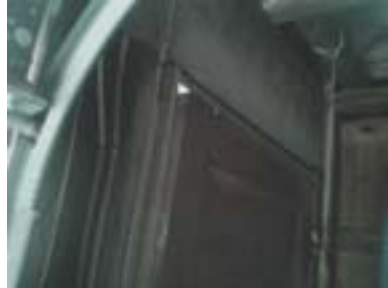
- Sliding glass door slides poorly or improperly installed at:
- Sliding glass door does not latch/lock properly at:
- Sliding or other screen door is missing/damaged at:
- ↳ Damaged doors at:garage exterior a hollow/interior door and wrapped.

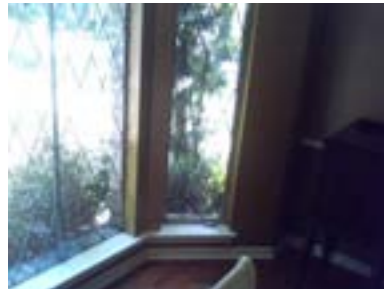
⌋ Some windows are difficult to open or close at: both catching in dining room, left upstairs center tub to name one,

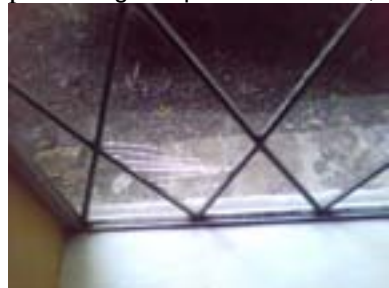
⌋ Some glass panes are loose, damaged/broken or missing at: front pool table room,

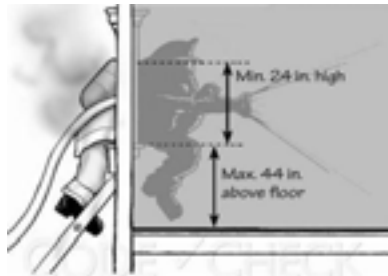
- ⌋ Windows in sleeping areas are of inadequate size or over 44" from ground for egress at: up bedrooms are 47 to 48" from floor.

The second exit required in a bedroom is usually a window. The dimensions of the openings are to ensure the residents an escape route, but equally important, they are designed to allow a firefighter with a backpack to enter. The opening must be at least 24" high and at least 20" wide, with a net area at least 5.7sq.ft., per Table 15 in Code Check Building.

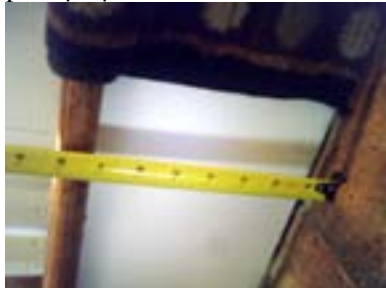
- ∴ Vertical railing spacing is greater than 4";
- ∴ Hand railing is not terminated properly;
- ⌋ Improper dimensions of stair raisers and over 7 3/4"; first 8 inches,

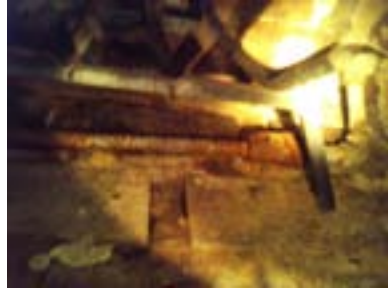
⌋ Damper is missing a clamp or bolt or is not blocked open and should be present in case of a gas leak, the damper must not be completely closed when a gas starter valve is present (even when direct draft holes are present).

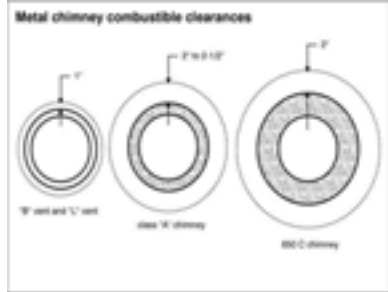
- Currently the chimney flue is inaccessible. Building insulation in contact with a metal chimney can cause hot spots that can burn out over time. Contact the chimney manufacturer for exact requirements. In the absence of the manufacturer's requirements, a free space of at least 2" is recommended to all construction materials and insulation should be remedied for safety against the possibility of damage that can lead to a fire if determined the chimney is in contact.

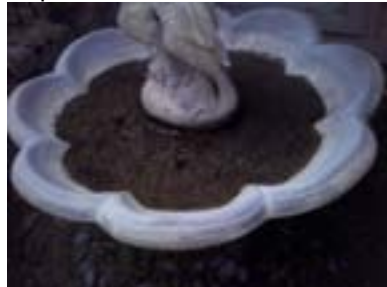
- .. Some debris or bricks are leaning against the house/garage:
- .. Some bricks are stacked in garage and would be a good idea to spread the load;
- .. Some wasps nests, insects or ant beds were observed at:
- .. Some mailbox or flag issues were observed:
- ⌋ Some other safety or tripping hazards exits around house:diving board,no alarm on back door,ftn not inspected or checked and standing water present to name some issues,

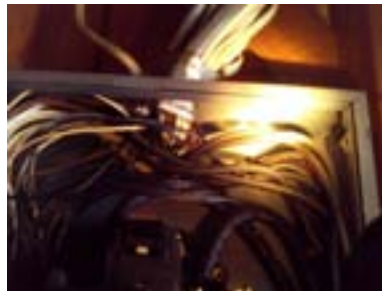
- ⌋ Panel(s) are not labeled properly;
- ⌋ Panel(s), breakers and all equipment are not UL labeled;
- ⌋ Panel has more than 6 main disconnects;
- ⌋ Panel top switch must be less than 6 feet 7 inches from the ground in the up position;
- ⌋ Working space shall be 3 feet out from panel, 30 inches wide to 6 feet 1/4 inches high and 6 feet 6 inches head room with no more than 6 inches of shrubs/debris from the wall.
- ⌋ Panel(s) are loose at the wall, not flush mounted, missing screws or pointed screws.
- ⌋ Improper cable bundling; all wires are entering at the top through one hole which is not fire stopped vs. spread at the top which is considered fire stopped which is a new regulation;

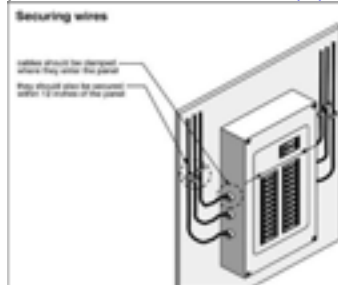
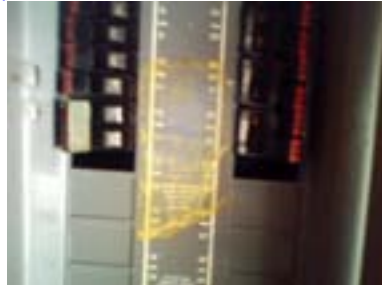
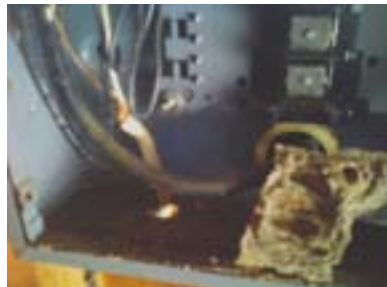
- ⌋ Panel inner safety cover is loose or missing
- ⌋ One or more knockouts are missing in front and at bottom/top or improper bonding locknut or connection in place with the use of clamps at connection from main and not secured outside panel; [2008 NEC 250.92 \(A\) and \(B\)](#);

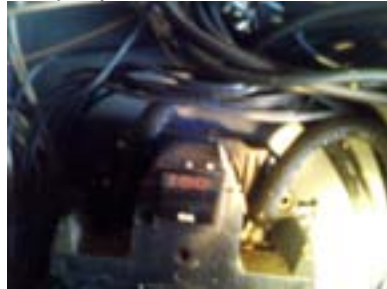
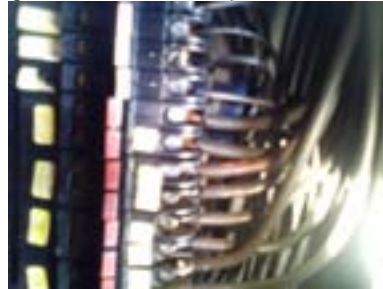
- .. Insulation damaged on conductors, wire bundled more than 2 inches;
 - .. Ground wire not connected correctly (or broken) to grounding rod or a loose/improper (bronze or zinc) clamp in use and should be tightened;
 - .. Concrete encased electrode in place with home that has a vapor barrier between the slab and the dirt.
 - .. Incorrect size of breakers/fuses and/or loose breakers or improper trip wire used to connect;
 - .. Incorrect wire on breakers/fuses; observed white wires used for hot current attached to a breaker which are not identified, green for other than a ground and/or red and black for other than hot current; or main neutral wire not less than one size smaller than hot lead.
- ⌋ Lack of anti-oxidant grease on the aluminum service entrance conductors from the power company; all AL conductors including the bottom 30amps.

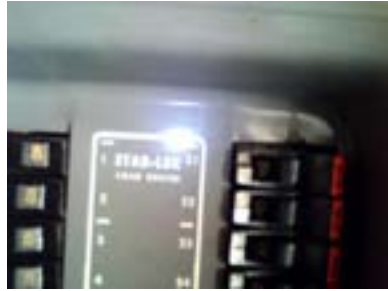
- .. Improper panel at separate structure and not a main disconnect or ground wire/ rod;
- ⌋ This is a Federal Pacific Stab breaker panel that should be evaluated by a professional electrician and please refer to the Federal Pacific clause below that is recommended to add by Inspector Association;

Safety Warning*** I have observed a Federal Pacific Electric "Stab-Lok" service panel in the house. This panel could be a latent fire hazard: its circuit breakers may fail to trip in response to an overcurrent or a short circuit. Failure of a circuit breaker to trip can result in a fire, property damage, or personal injury. A circuit breaker that may not trip does not afford the protection that is intended and required. Simply replacing the circuit breakers is not a reliable repair. The panel should be replaced, and significant expense may be involved. Additional

Note: This panel is a 150 Main lug coming in from the City through an underground lateral. This panel is a FEDERAL PACIFIC brand rated for a 200 max AMP and is a copper/aluminum conductor coming in from the power company and copper throughout the house located inside the garage.

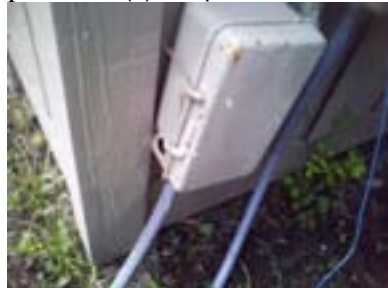
b Panel(s) not present at ac shut off and the pool disconnect is rusty/loose,

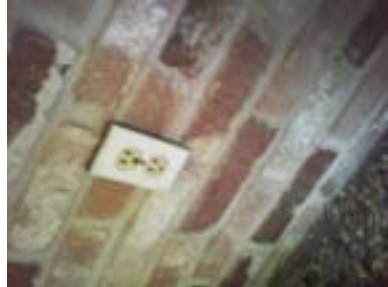
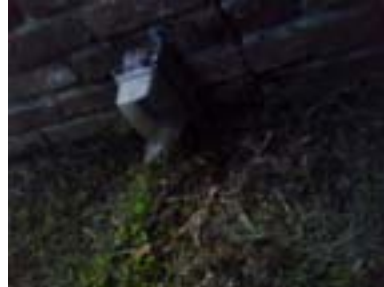
⌋ One or more junction boxes do not have covers or rain protective/weather resistant boxes for exterior locations in all damp or wet receptacle areas and should be like 1 by fountain; [\(2008 NEC 406.8\)](#);

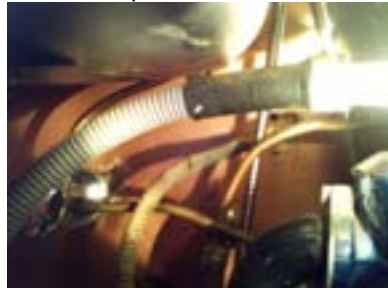
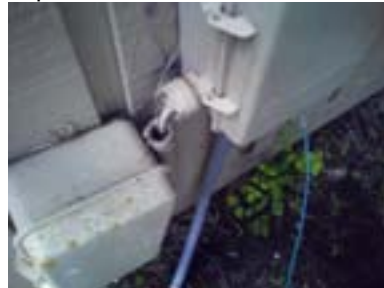
⌋ One or more wiring connections or wire splices are not in junction boxes or fully enclosed conduit; disposer where enters wall, at pool disconnect.

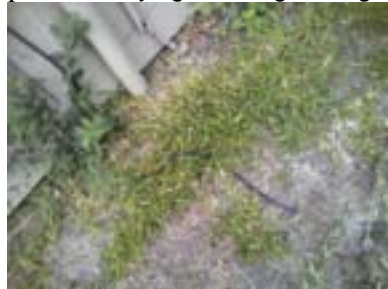
⌋ Wires lying on the ground; garage,

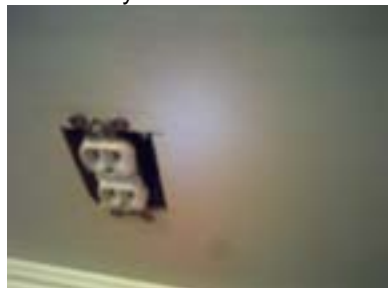
⌋ Observed one or more outlets, switches or electrical device installed through combustible material that are not flush mounted as required by code or is missing a plastic (fire rated enclosed spark ring) box at: may be others as seen in upstairs office.

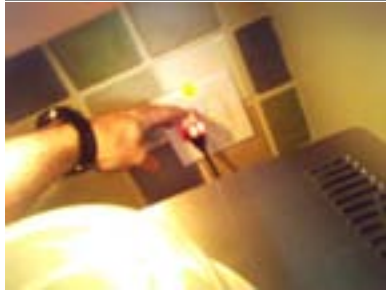
Kitchen: ∴ Yes ⌒ No ○ N/A all 4 should trip and reset to kitchen ;[required in 1987 within 6 ft of sink,1996 was all that serve counter top outlets;](#)

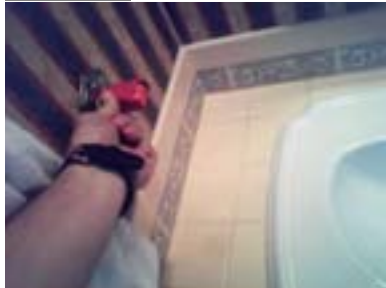
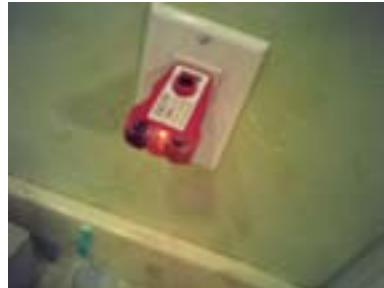
Bathrooms: ⌒ Yes ⌒ No ○ N/A all should trip,1 open ground in master,up center not tripping with tester,however is manually and turns off lights and up south the only one that works either way;[required since 1975;](#)

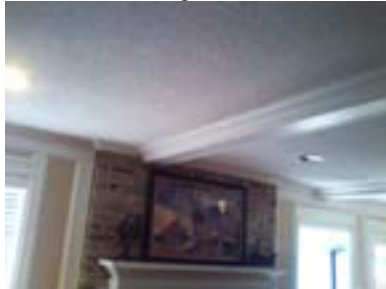
Some light fixtures and/or bulbs did not function and could be either; 1 over fireplace and 2 square ones in living room, 1 in master, 1 outside in the front to name some.

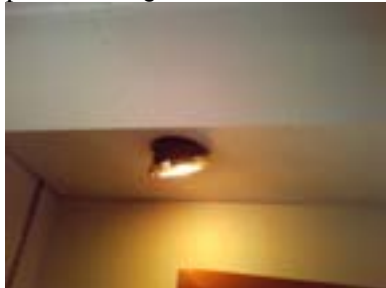
Closet light fixture does not have proper clearance
 Some light fixture covers are damaged/missing; 1 in living room cabinet,

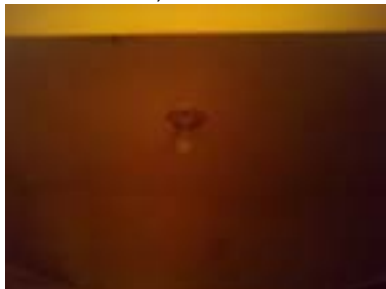
Some/all light fixture globes are missing from the clothes closets which must be present per NEC standards;

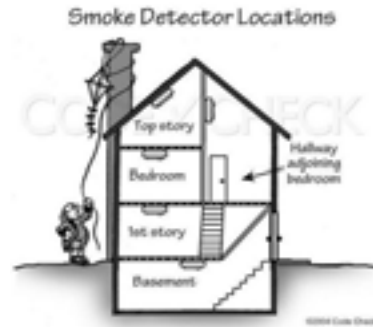
- o No alarms in hallways
- p Batteries are chirping;up,

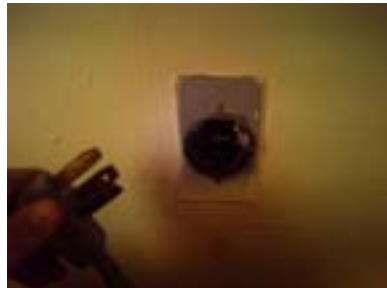
Note: The clothes dryer outlet has a 3-prong connection and was checked to ensure it reached 240AMPS. Newer dryers use a 4-prong connection while older dryers use the 3-prong type which are out of code. (Gas outlet is NOT provided for dryer);

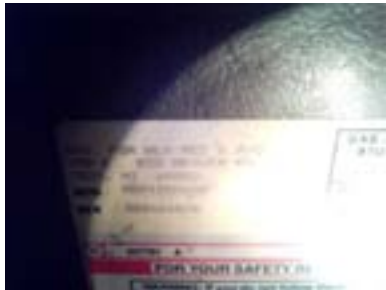
This/These unit(s) is/are a Split level MLX (MAY BE CONSOLIDATED INDUSTRIES) brand model # and serial # and determined was/were manufactured in 1992 by analyzing the data plate.

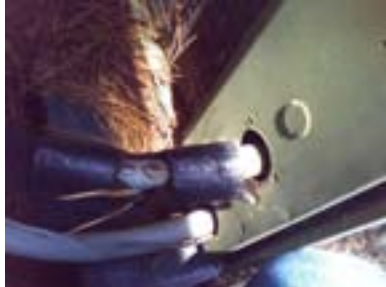
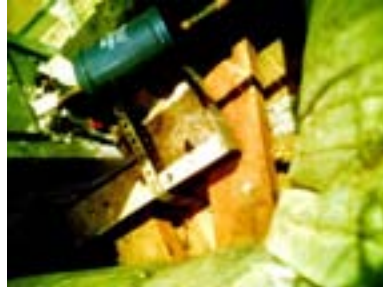
⌋ Freon lines not properly insulated at: ⌋Condenser(s) ⌋Air Handler(s) ⋮ In Attic;

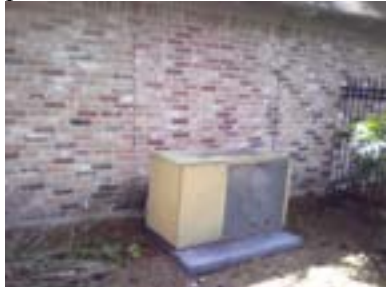
⌋ No electrical cut-off within view of condenser unit;

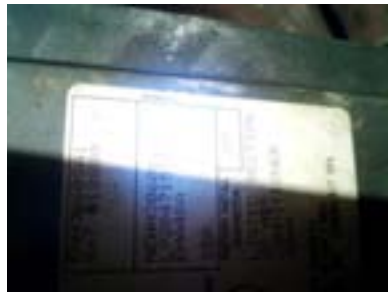
- ⌋ System(s) shows (show) signs of an original unit (most likely condenser is 37 years old and evap is a 1992-18 years old).. Recommend cleaning, servicing and/or further evaluation by a licensed professional;

Type:- INTER-CITY -EVAPORATOR COIL(S) IN ATTIC ARE - Model # and Serial # is below;1992,

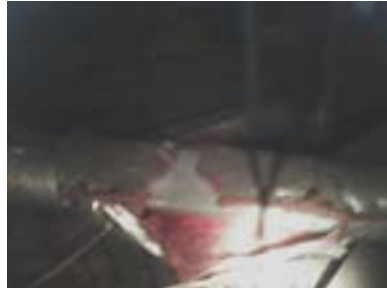
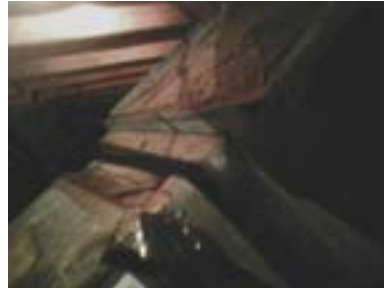
- Ducting is kinked or restricted in one or more places which may be affecting airflow or found a heat differential less than 8 degrees per room at:
- ⌋ Some ducting moisture barrier or plenum is damaged, missing and/or deteriorated or not sealed properly at the connections or unit;open ductwork in walk in access and very open plenum on return side of unit,

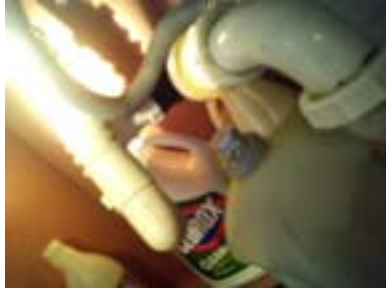
Leakage around sink(s) at:under kitchen and may replace drains,

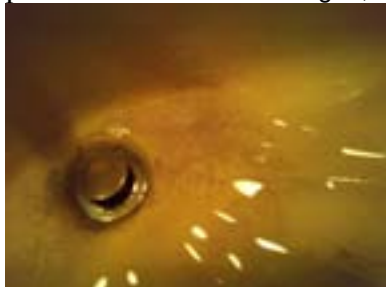
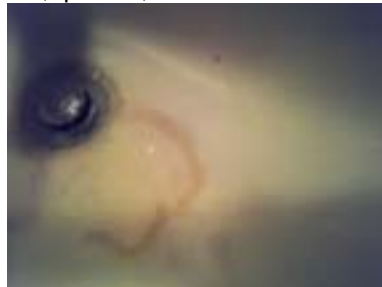
- Faucets have low water pressure
- Drain stop inoperable,missing and/or not properly holding water or draining,both up south and right up center,
- Hot and Cold water reversed
- Loose/damaged faucet handles and/or a constant drip;
- Finish on sink is damaged;master,upstairs,

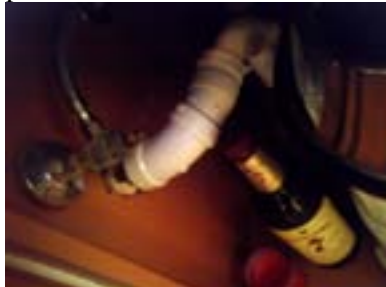
Shut-off valves under sink;wet sink knob missing,both under left master sink,

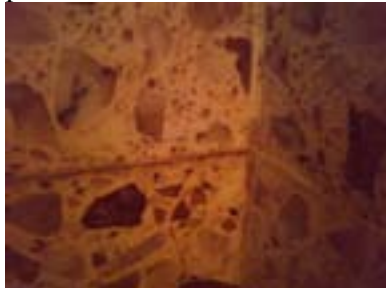
- o Leakage around tub(s)
- o Faucets have low water pressure
- o Water hammering noted
- o Leakage around shower(s)
- o Absence of safety glass enclosure
- o Shower head is leaking;
- .. Shower head is loose or missing;
- .. Shower or tub has rust behind drains/faucets,
- .. Hot and cold water reversed;
- o Loose/damaged faucet handles
- o Improper slope of shower floor
- o Tile turned in south;

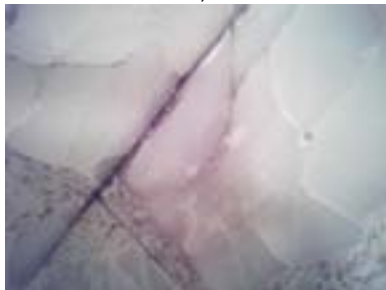
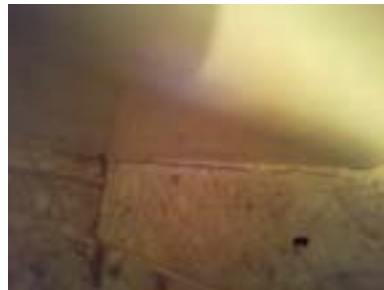
- o Shower diverter valve not operating
- .. Shower diverter valve allowing water from tub faucet when shower is in operation;
- .. Enclosure needs to be sealed;or bottom drip guard damaged;
- .. Shower walls with installed shower heads shall be finished with a nonabsorbent surface (tile, fiberglass, etc.) not less than 6 feet above the floor, (R307.2);
- o Caulking or grout in need of repair or (could be mildewed caulk in place);master shower,up center tub and minor,

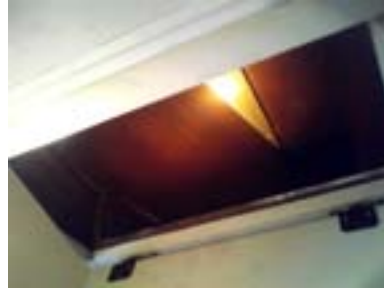
- Access panel is loose on the wall, screws are not holding panel snug to wall or not secured properly;
- Leakage from overflow or past leakage and a lot of extra caulk;

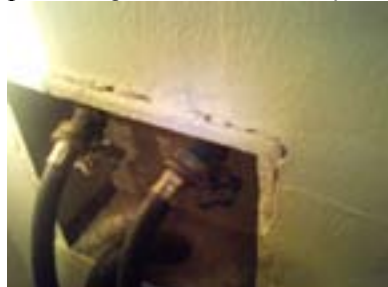
- ⌋ Washing machine connected at this time - faucets, drains not tested for proper operation;
- ⌋ Leakage or **corrosion** at plumbing connections; left,

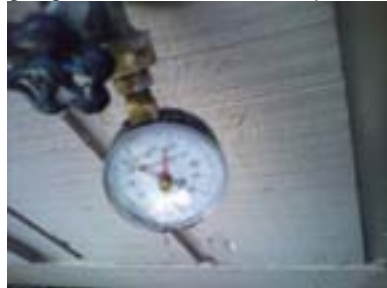
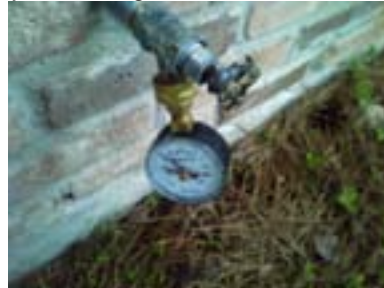
⌋ Faucet handles are loose, damaged, missing or just leak/drip at the nut or handle when the psi gauge is attached;back drips,side by ac damaged.

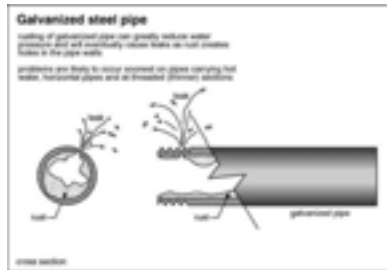
Main water pipes are ∴ Plastic ∴ CPVC-PVC and PVC is not recommended as a water supply line inside the house ∴ Copper ⌋ Galvanized;

Must remember that galvanized piping will corrode from the inside out and an older property could have potential past,present or future leaks.

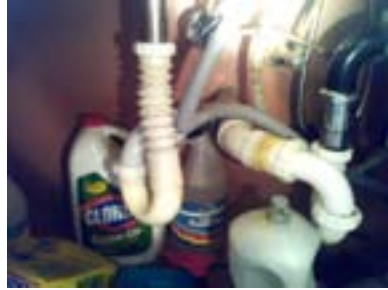
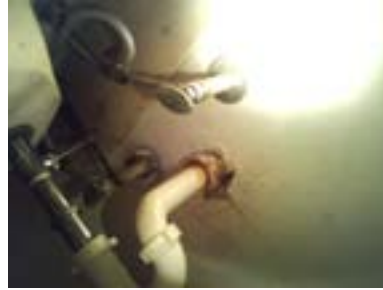
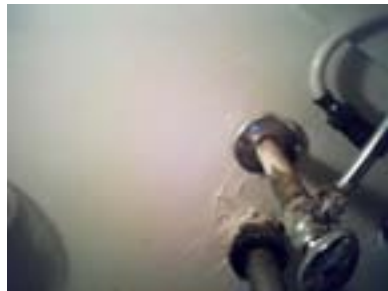
- ⋮ Drain not draining quickly or takes a while for sink or tub to drain and may be clogged or blocked at:
- ⌋ Drain connections; some corrosion present throughout under sinks, improper/amateur drain under kitchen, corrosion under right master, left up center sink, some drains are still original metal,

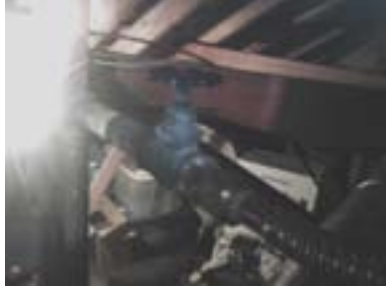
- ⌋ Corrosion;slight flux on shut off,

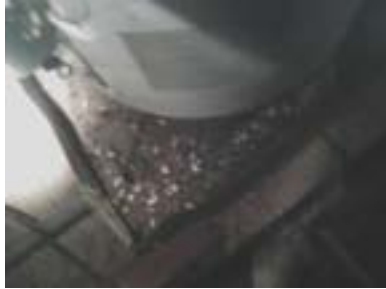
- .. Unit is located in a Garage or adjacent area and is not elevated so that its ignition source is 18" above the floor
- .. Unit was not in operation at the time of inspection. Hot water temperature was not checked, inspection limited
- .. Unit has no drain pan and/or drain line installed under the unit if on second floor, attic or next to an inside wall or unit blocking opening.
- ⌋ Unit drain pan has debris in pan; appears some rust and should have been replaced/cleaned back to original state with water heater replacement,

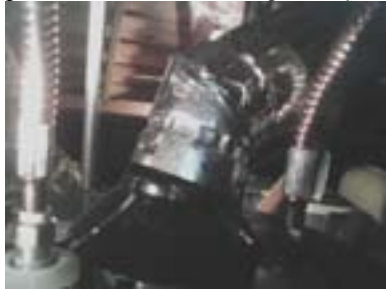
- .. Leakage around bottom of unit
- .. Leakage around connections
- .. Leakage around storm collar or flue
- ⌋ Flue is loose, damaged or poorly connected; should adjust flue so all gas goes out.

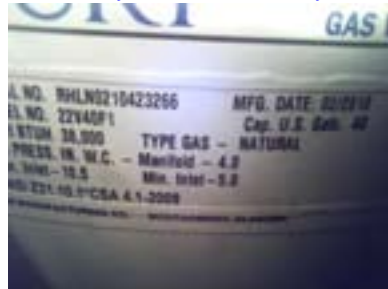
- ∴ T/P valve has no drain line and/or less than 3/4 inches
- ∴ Drain line is not plumbed to exterior
- ∴ T/P valve not installed at designated location
- ∴ Drain line runs uphill at some point
- ∴ Corrosion and/or leakage at connections including the TRP not properly resetting after operated;
- ⊔ Drain line is threaded at termination point;older galvanized outlet.

Type:RHEEM FURY and the info in below picture. **The TRP valve is NOT tested** (except for new construction, warranty inspections, 3 year old homes or less that are vacant) or operated at the time of inspection due to sometimes if has not been tested in the past year or so may not close properly leaving a constant water drip from the TRP line, however should always keep the pan clean and wiped down and test the TRP valve each year as to keep the rust and sediment buildup to a minimum. On homes 3 years or older may consider replacement of TRP valve if appears corroded;

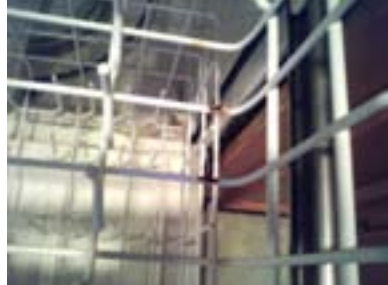
- .. Soap dispenser not functioning properly, missing rack rollers or sprayer parts missing.
- .. Unit is loose in cabinet and most likely needs screws added or tightened;
- ⌋ Rust present in interior of unit or racks,slightly,

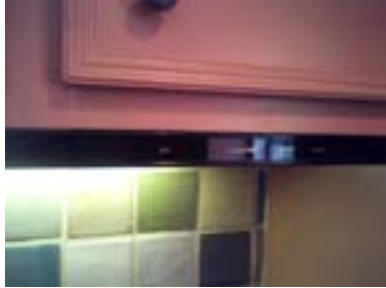
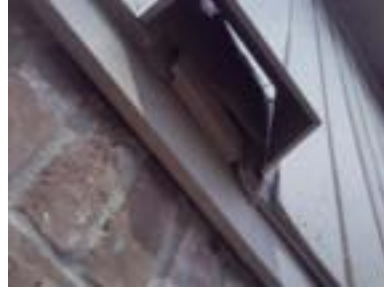
- .. Fan/Motor assembly vibrates and/or is noisy;
- .. Control knobs/switches defective or missing;
- ⌋ Fan and/or blower does not operate properly or could not get on with switch and needs attention and screen is not flush to wall outside;

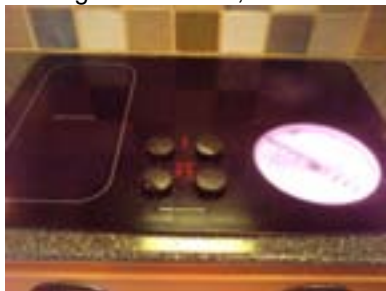
⌋ Burners do not operate at high and low settings;left induction side not working with knobs and making a loud noise,

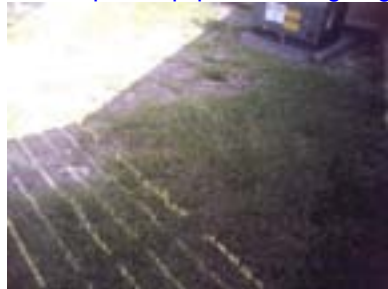
Note: Tested all zones for proper spraying and functioning heads. The items in the summary are areas of concern. This is a HUNTER SRC system with 7 posted zones and panel is in garage. Discovered a total of about 93 to 95 heads at the time of inspection and does have lack of coverage at side of pool equipment and garage. The anti-siphon is 17 inches tall.

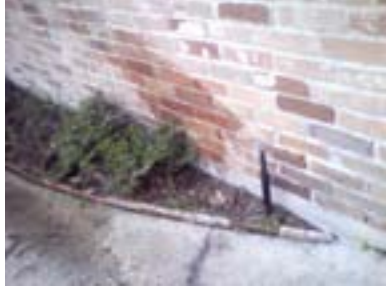
STATION 3:

Observed about 13 to 14 total heads at; front beds by house and 1 sprays the house;

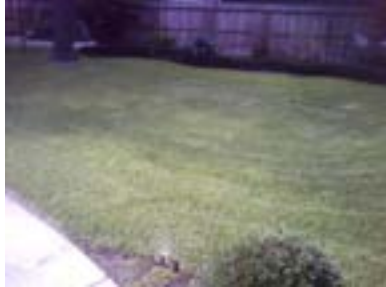
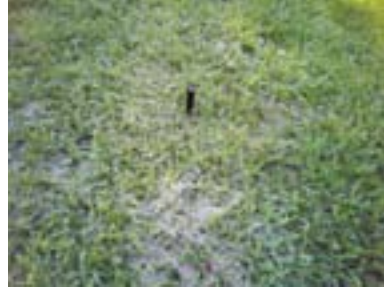
STATION 4:

Observed about 11 total heads at; back yard by ac unit and 1 not spraying in center;

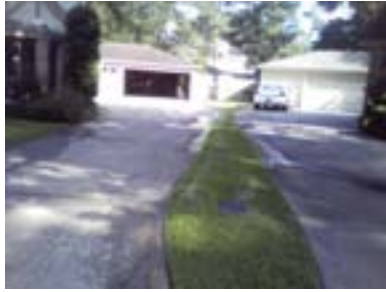
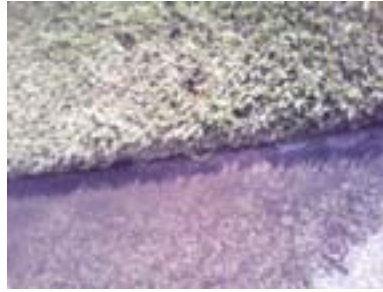
STATION 7:

Observed about 16 total heads at; front and back south side and 2 buried and dug 1 out;

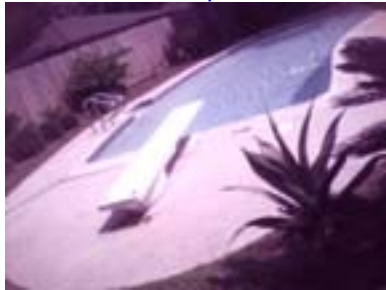
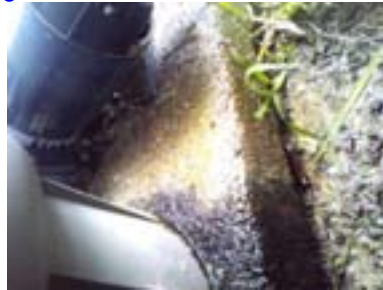
Yeary Inspection does not perform inspections on spas and pools. Would recommend to ask the homeowner about the service history and schedules and employ a spa/pool company or can recommend a spa/pool inspector for a detailed inspection. Please refer to www.yearyinspection.com website for a complete list of Pool safety rules under the safety tab and pay close attention to all door and enclosure requirements. Diving boards are not recommended and pool equipment is leaking.

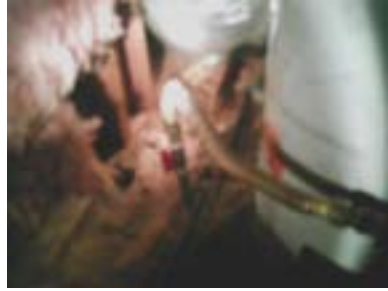
⌋ Missing gas drip leg or sediment P-trap downstream of the equipment shut off valve as close to the inlet of the equipment on gas line, (G2419.4);both water heater and furnace gas lines,

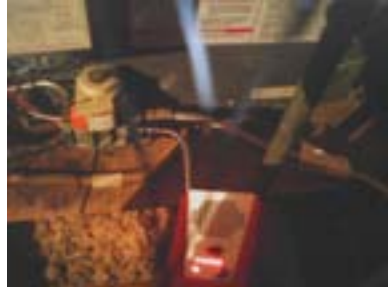
⌋ Gas leaks detected around unit;at pilot housing screw that is faint on outside of furnace which is most common for this type;
