Local Lane

Houston, TX

February 24, 2010

This Limited, Visual Inspection Report is prepared exclusively for

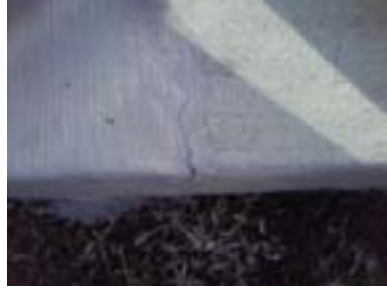
- ⌋ Cracks in wall(s) and/or ceiling;
- ⌋ Floors visibly not level
- ⌋ Cracks in brick, stone, or stucco;
- ⌋ Cracks in exposed concrete floors
- ⌋ Door and/or window frames out of square
- ⌋ Cracks in sidewalks, driveway, patio or garage which is very common;back porch,

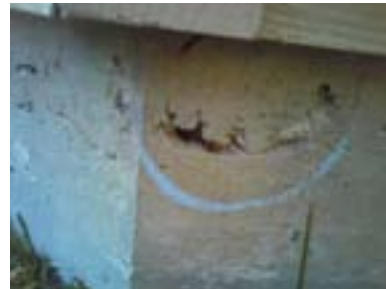
- ⌋ Cracks in slab on outside edge;
- ⌋ Beam/Rafter condition and/or Pier Condition which if rafters have pulled away from the ridge board or split should be blocked or repaired;
- ⌋ Excessive or improper shims
- ⌋ Wood form strips or other wood observed next to the slab which are conducive to wood destroying insects, which could be removed and replaced along with all cracks sealed with blown in foam covered with a thick layer of caulking;
- ⌋ Post tension live end tips are exposed and should be covered;
- ⌋ Nails or metal is exposed (only couple noticed) which could be removed and covered;

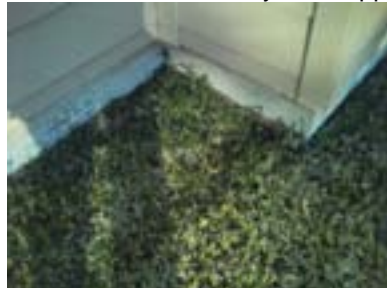
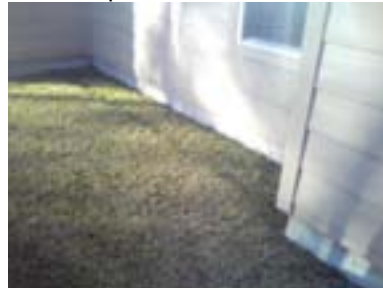
⌋ Improper drainage from foundation and not a decline at all locations away from slab and/or a 6 inch decline at 10 feet away;back appears could pond.

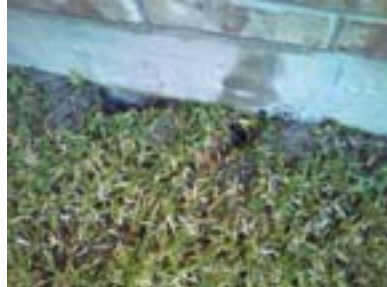
⌋ Erosion or ponding next to foundation/driveway or in yard;under water heater drain lines,

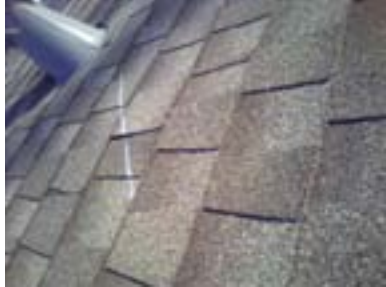
⌋ Roof decking raised;over garage side,

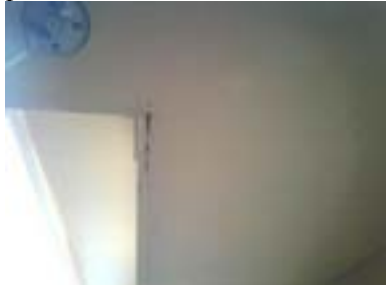
⌋ Trim, soffit, fascia boards are in need of repair;gap over master,

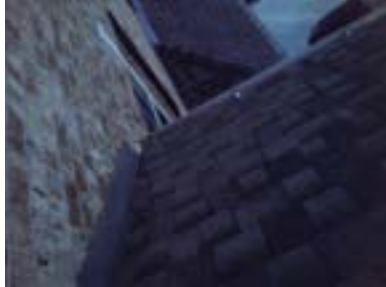
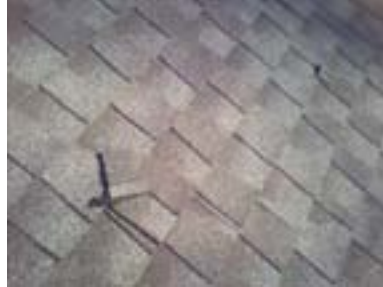
- .. Tree branches are too close to the roof structure;
- .. Roof ventilation system damaged and in need of repair
- .. Drain,waste vents missing, deteriorated (some have been chewed and/or cracks around boot where water can enter around) or improper installation (less than 6 inches above roof or 10ft horiz or 2ft above openings) or not protected with latex paint observed;
- .. Loose, missing and/or damaged gutters or downspouts;
- .. Felt should be over the drip edge flashing at the front and back eaves and be tucked under at the sides or rack so rain water will not get between the flashing and wood and cause water penetration;
- .. Observed the shingles are loose or not-glued down properly to the edge of the drip edge flashing (poor starter course);
- ⌋ Debris, nails on the roof that must be kept clean so that it does not damage the roof;hanger around front gutter,

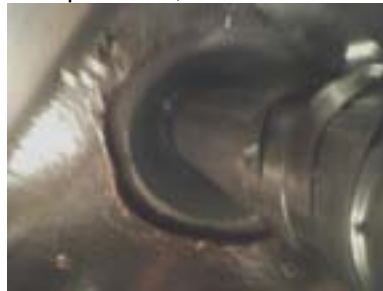
- .. Roof penetration(s) or flashing not properly secure, flashed/sealed;
- .. Brick chimney not properly flashed and counter-flashed;
- .. Skylight covers not secured and/or flashed properly
- .. Chimney cricket/saddle is missing if 30+ inches wide;
- .. Missing rain skirts on metal fireplace or furnace flues
- .. Missing/damaged rain caps on furnace/water heater flues
- ⌋ Storm collars are not caulked completely on furnace/water heater flues and/or could view daylight from attic access;left water heater and up furnace,

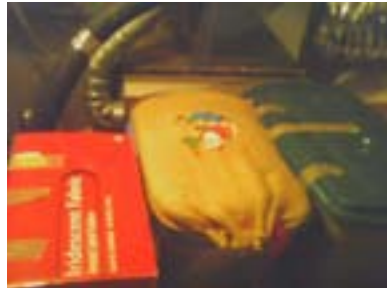
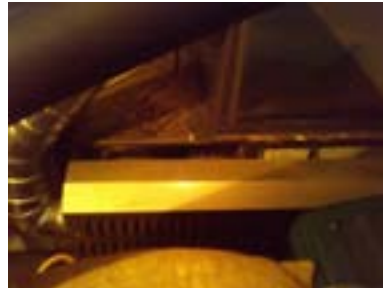
- .. Observed exposed gas or drain/water pipes that are loose or out in the walkway and should be blocked or strapped throughout;
- ⌋ Observed storage too close to furnace and access was open on both units and were moved and re-attached after checked,

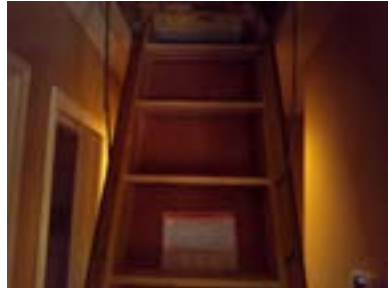
⌋ Lack of foam board insulation inside the steps;

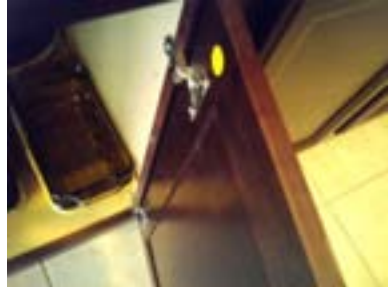
- Nail pops observed that could be repaired
 - Gaps or cracks underneath sinks around pipes, outlets, etc.;
 - Past water damage underneath sinks;
- ⌋ Cabinets, counter, mirror or drawer issues: loose at hinges, missing, several want close properly etc.; loose hinges marked in kitchen,

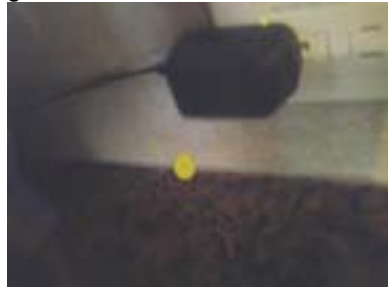
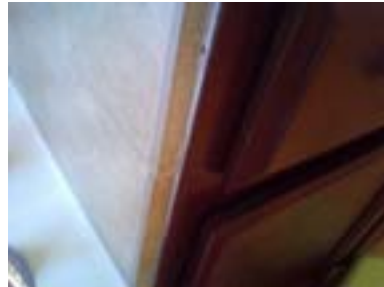
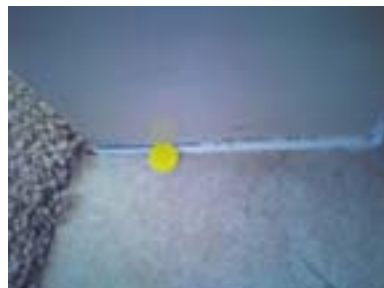
- ⌋ Caulking/sealant is separated or missing in some areas; around kitchen backsplash, minor, both sides of master tub, top of tub, corner wall over tub, master windows, bottom of stairs, office at trim, around game room sink to name some,

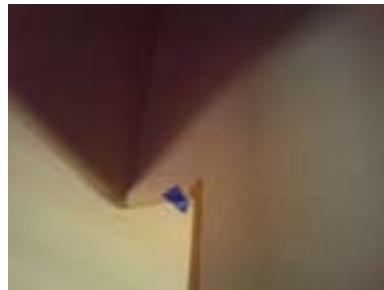
⌋ Trim boards, shelves/racks or **hardware is damaged/loose** at several areas;
⋮ Observed several paint discolorations and scuff marks throughout the house;
⌋ Observed several paint chips or sheet rock cracks throughout; some marked, over all tubs, corner of up bathroom, over entry by media room door to name some,

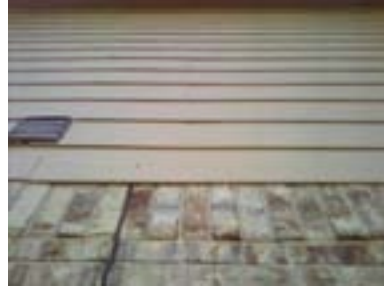
⌋ Mortar is separated or missing in some areas;between some bricks at corners,around windows,around east side windows,

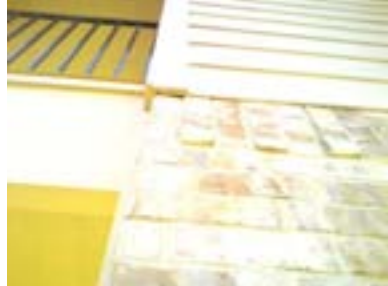
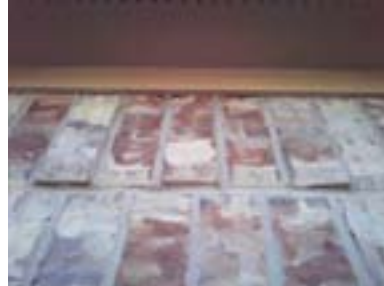
⌋ Caulking/sealant is separated or missing in some areas and should block/seal any and all openings between the wall and trim work, back corner,front corner,over garage and front room,

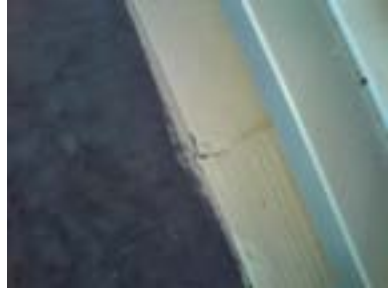
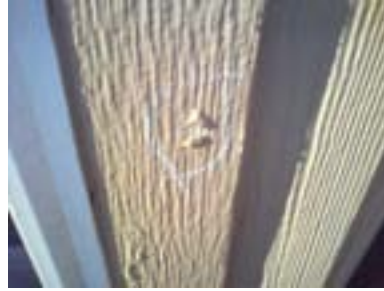
∴ Some cracks at the brick, stone, or stucco siding
∴ Wood siding is water damaged in several areas;
⌋ Siding shingles;chip on balcony under door,paint chips around,

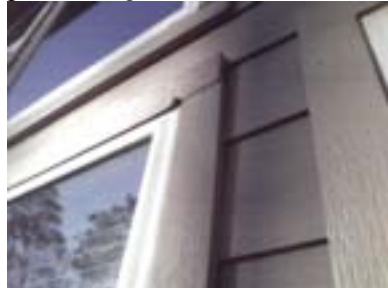
⌋ Flashing over window trim;turned in back,

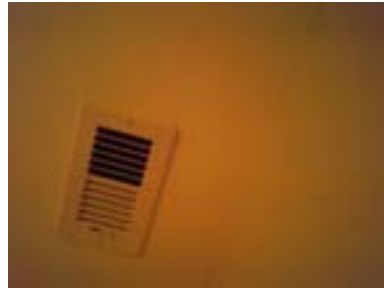
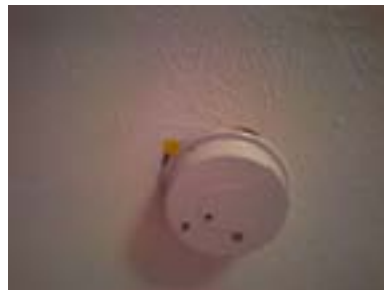
⌋ Ceiling cracks or imperfections in some areas(very common in vaulted ceilings) at;breakfast area, half bath, around front dining column, around girls detector, up girls room, up boys front room, couple of places game room, media room to name some,

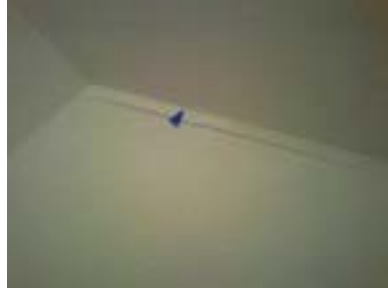
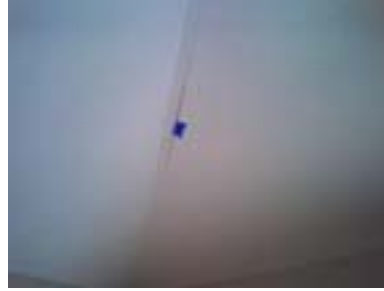
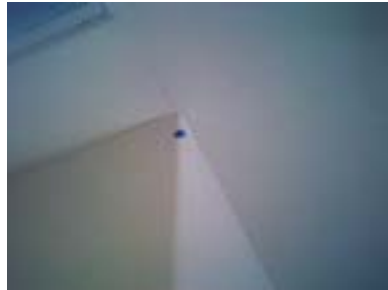
- .. Water stains on ceiling - measured with a moisture meter set on gypsum for sheet rock and registered .1% moisture content which is dry and past damage could be repaired;
- .. Paint discolorations;
- ⌋ Freshly painted
- ⌋ Nail pops in ceiling which could be addressed; 4 or more along wall in master, up middle bedroom, boys room to name some,

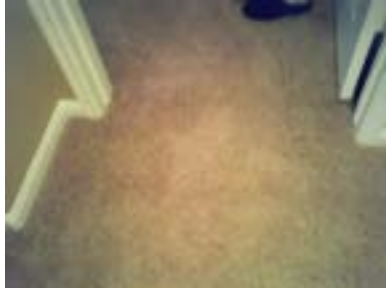
- .. Freshly painted or stained floor
- ⌋ Floors were uneven or creaked when walked across or warped/bowed in areas:between hall and guest room is raised,creaks in media room,

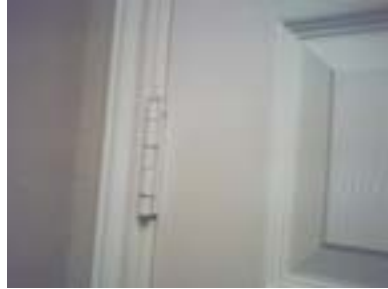
- ⌋ Observed that the automatic self closing device/hinge required by current IBC (International Building Code) on the door between the house and the garage needs adjustment to operate properly or is not present which is recommended to help prevent fumes in the garage from entering the living area and to ensure always fire blocked.

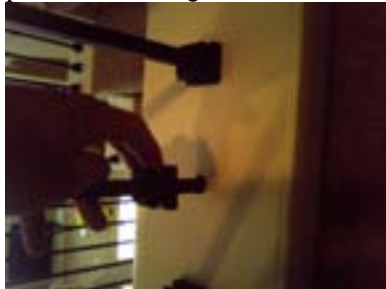
- ⋮ Hand railing is loose/missing at one or more locations;
- ⌋ Vertical railing decorative trim is loose at bottom, only a few.

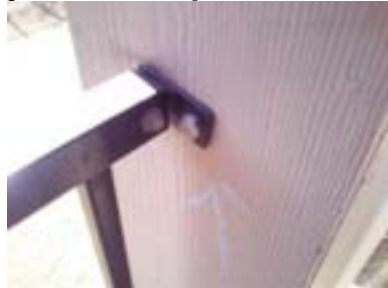
- .. Vertical railing spacing is greater than 4"
- .. Railing height is less than 36"
- þ Some decking fasteners are backing out;3 are loose on corners,

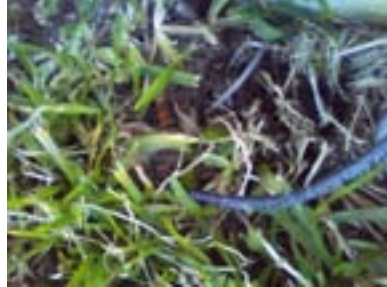
- ⋮ Panel(s) are not labeled properly
- ⋮ Panel has more than 6 main disconnects;
- ⋮ Panel(s) are loose at the wall, missing screws or pointed screws.
- ⋮ Improper cable bundling;all wires are clamped together vs. spread which is a new regulation;
- ⋮ Panel inner safety cover is loose or missing
- ⋮ One or more knockouts are missing
- ⌋ Ground wire/rod could not be verified or buried in ground;

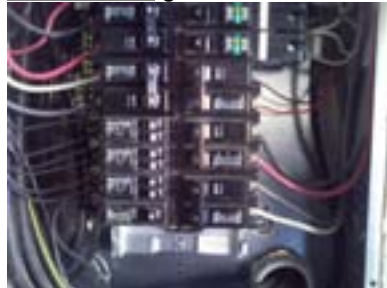
⌋ Incorrect wire on breakers/fuses;observed white wires used for hot current attached to a breaker and not identified,green for other than a ground and/or red and black for other than a hot current;

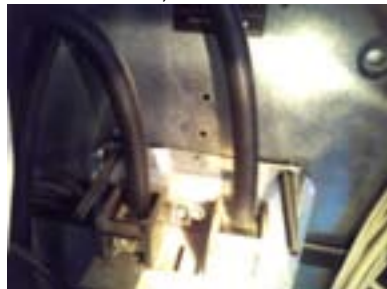
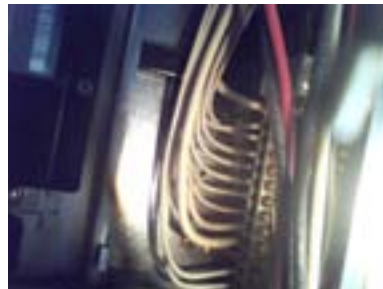
⌋ Lack of anti-oxidant grease on the aluminum service entrance conductors from the power company;3 leads in main,

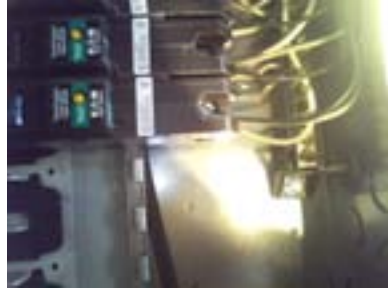
- .. Incorrect size of breakers/fuses
- ⌋ Grounds and neutrals on same bus bar or connected;remove silver connecting strap,

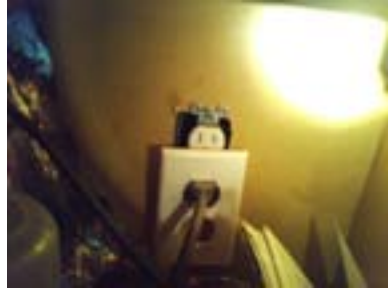
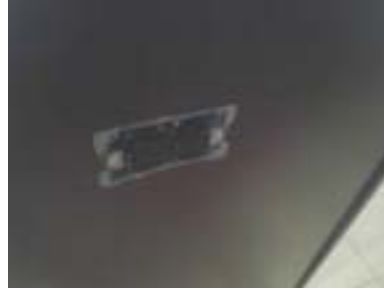
- ⌋ Observed one or more outlets, switches or electrical device installed through combustible material that are not flush mounted as required by code or is missing a plastic box (spark ring) at:may be under cooktop and under sink as seen above range and should be like Island;2nd picture.

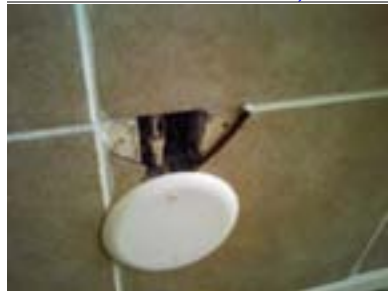
Kitchen: ⌋ Yes .. No ○ N/A 8 trip and reset to kitchen and should be one behind bar, ;[required in 1987 within 6 ft of sink,1996 was all that serve counter top outlets;](#)

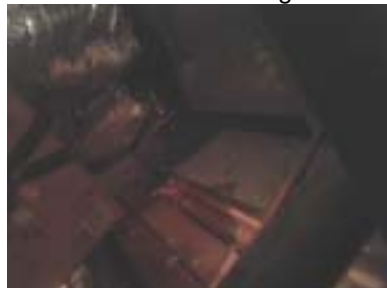
- " Freon lines not properly insulated at: ○ Condenser(s) ○ Air Handler(s) " In Attic
- Condenser unit(s) coils dirty
- " Condenser unit(s) are not level
- No data plate present or verified;
- No electrical cut-off within view of condenser unit
- Condenser coil(s) fins are damaged
- Air handler plenum is not properly sealed
- " Condenser airflow is restricted by foliage;
- No drain pan and/or drain line under the air handler
- Rust, debris and or water was found in the overflow pan like it may have overflowed in the past and should be cleaned or replaced to ensure it does not leak;
- ⌋ Debris and insulation was found in the overflow pan and should always be kept clean in case condensation occurs or primary drain line clogs. The secondary drain pan and line must be free of debris so will not clog which could result to water damage to the house.

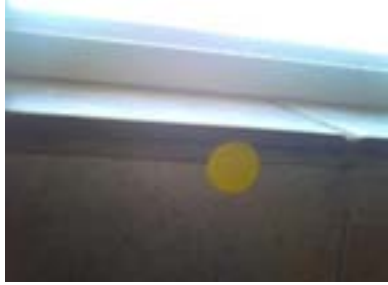
- .. Shower or tub has rust behind drains/faucets,
- .. Hot and cold water reversed;
- o Loose/damaged faucet handles
- o Improper slope of shower floor
- .. Tile loose and/or missing;
- o Shower diverter valve not operating
- .. Shower diverter valve allowing water from tub faucet when shower is in operation;
- .. Enclosure needs to be sealed;or bottom drip guard damaged;
- .. Shower walls with installed shower heads shall be finished with a nonabsorbent surface (tile, fiberglass, etc.) not less than 6 feet above the floor, (R307.2);
- p Caulking or grout in need of repair; top of boys bath,

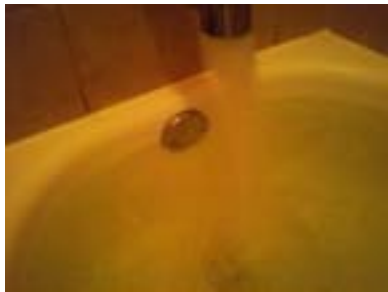
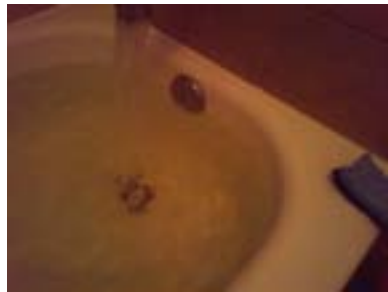
- o Drain stop inoperable or missing
- o Soap dish missing
- o Porcelain chip
- p Access panel is missing behind hall shower overflow and faucets; all are missing,
- o Access panel is loose on the wall, screws are not holding panel snug to wall or not secured properly;
- o Leakage from overflow

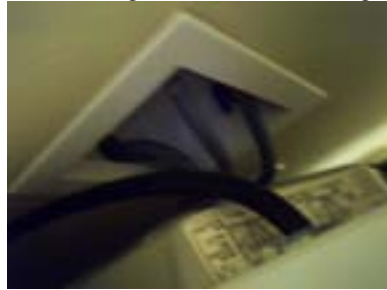
- p Washing machine connected at this time - faucets, drains not tested for proper operation
- .. Leakage at plumbing connections
- .. Dryer vented into attic or garage

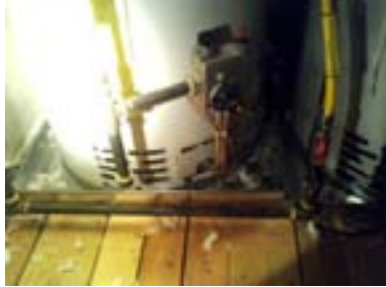
⌋ Unit drain pan has debris in pan,

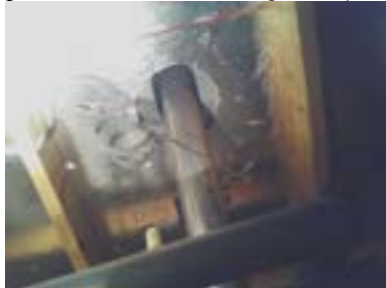
- ⋮ Leakage around bottom of unit
 - ⋮ Leakage around connections
 - ⋮ Leakage around storm collar or flue
- ⌋ Flue is loose, damaged or poorly connected;right not strapped,

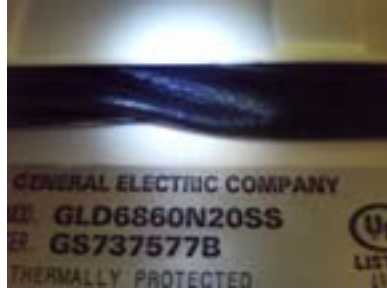
Note: Operated the dishwasher and appears to function properly. This unit is a GE brand and model/serial # is below.

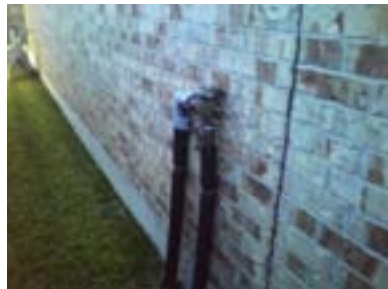
Note: Tested all zones for proper spraying and functioning heads. The items in the summary are areas of concern. This is a HUNTER PRO-C system with 6 posted zones. Discovered a total of about 60 heads at the time of inspection. The anti-siphon is 43 inches tall and not winterized.

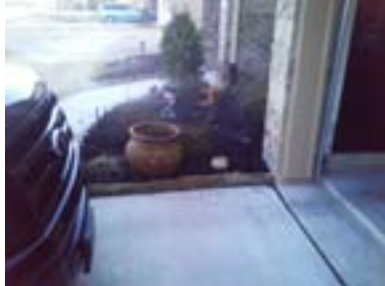
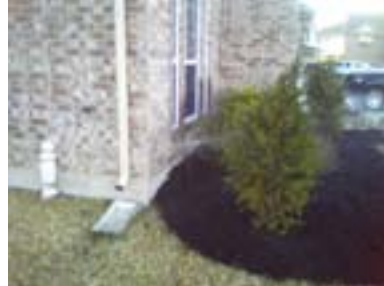
STATION 1:

Observed about 12 total heads at; front beds and several spray the wall which should be adjusted;

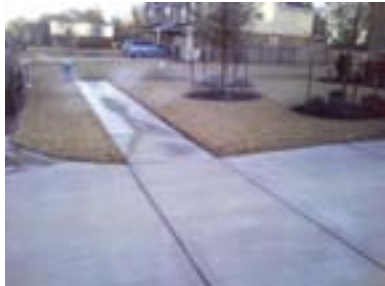
STATION 2:

Observed about 12 total heads at; front yard;

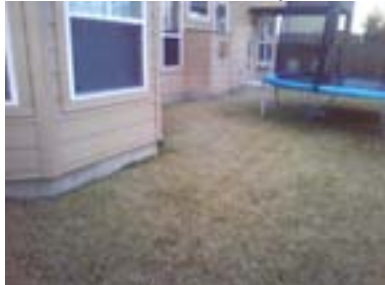
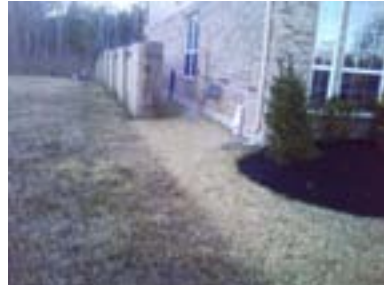
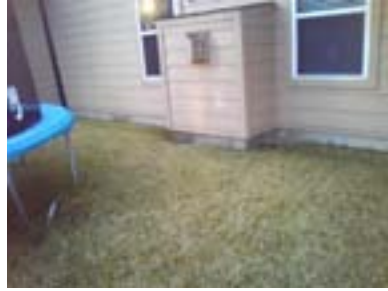
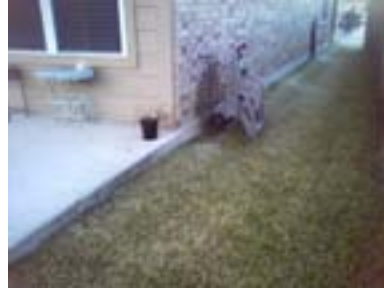
STATION 3:

Observed about 16 total heads at; kitchen side and back by the house and several (about 3) spray the wall which should be adjusted;

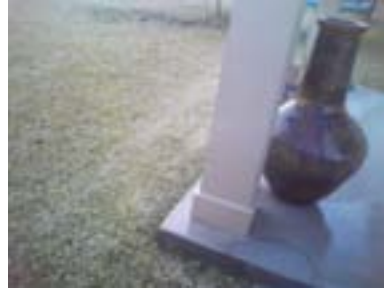
STATION 4:

Observed about 4 total heads at; rotating heads in back center yard and 1 sprays the columns which should be adjusted;

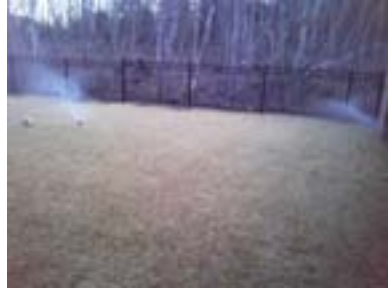
STATION 5:

Observed about 4 total heads at; very back and several spray the fence which should be adjusted;

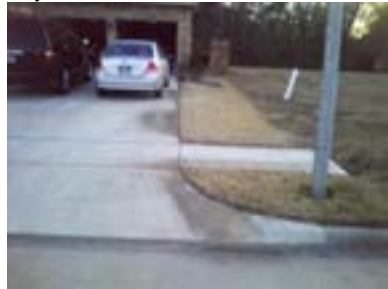
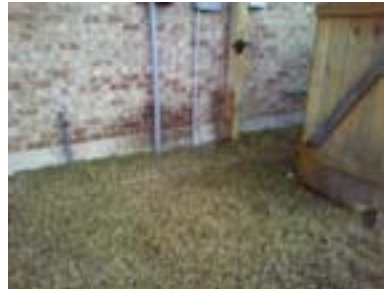
STATION 6:

Observed about 12 total heads at; garage side and several (1 to 2) spray the wall which should be adjusted;
