New Community Dr.

Kingwood, TX 77345

June 24, 2010

This Limited, Visual Inspection Report is prepared exclusively for

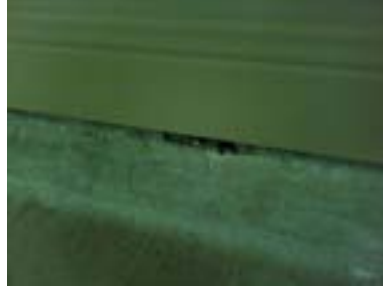
- ⋮ Cracks in wall(s) and/or ceiling;
- ⋮ Floors visibly not level
- ⋮ Cracks in brick, stone, or stucco;
- ⌋ Cracks in exposed concrete floors; few small chips in garage,

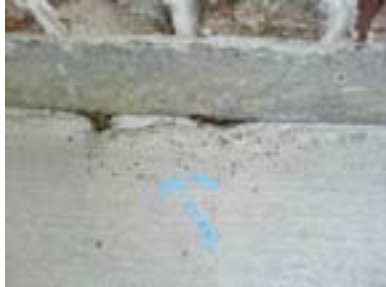
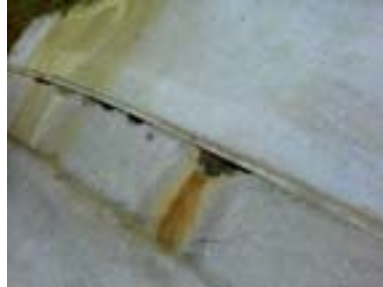
⌋ Cracks in sidewalks, driveway, patio or garage which is very common; may seal at front patio along wall, end of driveway to name some.

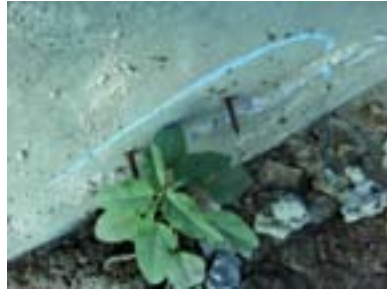
- Soil is high and should be removed away from the brick so that there is a 6 inch decline at 10 feet away from the foundation which is a cause of foundation settlement;
- Observed typical spalling (crumbling of slab) or honey combing. This can be epoxied or touched up and usually happens around the corner/edges of the slab because the stress will break the slab.
- Low spots around house allowing water to pond against the slab - recommend placing a gutter system with downspouts and splash pads if not present and repair the drainage issues
- Observed trees are very close to the structure in areas which tend to pull water from underneath the slab and may cause heaving or foundation issues:

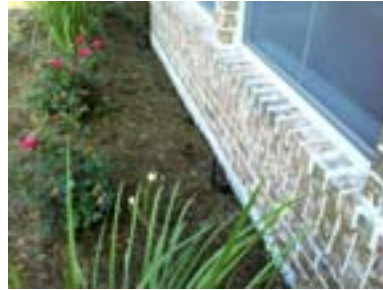
⌋ Improper drainage from foundation and not a decline at all locations away from slab and/or a 6 inch decline at 10 feet away or less than a 5% slope to swale when barrier prevents 6in/10ft; front mulch needs adjusting.

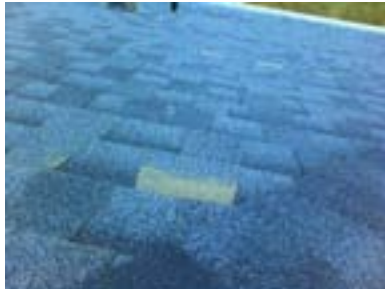
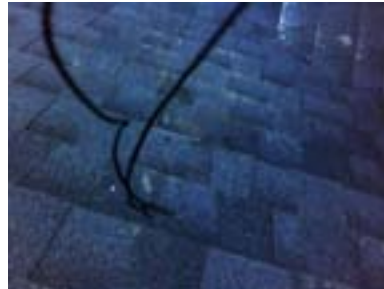
⌋ Some damaged or raised shingles throughout; 1 tear, a few raised on front over garage and ridge, several discolored/scuffed under front dormer and back noticed;

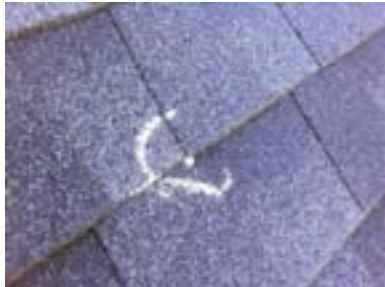
⌋ Observed some exposed nails and/or staples showing that should be covered or caulked as part of routine maintenance; a few nailed low,

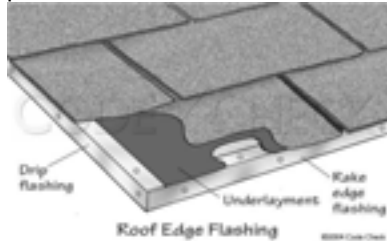
- .. Roof covering is in contact with siding;
- .. Leaves/debris in the gutters and downspouts;
- .. Tree branches are too close to the roof structure;
- .. Roof ventilation system damaged and in need of repair
- .. Drain,waste vents missing, deteriorated (some have been chewed and/or cracks around boot where water can enter around) or improper installation (less than 6 inches above roof or 10ft horiz or 2ft above openings or 12in to vert surface) or not protected with latex paint observed;
- .. Loose, missing and/or damaged gutters or downspouts;
- .. Underlayment should be over the rake edge flashing at the front and back eaves and be tucked under at the sides so rain water will not get between the flashing and wood and cause water penetration;

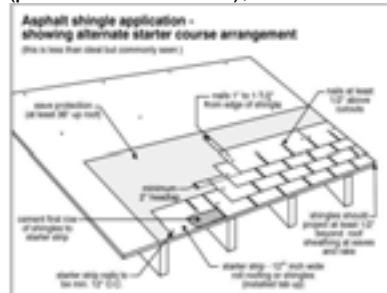
- .. Observed the shingles are loose or not-glued down properly to the edge of the drip edge flashing (poor starter course);

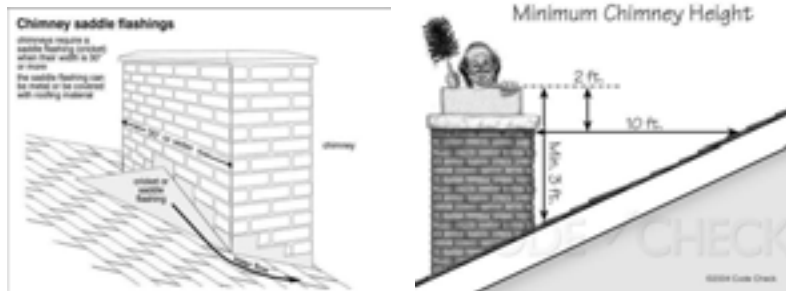
- ⊆ Debris, nails, straw, and/or leaves on the roof that must be kept clean so that it does not damage the roof;
- .. Roof penetration(s) or flashing not properly secure, flashed/sealed;
- .. Brick chimney not properly flashed and counter-flashed;
- .. Skylight covers not secured and/or flashed properly
- .. Chimney cricket/saddle is missing if 30+ inches wide or not the proper height;

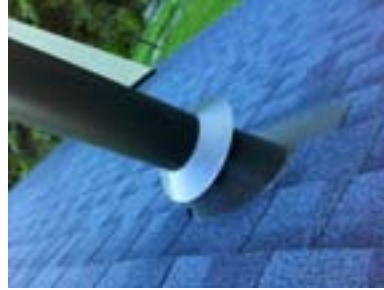
- .. Missing rain skirts on metal fireplace or furnace flues
- .. Missing/damaged rain caps on furnace/water heater flues
- ⊆ Storm collars are not caulked completely on furnace/water heater flues and/or could view daylight from attic access;furnace,

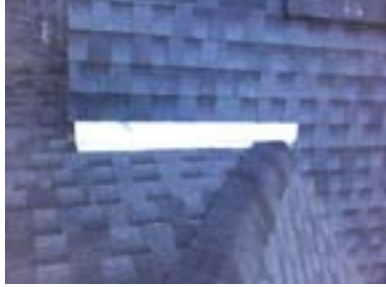
⌋ Flashing in need of repair; may paint valley flashing,

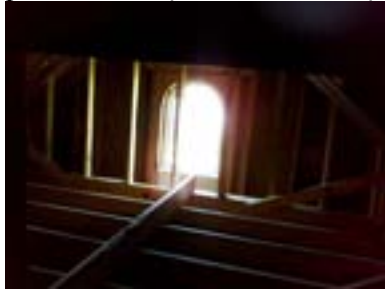
- .. This house does not have a radiant barrier installed and most new homes have for energy efficiency;
- ⌋ Dormers;unpainted windows;preference if homeowner wants painted;

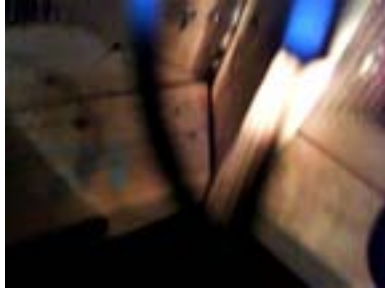
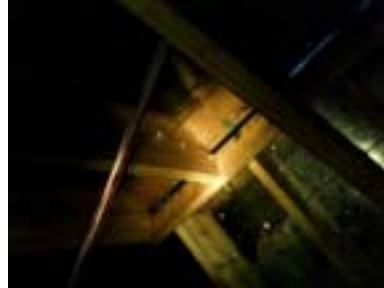
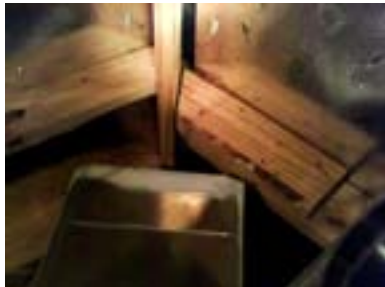
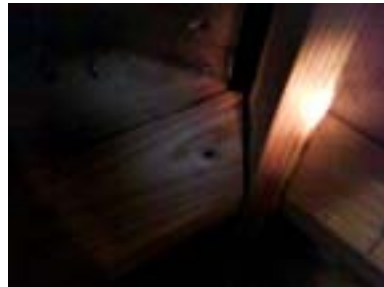
- .. Damaged and/or missing roof sheathing
- .. Openings observed around corners of attic that should be blocked;
- ⌋ Roof support; observed 1 or more rafters that are not fully flush against the ridge board (some poor cuts) or *do not meet or align on both sides (off tension) which could be blocked*,another rafter next too sistered past the purlins or other methods or just monitored;some specifics are a poor cut over living area furnace,garage and marked a few,however no immediate cause for concern,

- ⌋ Roof support from ridge boards (min.1x & full depth of cut rafter),rafters,bracing (2x4 max. 45% from vert), purlins (no smaller than rafter), collar ties (can be 1x4,upper 1/3 of roof section) may not **adequate**; a few rafters on kitchen side in center are nailed off center down past ridge board and a brace is loose in front of hall access and marked;

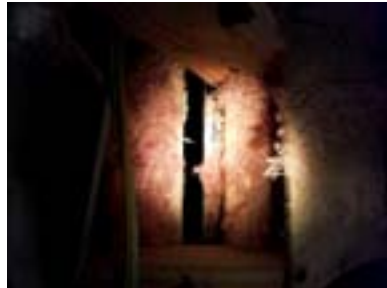
- ⋄ Bath/Kitchen vents terminating in attic or not properly sealed at roof decking;
- ⋄ Evidence of moisture penetration
- Open raceway from the garage to the house which should be blocked at the garage with a fire rated material. This creates an open chimney if a fire occurred and should be fire blocked;
- ⌋ Open chase should be fire blocked every 10 feet horizontally or vertically including around duct penetrations, between floors, and other openings and currently if a fire occurred could serve as a chimney;side front wall,

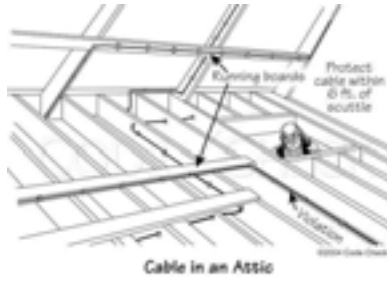
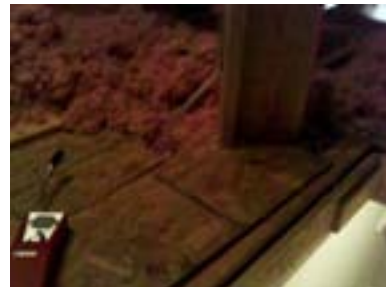
- ⌋ Current regulation requires all wires within 6 feet of the attic opening to be protected and observed unprotected electrical wires near the opening. This could lead to wire damage and possible electrical shock or potential fire hazard.;master access.

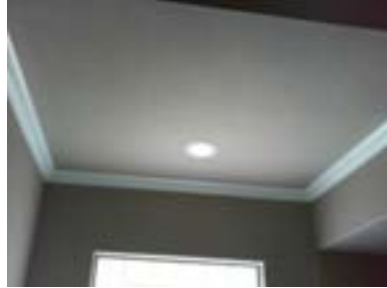
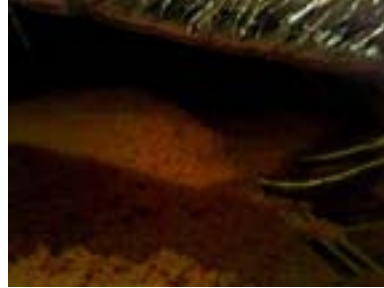
⌋ The recessed lights should be Insulated ceiling lights since insulation or combustibile material is touching the canister or closer than 3 inches. Even when these lights are air-tight or IC lights it is a good idea to pull all insulation away from the canisters because they can shut off due to getting too hot;over master tub going off and on,

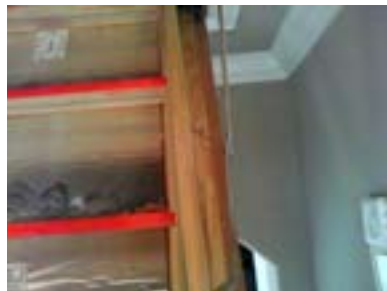
⌋ Lack of weather-stripping on the outside edge of hall access;

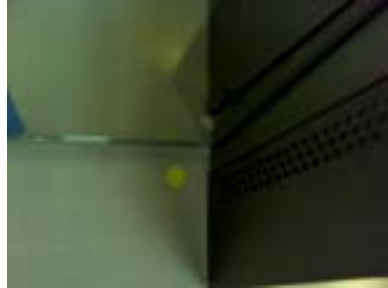
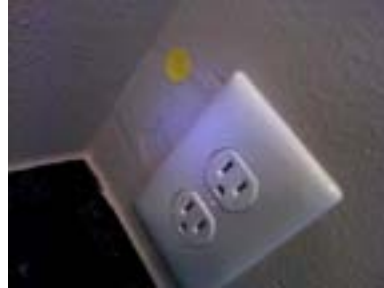
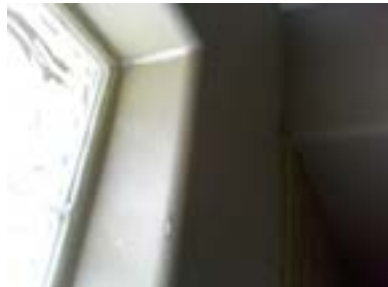
∴ Caulking/sealant is separated or missing in some areas;
∴ Trim boards, shelves/racks or hardware is damaged/loose at several areas
⌋ Observed several paint discolorations and scuff marks throughout the house;some marked in kitchen,pantry,bathroom,around master tub,

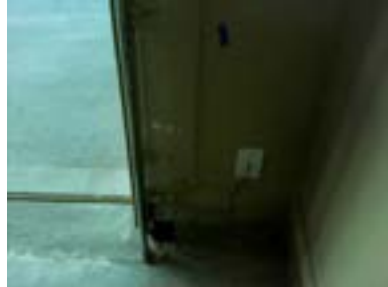
⌋ Observed several paint chips or sheet rock cracks throughout;several in garage,

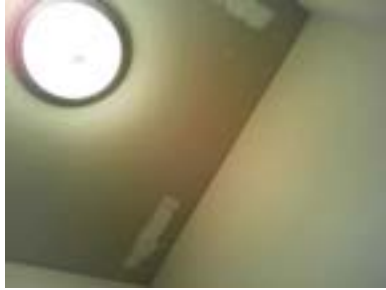
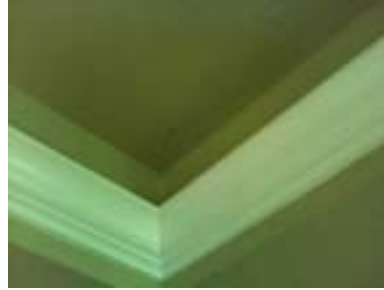
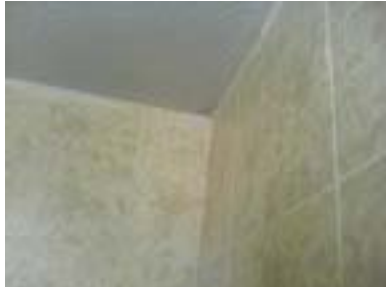
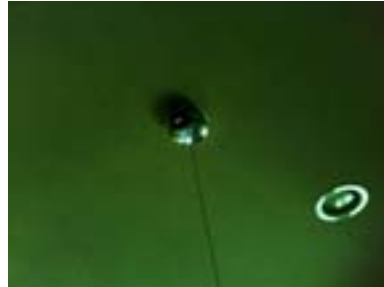
- ⌋ Ceiling cracks or imperfections in some areas (very common in vaulted ceilings) at; master bathroom,
- .. Water stains on ceiling - measured with a moisture meter set on gypsum for sheet rock and registered .1% moisture content which is dry and past damage could be repaired;
- ⌋ Paint discolorations; kitchen, scratch in formal, master bath shower, center of master, paint around

- ⌋ Freshly painted;
- ∴ Nail pops in ceiling which could be addressed;
- ∴ Caulk or trim pull away from the ceiling which should be addressed
- ∴ Substance on ceiling
- ∴ Observed ceilings are out of square or bowed in areas:
- ∴ Observed ceiling height in a habitable space is under 7 ft except 6ft 8 in over bath over fixtures and front clearance,(305.1 IRC);

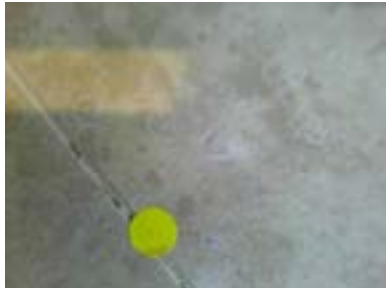
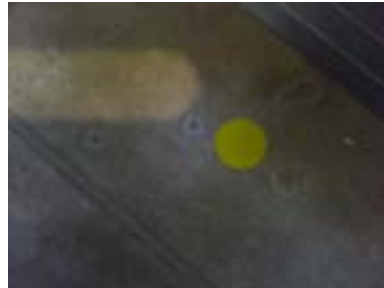
- ⌋ Floor cracks, scratches, or grout/seal openings in some areas;grout opening in center of living room,back kitchen door and a few scratches,

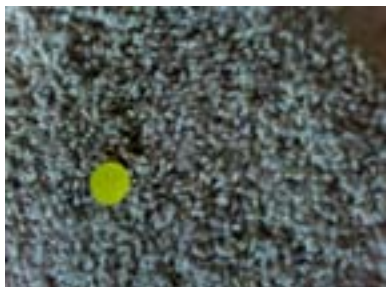
- ∴ Paint stains on floor;
- ∴ Linoleum or floor covering is torn and/or some carpet trim is exposed or needed,
- ⌋ Carpet and floor covering is stained;stain in middle room,

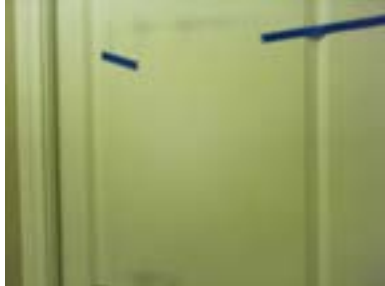
⊔ Damaged doors at: paint discolorations, laundry, bedroom doors, most other sliding doors,

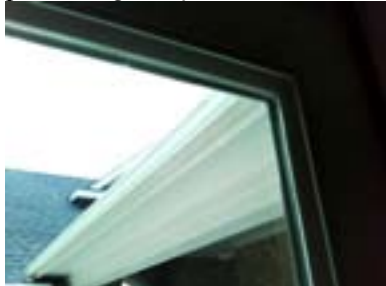
⌋ Some glass panes:should clean all paint and scuffs from all glass,

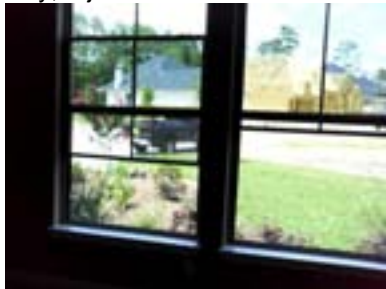
⌋ Some window lift supports are loose, damaged,:left in front bedroom not staying open all the way;adjust.

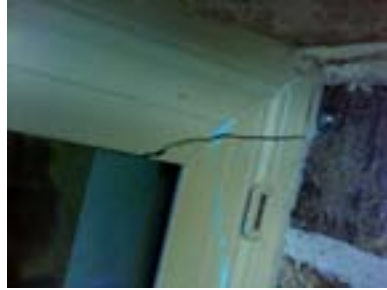
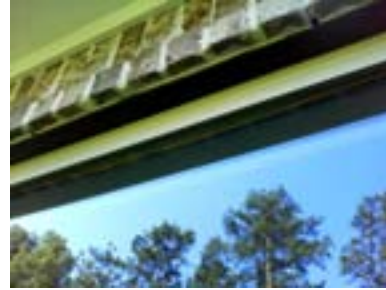
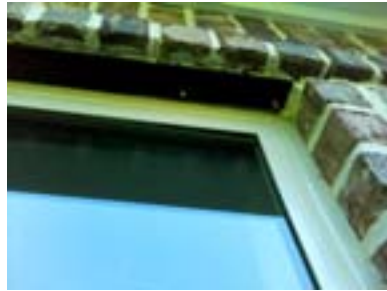
⌋ Some missing or damaged trim or latches or out of alignment at:damaged exterior trim in living room and not aligned at the top,

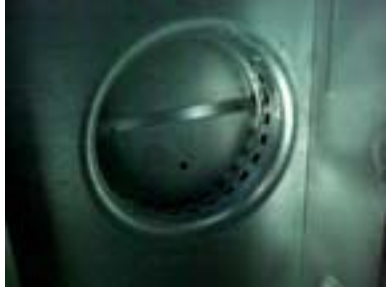
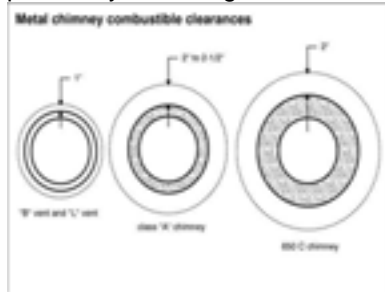
- Masonry Fireplace Clearances**
- .. Firebox hearth extension is less than 2 inches thick and/or hearth less than 4 inches;
 - .. Some brick mortar is loose and/or missing
 - .. Creosote build-up in firebox or flue;
 - .. Damper is in need of repair
 - .. No rain cap and/or spark screen in place is missing or damaged;
 - .. Hairline cracks in the firebox
 - .. Clean-out cover is loose and/or damaged
 - .. No firebox screen
 - .. No gas valve access panel
 - .. Starter wand is damaged or some closed holes;
 - .. Improper installation of gas log system
- | Damper is missing a clamp or bolt or is not blocked open and should be present in case of a gas

leak, the damper must not be completely closed when a gas starter valve is present (even when direct draft holes are present;2432.1 IRC).

- .. Stator wand is missing the air-mixer valve;
- .. Currently the chimney flue is inaccessible. Building insulation in contact with a metal chimney can cause hot spots that can burn out over time. Contact the chimney manufacturer for exact requirements. In the absence of the manufacturer's requirements, a free space of at least 2" is recommended to all construction materials and insulation should be remedied for safety against the possibility of damage that can lead to a fire if determined the chimney is in contact.

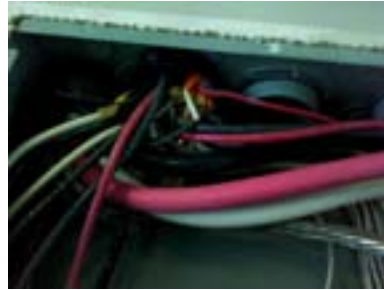
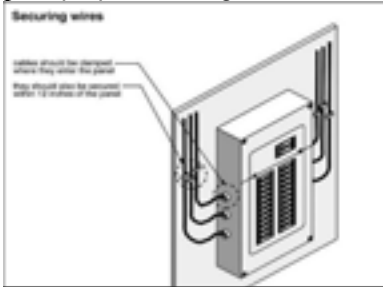
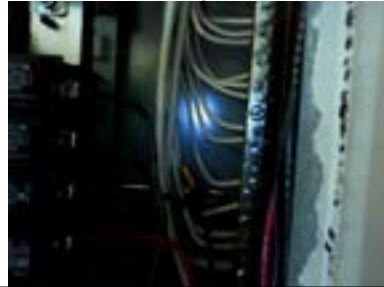
- .. Panel inner safety cover is loose or missing
- ⌋ Improper bonding locknut or connection; main strap not connected; [2008 NEC 250.92 \(A\) and \(B\)](#);

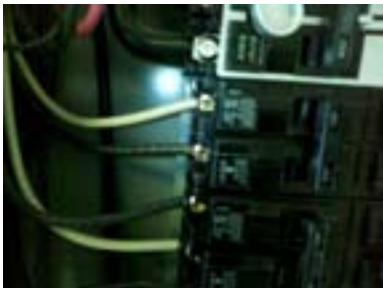
- ⌋ Lack of anti-oxidant grease on the aluminum service entrance conductors from the power company; all AL conductors.

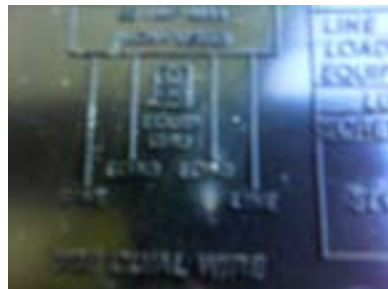
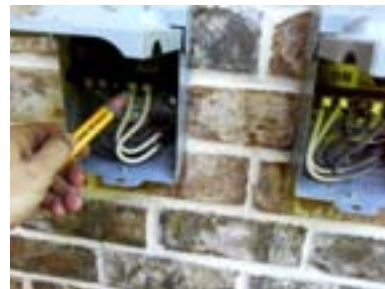
Ⓟ Observed that both A/C disconnect(s) over the A/C unit has the line load reversed. The line side (this panel is the OUTSIDE wires per the diagram) should always be the hot wire and load should be neutral and BOTH ARE reversed.

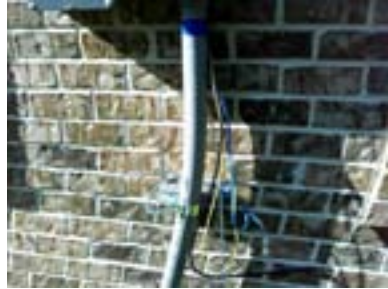
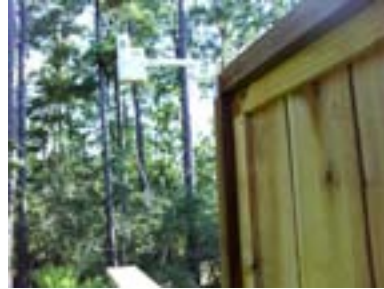
- .. One or more junction boxes do not have covers or rain protective/weather resistant boxes for exterior locations in all damp or wet receptacle areas;[\(2008 NEC 406.8\)](#);
- .. One or more wiring connections or wire splices are not in junction boxes or fully enclosed conduit;
- ⌋ Wires loose on the wall;low voltage in back waiting for connection,rain sensor not connected.

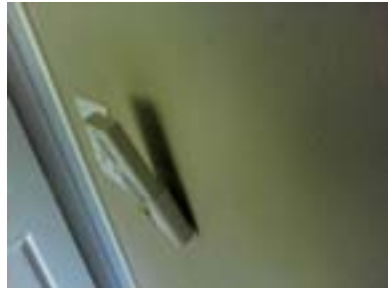
- .. Observed a receptacle more than 12 inches under Island counter.
- ⌋ Observed and touched several loose outlets throughout the house that must be tightened- [\(by removing the front cover if present and tightening the inside screws and replacing the covers\)](#):some loose,broken,not flush to the wall or gaps around may have been marked;fan switch hanging in middle bedroom,

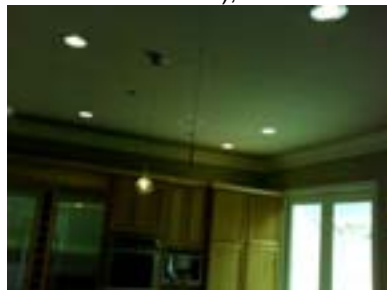
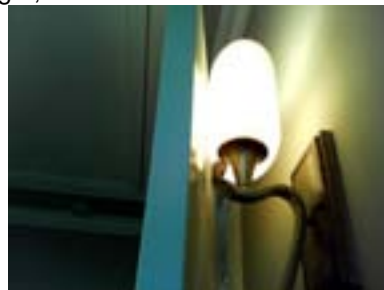
- Some light fixtures and/or bulbs did not function and could be either;
- Closet light fixture does not have proper clearance
- Some light fixture covers are damaged/missing; cover in kitchen and missing a globe (repaired while was there), hall door hits light,

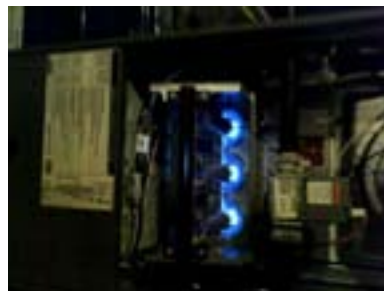
Note: The panel was removed and the heat was ignited. The heat displayed a nice blue flame and did not see any rust buildup. The heat was set on high as would go and ran for about 10 to 15 minutes and registered from **120 to 137F in living area except 1 closet to wall in center dining room is 110F and 139 to 142F in master area** using an infrared thermometer and testing each register. Over 110 F is a good read for this amount of time and this type of check helps to ensure the ductwork is connected to the register vent.

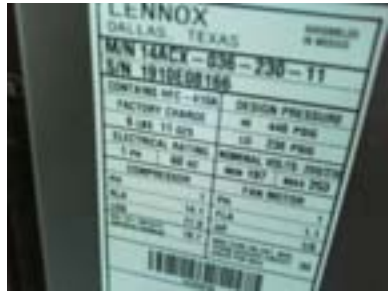
Type:LENNOX-LIVING AREA CONDENSER UNIT - Model # and Serial # is below with a min of 20 AMPS and max circuit breaker of 30 AMPS and is 3 ton unit manufactured in 19th week of 2010 by analyzing this data plate.

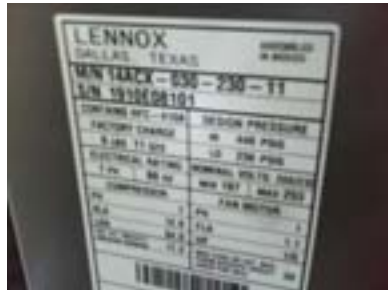
Type:LENNOX-MASTER CONDENSER UNIT - Model # and Serial # is below with a min of 20 AMPS and max circuit breaker of 30 AMPS and is 2.5 ton unit manufactured in 19th week 2010 by analyzing this data plate and closet to master.

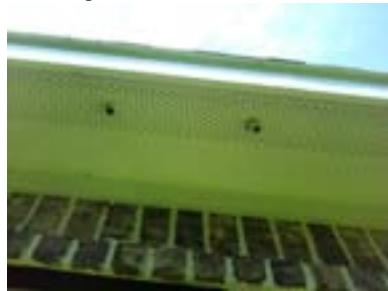
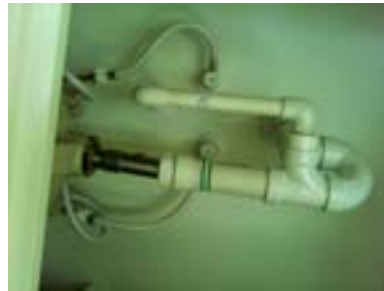
Observed the secondary drain line terminates over the **BACK** which if water is ever noticed dripping from that downspout would indicate the primary line is clogged and water will be in the attic pan and attention is needed. The primary drain line could not be inspected, due to being covered with insulation, catwalk, and or/ lack of accessibility and cannot always be certain that a pipe is not broken or connected properly, however only noticed 1 outlet in master sink; may be t'ed together, should investigate.

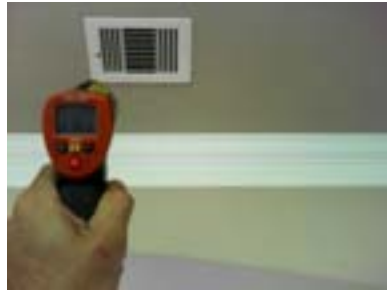
- Some ducting moisture barrier or plenum is damaged, missing and/or deteriorated or not sealed properly at the connections or unit;
- There is no central airflow to the room addition(s) and/or garage conversions;

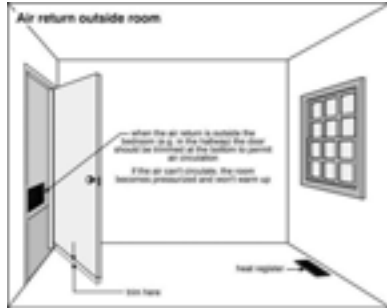
- Some supply registers have a heavy debris, rust or mildew buildup on the outside grates and/or very dirty return chase;
- Some registers are loose or not flush against the wall/ceiling; master return,

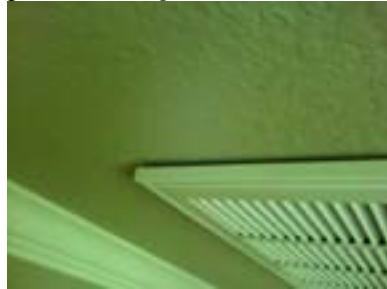
- Return air plenum is open inside and not sealed and/or wires, plumbing pipes which may be allowing air to escape and could be enclosed with duct board for increased efficiency and cover wires/pipes even when on an interior wall.
- Ducting is lying on the attic floor or resting against each other throughout the attic which should be well suspended throughout the attic;
- **Return air filters are present throughout the house and should be replaced because are dirty;**
- 12x12x1 ○ 12x24x1 ○ 16x25x1 • 20x25x1 • 20x30x1; ▫ 2 /16x25x4-in line/attic;

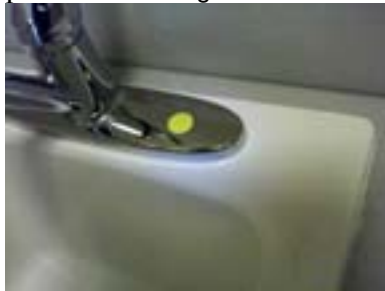
- ⓪ Leakage around sink(s) at:
- ⓪ Min. water service is under 3/4 in (2903.7 IRC),
- ⓪ Faucets have low water pressure
- Ⓟ Drain stop operable, but not properly holding water or draining, half bath,
- ⓪ Hot and Cold water reversed
- Ⓟ Loose/damaged faucet handles; laundry loose,

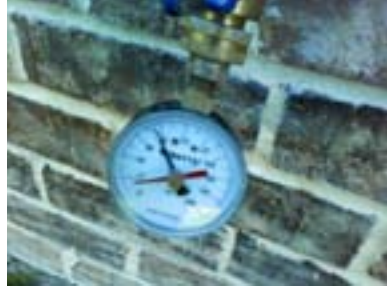
Outside Water Pressure: 75 PSI in the front behind garage and 75 on side of garage, 75 PSI in the back, 75 PSI on the east side at shut off was observed when checked with a PSI Water gauge. The standard water pressure should be between 40 to 80 PSI and if over 80 PSI is considered out of range.

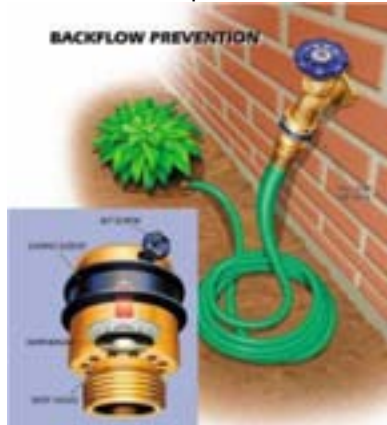
- Under 40% water pressure requires a booster pump and over 80% must be regulated, (2903.3 IRC);
- No backflow prevention at hose bibb(s):

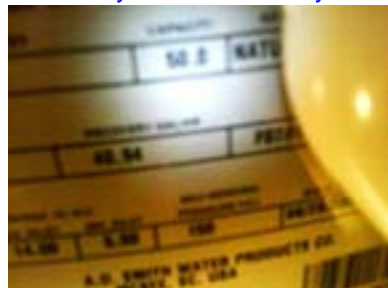
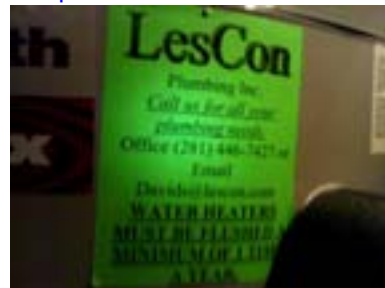
Type:A.O.SMITH and the info in below picture. **The TRP valve is NOT tested** (except for new construction, warranty inspections, 3 year old homes or less that are vacant) or operated at the time of inspection due to sometimes if has not been tested in the past year or so may not close properly leaving a constant water drip from the TRP line, however should always keep the pan clean and wiped down and test the TRP valve each year as to keep the rust and sediment buildup to a minimum. On homes 3 years or older may consider replacement of TRP valve if appears corroded;

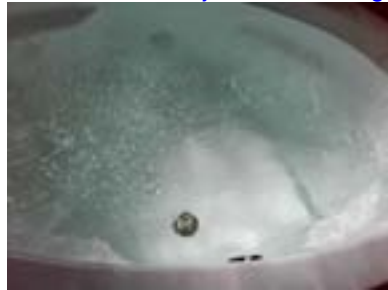
Operated the jets for several minutes and checked for GFCI,leaks and all other accessible items and confirmed that 6 jets are working including the suction and has access;

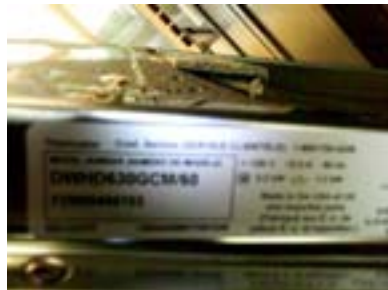
Note: Operated the dishwasher and appears to function properly. This unit is a THERMADOR brand and model/serial # is below.

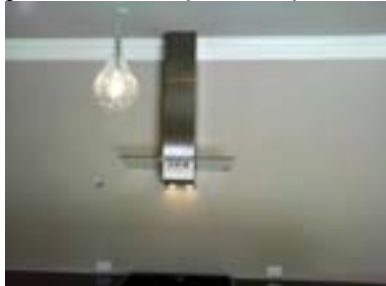
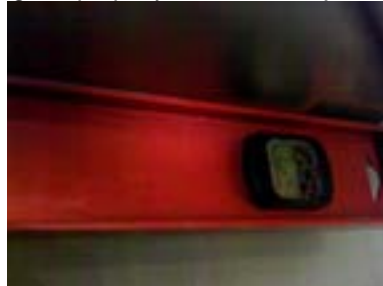
- .. Filter is dirty/greasy;
 - .. Light not functioning;
 - .. Vent pipe terminates improperly or does not completely vent all air to the exterior. The range is not the best system because it circulates the air back into the kitchen vs. to the exterior, however appeared to function at the time of inspection. Prefer the type system that takes the air to the exterior vs. recycling inside the house;
- ⌋ Fan assembly flue may not be aligned properly and level off just a little,

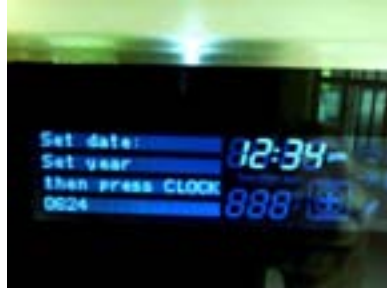
The oven is a Thermador unit and was tested by placing on 350 F and checked two or more times with a Laser thermometer. Registered 319 F after the 10 minute timer was set and sounded and 7 minutes more was 404 F and was 365 F after the next 10 minutes. Warming drawer was 167 F at bottom.

The Broil (usually between 500 to 550 F) HI function was tested and registered 598 F in the center with laser thermometer after several minutes which is high read.

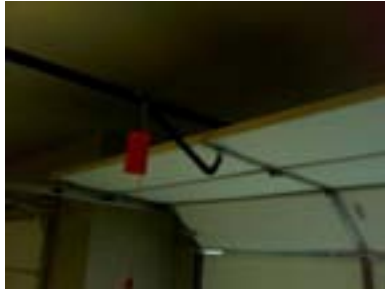
- .. Missing safety wire inside door springs
- .. Switch is loose or too damaged to operate opener
- ⌋ Electronic sensors not installed at proper heights;3 about 7 inches; **all should range between 4 to 6 inches from the ground.**
- .. Unit(s) are loose or not properly secured to ceiling
- .. Electronic sensors do not operate
- .. No safety quick release rope to disable opener
- .. Latch device is not secured or blocked properly so that it cannot be latched which is a must with automatic door openers in use;
- .. Remote door opener not observed or present;
- ⌋ Missing the support shield on the top of the door which is required unless the manufacture states otherwise;

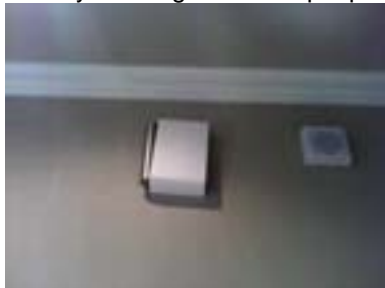
- .. Doorbell did not function;
- ⌋ Doorbell switch/cover is loose or damaged;loose on inside hall wall and could not hear front doorbell so may investigate with 2 people.

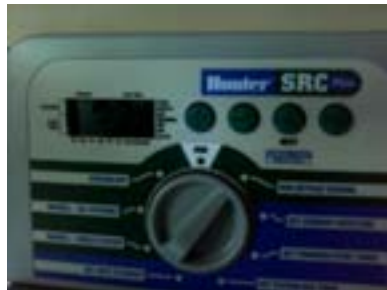
Note: Tested all zones for proper spraying and functioning heads. The items in the summary are areas of concern. This is a HUNTER SRC PLUS system with 6 posted zones. Discovered a total of about 70 heads at the time of inspection. The anti-siphon is 30.5 inches tall.

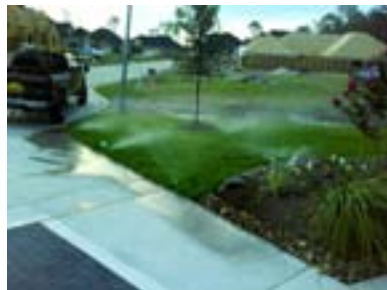
STATION 1:

Observed about 12 total heads at; front yard both sides of driveway;

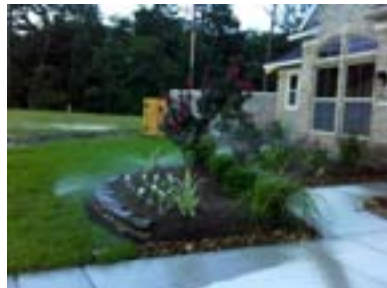
STATION 2:

Observed about 17 total heads at;front beds;

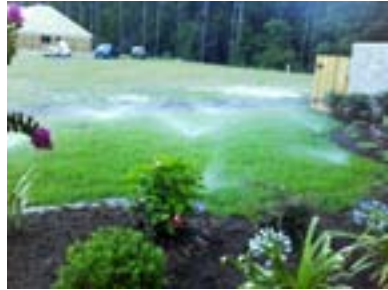
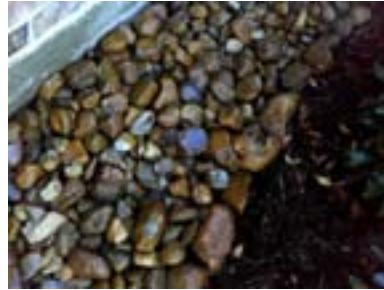
STATION 3:

Observed about 14 total heads at; 8 in front east side and 6 in back and 1 under rocks is covered or broken,

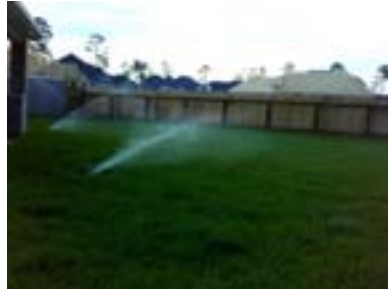
STATION 4:

Observed about 7 total heads at;back east side;2 spray the fence wall,

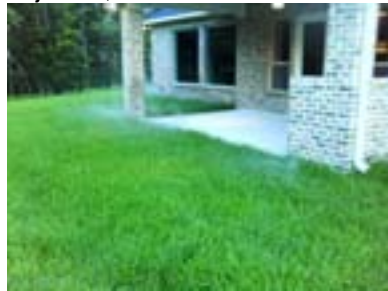
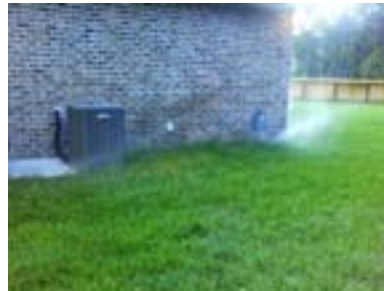
STATION 5:

Observed about 13 total heads at;all along back wall and several spray the wall which should be adjusted;

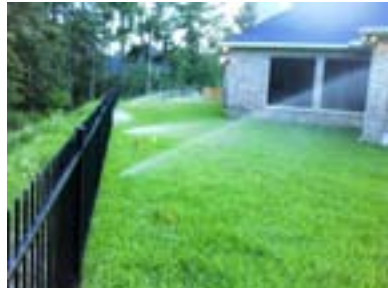
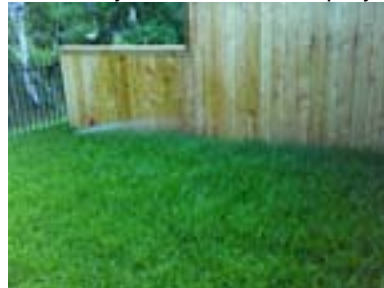
STATION 6:

Observed about 7 total heads at; back west yard and about 2 spray the wall which should be adjusted;

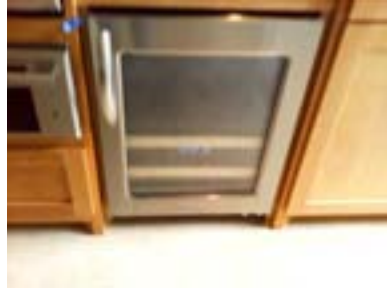
Note: Did check the (Thermador) refrigerator with laser one time and got a 41 F and the freezer registered 16 F and the wine (Kitchenaid) rack was 41F , however is not a complete check that would be needed to inform that it is working properly. Just a courteous temperature check.
