Vacation Street

Galveston, TX

June 2, 2010

This Limited, Visual Inspection Report is prepared exclusively for

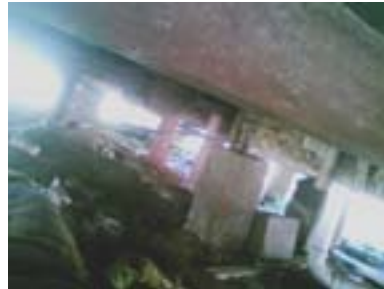
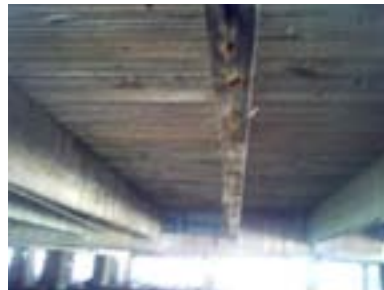
⌋ Beam/Rafter condition and/or Pier Condition which if rafters have pulled away from the ridge board or split should be blocked or repaired;noticed 1 in attic and some beams were removed under master bedroom,some rot on beams under kitchen and **front open area sides;3rd picture**,some holes under a few others were noticed.

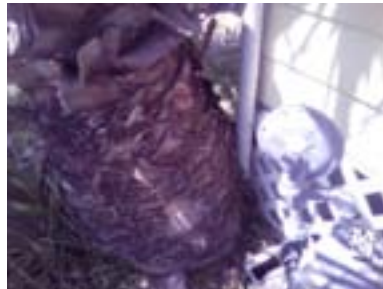
⌋ Observed trees are very close to the structure in areas which tend to pull water from underneath the slab and may cause heaving or foundation issues:

Should always seal any opening between concrete sections with blown in foam covered with a thick layer of caulking;

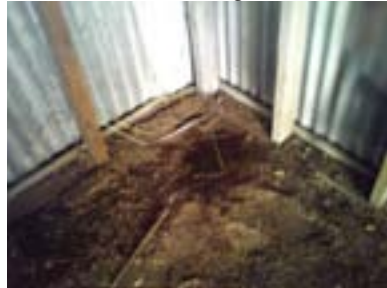
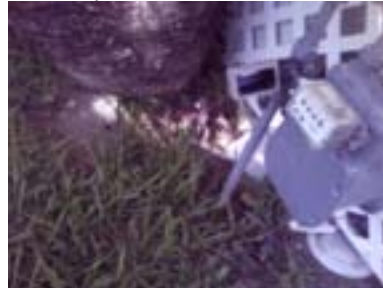
⌋ Erosion or ponding next to foundation/driveway or in yard; underneath as seen in foundation section, front under gas meter, corner of carport to name some,

⌋ Could consider adding a gutter system in all locations to divert the water away;
 French or corrugated drain system that should be monitored for leaks so that water does not seep into the ground and work under the slab;

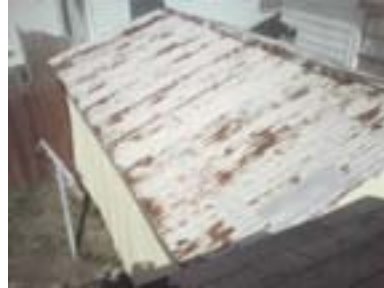
⌋ Some damaged;some scuffed in front,carport is rusted in places and a few patches,

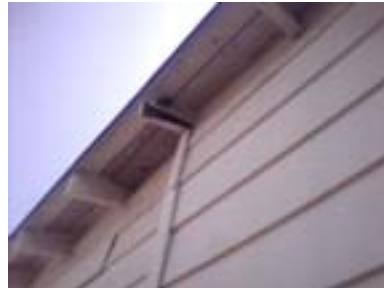
⌋ Trim, soffit, fascia boards are in need of repair;over back door,top outside fascia over bathroom has a crack and some soft rotted areas in back of bathroom along with fascia boards missing that need replacing,seal in front to name some,

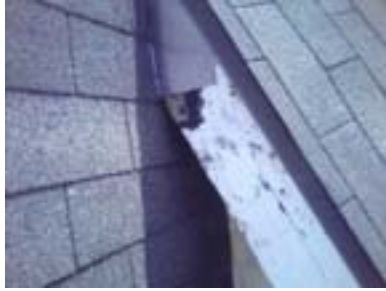
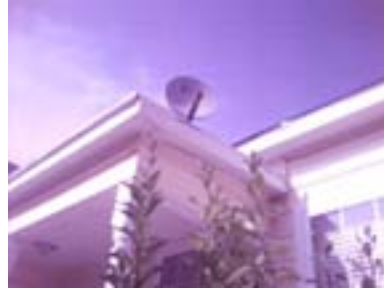
- ∴ Roof covering is in contact with siding;
 - ∴ Leaves/debris in the gutters and downspouts;
 - ∴ Tree branches are too close to the roof structure;
 - ∴ Roof ventilation system damaged and in need of repair
- ⌋ Drain,waste vents (some have been chewed and/or cracks around boot where water can enter around,however was caulked) and all are *not protected with latex paint observed*;

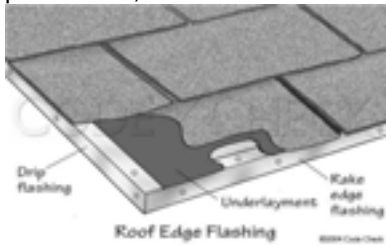
- ⌋ Loose, *missing* and/or damaged gutters or downspouts;
- ∴ Underlayment should be over the rake edge flashing at the front and back eaves and be tucked under at the sides so rain water will not get between the flashing and wood and cause water penetration;

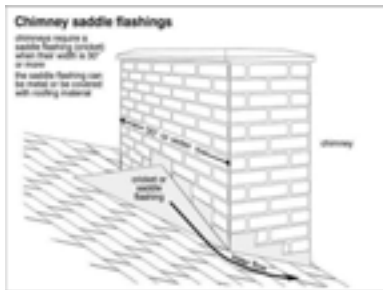
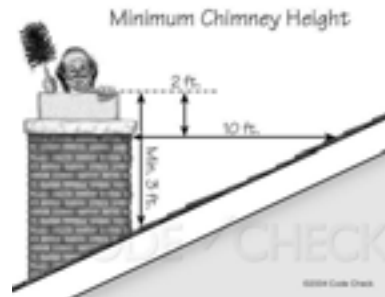
- Ⓟ Debris, nails, straw, and/or leaves on the roof that must be kept clean so that it does not damage the roof; loose 2x4 on front porch,
- .. Roof penetration(s) or flashing not properly secure, flashed/sealed;
- .. Brick chimney not properly flashed and counter-flashed;
- .. Skylight covers not secured and/or flashed properly
- .. Chimney cricket/saddle is missing if 30+ inches wide or not the proper height;

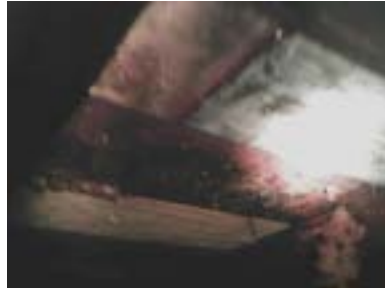
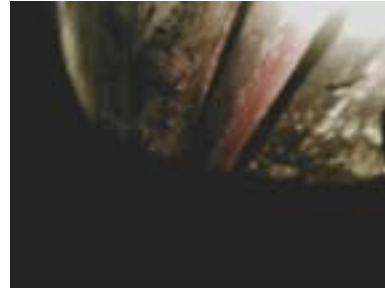
⌋ Damaged and/or missing roof sheathing;some open areas where felt is viewed and some discolored lumber,and wood rot around bathroom as seen from attic in below pictures and in roof pics.

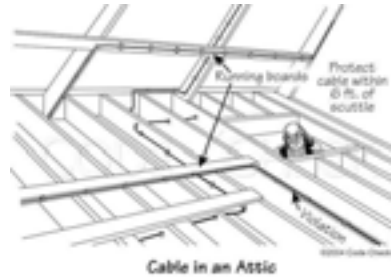
⌋ Current regulation requires all wires within 6 feet of the attic opening to be protected and observed unprotected electrical wires near the opening. This could lead to wire damage and possible electrical shock or potential fire hazard.

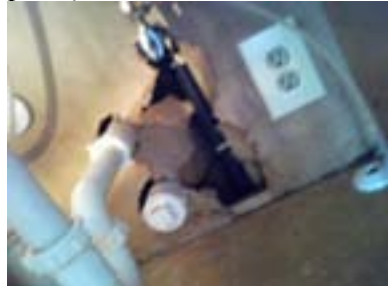
Ⓟ Gaps or cracks underneath kitchen sink around pipes,outlets, etc.;

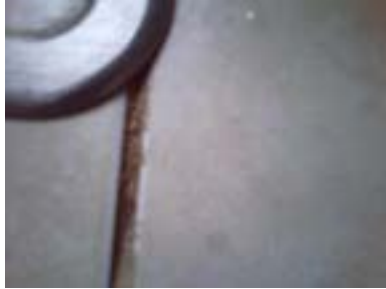
Ⓟ Cabinets,counter,mirror or drawer issues:grout separation in kitchen,

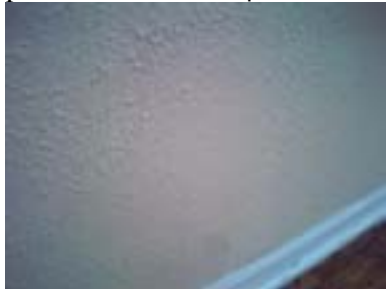
⌋ Trim boards, shelves/racks or hardware is damaged/loose at several areas
 ⌋ Observed several paint discolorations and scuff marks throughout the house;

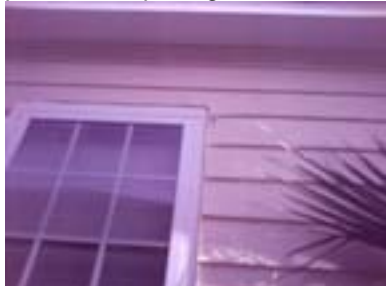
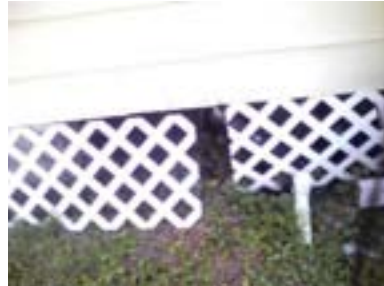
Type(s): ⌋ Brick ⌋ Cement Board ⌋ Wood and vinyl over in back and corners;
 ⌋ May be asbestos siding;
 ⌋ Fascia/trim/crawlspace skirting boards are damaged at several areas;next to window in living room,lattice is not secure on sides and around and really should have closed in with animal/rodent proof vent openings all around with an access door.

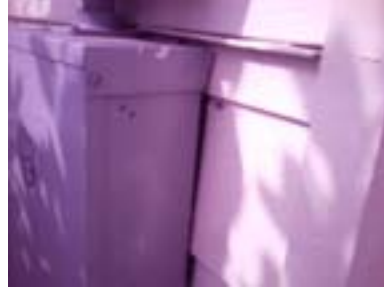
⌋ Caulking/sealant is separated or missing in some areas and should block/seal any and all openings between the wall and trim work,back door,panel.

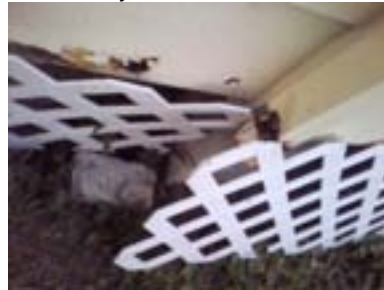
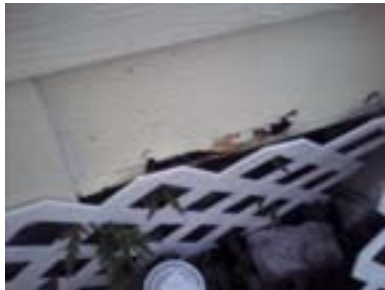
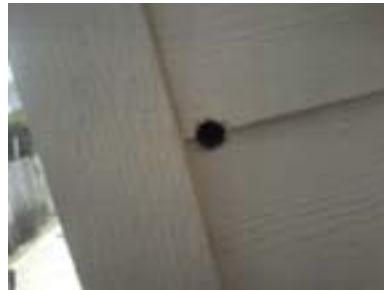
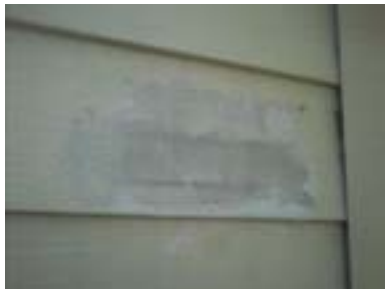
⌋ Siding shingles are cracked, loose or missing;all along bottom in back,corners and kitchen/living area side,past patch in back and hole in hardy on side was noticed,

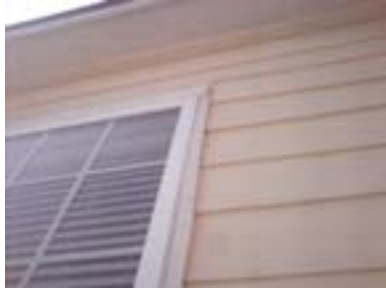
One or more areas were obstructed by foliage and/or other items;all around should be cut back,

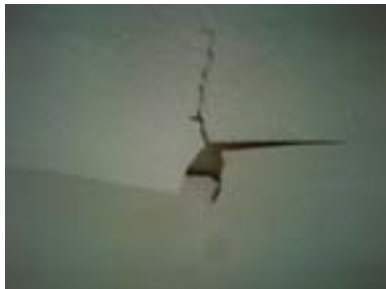
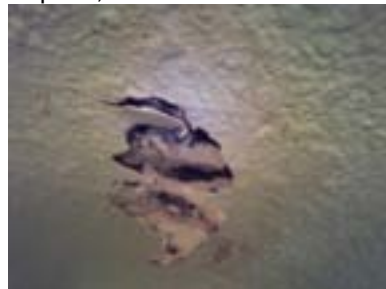
Water stains on ceiling - measured with a moisture meter set on gypsum for sheet rock and registered .1 to .3% moisture content which is dry and past damage could be repaired;over laundry and bathroom which has substance under paint,

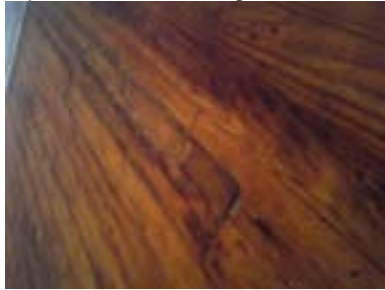
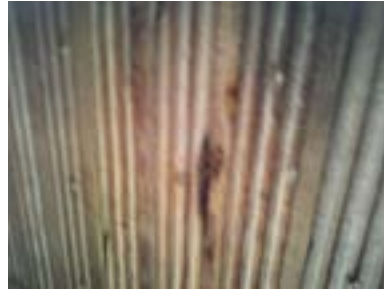
⌋ Floor cracks, scratches, or grout/seal openings in some areas;appears wall was removed in open room,some soft spots underneath around center,kitchen and bathroom noticed and may want to replace some damage.

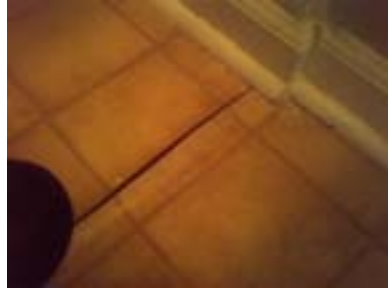
⌋ Linoleum or floor covering is torn;bathroom,

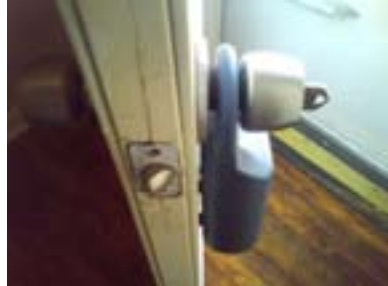
- .. Sliding glass door slides poorly or improperly installed at:
- ⌋ Sliding glass door does not latch/lock properly at: front,
- o Sliding or other screen door is missing/damaged at:
- ⌋ Damaged doors at:small split in front door as could have been kicked,

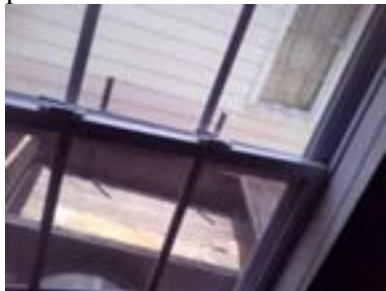
- p Some windows are difficult to open or close at: right master is not aligned in frame;

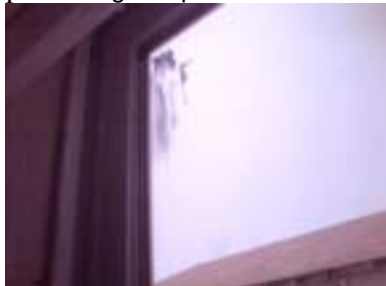
- p Some glass panes have a few scratches or paint on window,kitchen,front bedroom,bathroom,

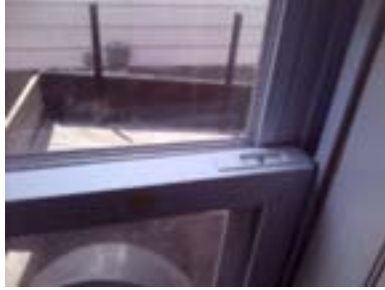
⌋ Some missing or damaged trim or latches or out of alignment at:right master swing out latch is broken and no latch on kitchen window.

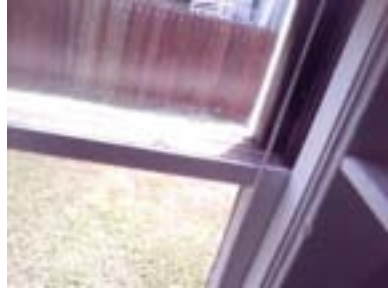
- ∴ Thermal pain window seals have failed and moisture has penetrated at:
- ∴ Inspection of the windows was limited due to furniture, window covers and/or stored items
- ∴ Burglar bars, clamps or blocked windows installed are a safety hazard. They do not provide adequate egress (escape) in the event of fire;
- ∴ Storm windows installed are a safety hazard, if they do not provide adequate egress in the event of a fire
- ⌋ Windows are single paned at:kitchen is original,

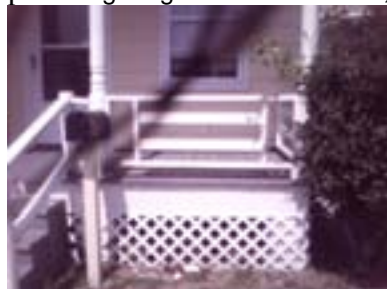
- ⌋ Vertical railing spacing is greater than 4";
- ⌋ Railing height is less than 36"; about 28 inches,

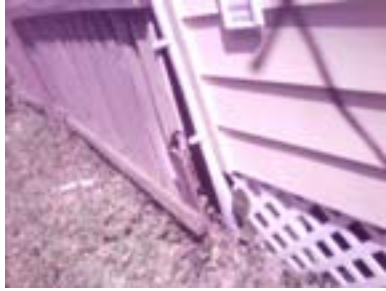
- ⌋ Fence is showing signs of wood rot or pickets are warped, leaning or falling off:

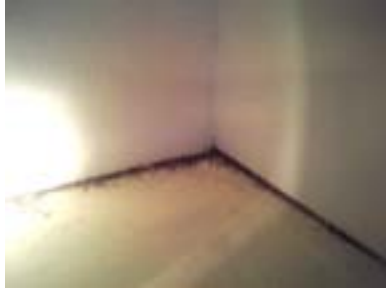
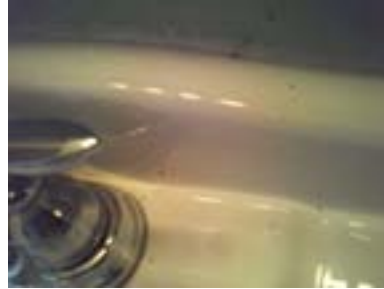
- .. Gaps underneath the fence that should be addressed:
- .. Observed a dead tree which should be removed or monitored to ensure does not fall on house:
- .. Address not visible from the street or road:
- .. Observed gate locks do not latch properly and should be adjusted:
- .. Some debris or bricks are leaning against the house/garage:
- .. Some bricks are stacked in garage and would be a good idea to spread the load;
- ⌋ Some wasps nests, insects or ant beds were observed at:see wdi report and activity under house,mice droppings in cabinet,ants in bathroom to name some,

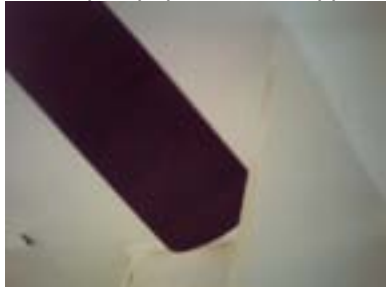
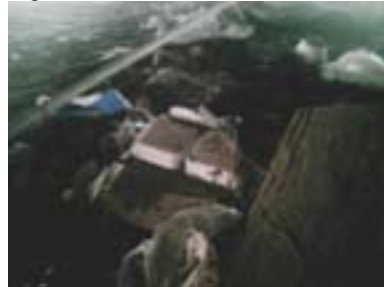
- .. Some mailbox or flag issues were observed:
- ⌋ Some other safety or tripping hazards exits around house:upper/top cabneits in kitchen hit fan blade when open,papers left on upper storage,and a lot of debris underneath in crawl space.

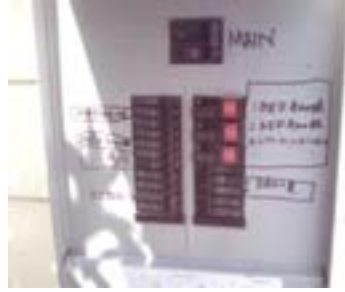
⌋ Panel(s) are not labeled properly; some are,

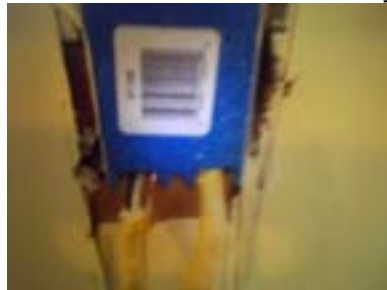
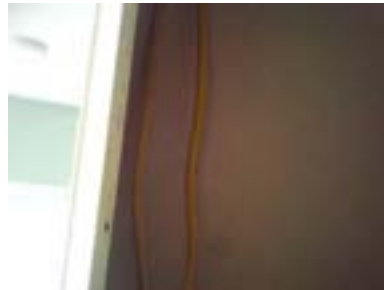
⌋ One or more wiring connections or wire splices are not in junction boxes or fully enclosed conduit; storage closet in living room, attic and open wires (enclosed in vinyl) in front closet which may consider a conduit chase or really should be behind walls.

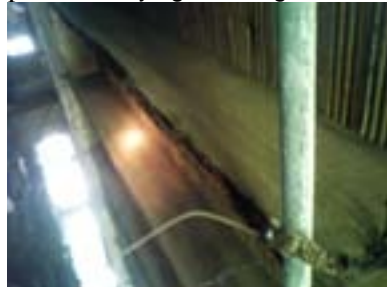
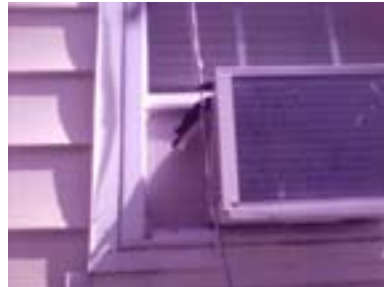
⌋ Wires lying on the ground, roof, under or around house;

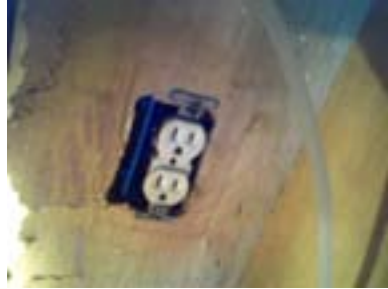
⌋ Observed one or more outlets, switches or electrical device installed through combustible material that are not flush mounted as required by code or is missing a plastic (fire rated enclosed spark ring) box at: may be others as seen under sink.

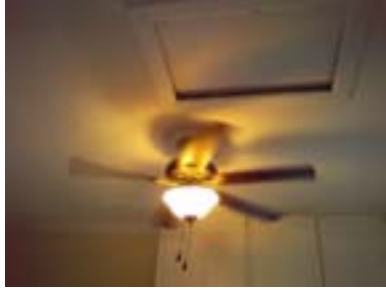
- ⌋ Ceiling Fans and/or light fixtures wobble or vibrate;kitchen,dinning room,

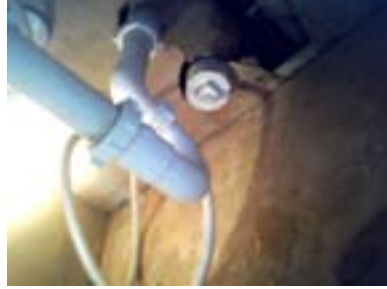
Leakage around sink(s) at: slight leak at kitchen p-trap which tightened and may have corrected.

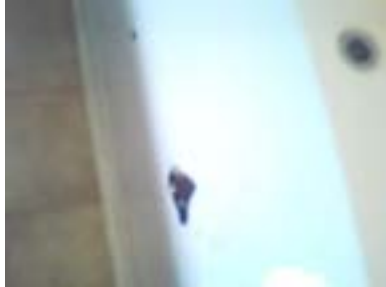
- ⌑ Drain stop is missing;
- Soap dish missing
- ⌑ Porcelain chips;

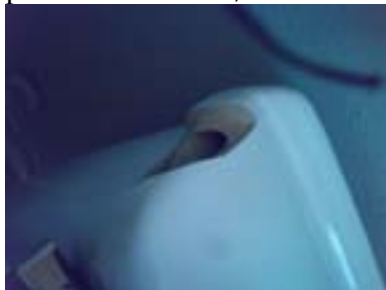
- Leakage around commodes;
- Seal leaking between tank & bowl;
- ⌑ Loose at floor mounting and may need reseating;
- Bowl or tank is cracked/damaged;
- ⌑ Flush mechanism operable,however must hold down to flush;
- Tank water level is too high;
- ⌑ Tank lid broken;

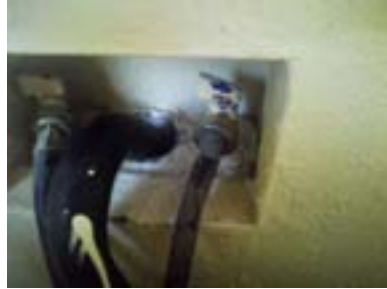
⌋ Washing machine connected at this time,however turned on for a short while - faucets, drains not tested for proper operation;

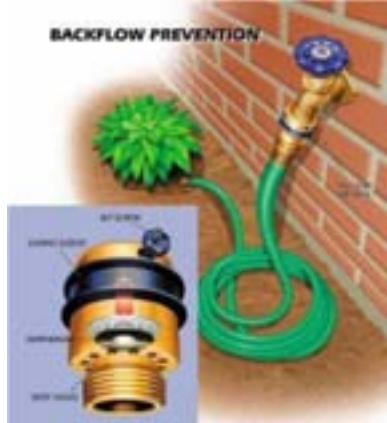
⌋ No backflow prevention at hose bibb(s):

- Faucet handles are loose, damaged, missing or just leak/drip at the nut or handle when the psi gauge is attached. This could be as simple as tightening,however not certain.
- Leakage or corrosion observed at:
- Insulation missing and/or needs reattaching;
- Sprinkler Anti-siphon is secure in ground or wall,however could/should be strapped to the wall or supported better.

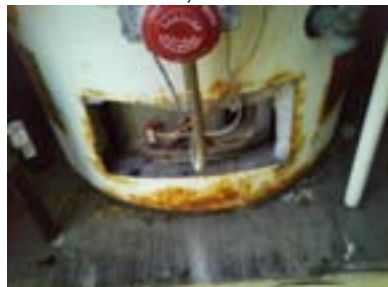
∩ Corrosion and/or signs of an intermittent leak at isolation valve, and/or plumbing connections or underneath unit; bottom rusted and most likely had water damage,

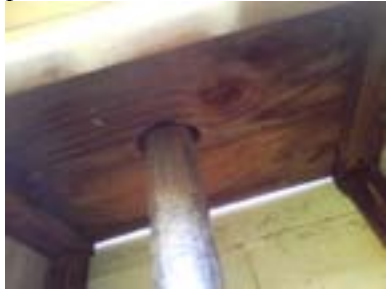
- .. Unit is located in a Garage or adjacent area and is not elevated so that its ignition source is 18" above the floor
- .. Unit was not in operation at the time of inspection. Hot water temperature was not checked, inspection limited
- .. Unit has no drain pan and/or drain line installed under the unit if on second floor, attic or next to an inside wall or unit blocking opening.
- .. Unit drain pan has debris in pan,
- .. Leakage around bottom of unit
- .. Leakage around connections
- .. Leakage around storm collar or flue
- .. Flue is loose, damaged or poorly connected;
- .. Hot and cold water lines reversed
- .. Unit is not properly vented for combustion air
- .. Cold water shut-off inoperable and/or missing
- ⌋ Flue is in contact or too close to combustibles;wood,

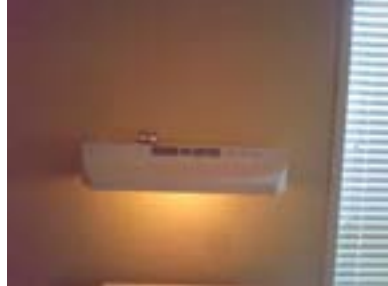
- .. Filter is dirty/greasy;
- .. Light not functioning;
- ⌋ Vent pipe terminates improperly or does not completely vent all air to the exterior. **The range is not the best system because it circulates the air back into the kitchen vs. to the exterior, however appeared to function at the time of inspection. Prefer the type system that takes the air to the exterior vs. recycling inside the house;**

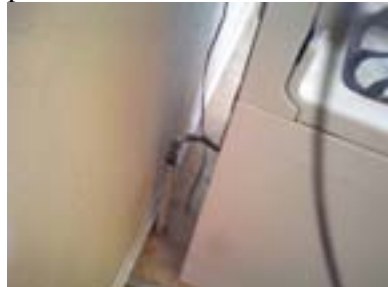
- .. Control knobs are loose,damaged and/or missing
- .. Gas leaks were detected around unit
- .. Burners do not operate at high and low settings;
- .. Absence of gas shut-off valve or improper location;(behind appliance).
- .. Inadequate clearance from combustibles
- .. Improper materials used for gas connections
- ⌋ Absence of anti-tilt device or should be tightened and secure;

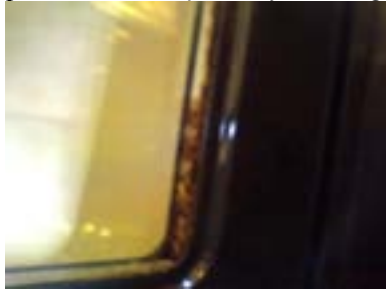
- .. Gas is off so could not confirm;
- .. Control knobs are loose and/or missing
- .. Gas leaks were detected around unit
- ⌋ Unit not securely mounted or loose in cabinet/counter;free standing;
- .. Broiler/heating element does not operate
- ⌋ Deficiencies;possibly allowing slight air around glass enclosure and debris in corner of glass,

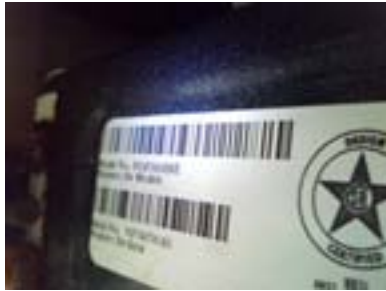
The oven is a FRIGIDAIRE unit and was tested by placing on 350F and checked two or more times with a Laser thermometer. Registered 334 F in the corner after the 10 minute timer was set and sounded.

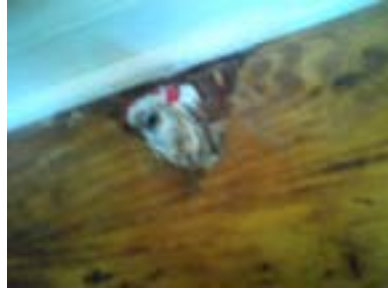
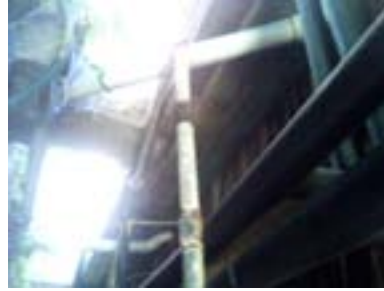
- .. May paint and protect gas line at meter where enters the wall;
- p Missing gas drip leg or sediment P-trap downstream of the equipment shut off valve as close to the inlet of the equipment on gas line, (G2419.4);water heater.
- p Gas shut-off valve;not capped at several on floor in house and some rust on lines under kitchen and water heater,

- Gas leaks detected around unit; may be at connection on gas line or at pilot housing if on outside of furnace or water heater;
- Absence of gas shut-off valve or improper location; (may be behind appliance).
