Summerwood Community

Houston, TX 77044

March 12, 2010

This Limited, Visual Inspection Report is prepared exclusively for

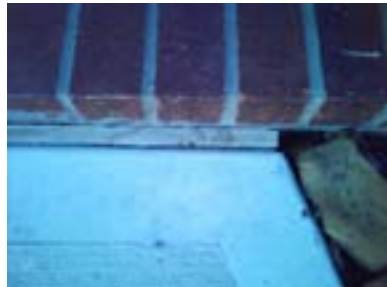
⌋ Wood form strips or other wood observed next to the slab which are conducive to wood destroying insects, which could be removed and replaced along with all cracks sealed with blown in foam covered with a thick layer of caulking; front.

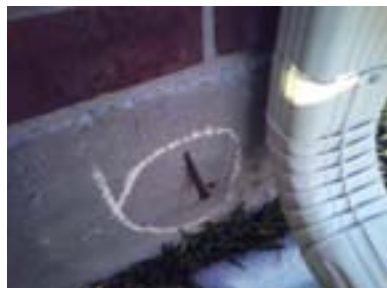
⌋ Nails or metal is exposed which could be a hazard and could be removed and covered; front corner.

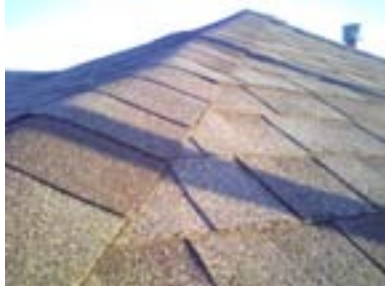
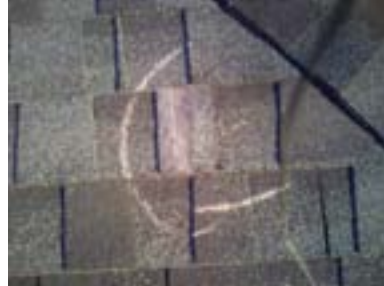
⌋ Some damaged,missing or raised shingles on ridges,valleys or throughout;a few lifts.

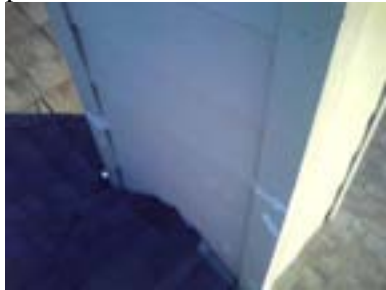
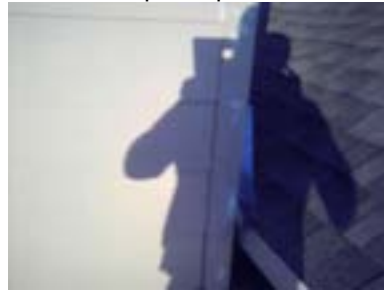
⌋ Trim, soffit, fascia boards are in need of repair;repaint and finish around chimney,

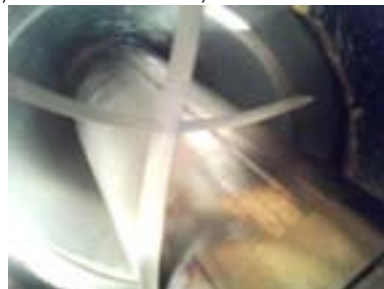
⌋ Storm collars are not caulked completely on furnace/water heater flues/chimney and/or could view daylight from attic access;chimney,down heater flue,

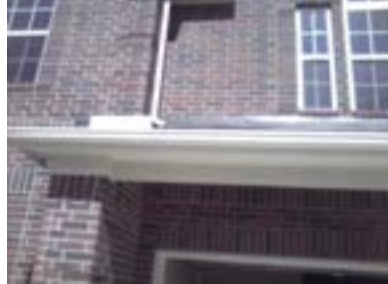
⌋ Flashing in need of repair or replacement; front over garage,

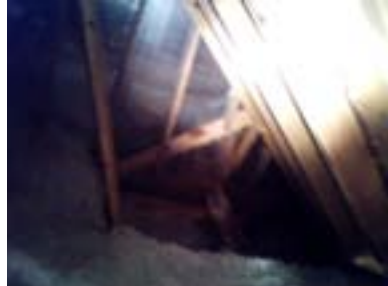
⌋ Step flashing is not in use (about 10 inch sheets) where a roof intersects at exterior wall which is the type approved per most manufactures (GAF) and J or L-flashing (long continuous sheet, which if water enters could run continuous) is in use;

⌋ The roof covering is in need of repairs or replacement, a Certified Roofing Company should be consulted

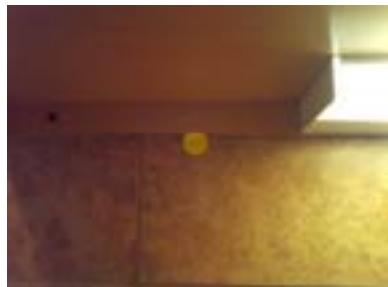
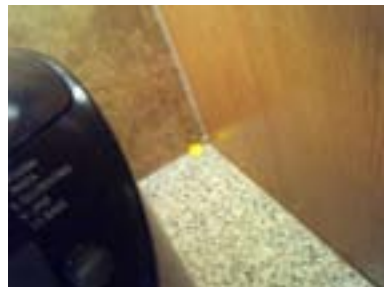
⌋ Caulking/sealant is separated or missing in some areas; shelves in pantry, right of dishwasher, top of backsplash around, end of cabinets, corners in kitchen, fireplace mantel and floor, molding trim all around to name some locations,

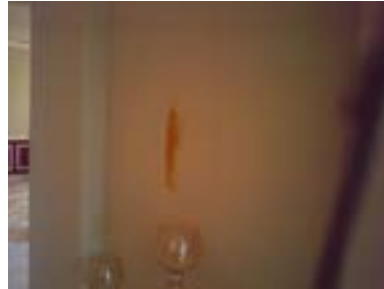
⌋ Observed several paint discolorations and scuff marks throughout the house;master bath,front dining,office entry wall,up bathrooms,

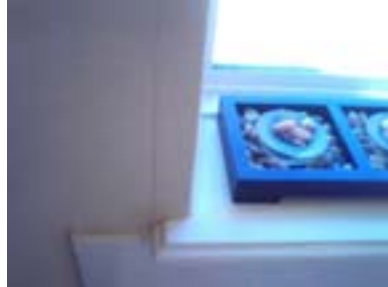
⌋ Observed several paint chips or sheet rock cracks throughout; some marked including under stairs,all around master bath window,living room corner,front entry on two columns,formal dinning sill,and top corner of most windows,office around windows,wine hall,laundry room corner,kitchen bedroom closet,few in upstairs front bedroom,over kitchen sink to name some areas.

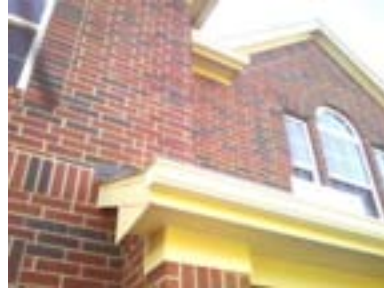
⌋ Mortar is separated or missing in some areas;between some bricks at corners,around windows,over garage,top,

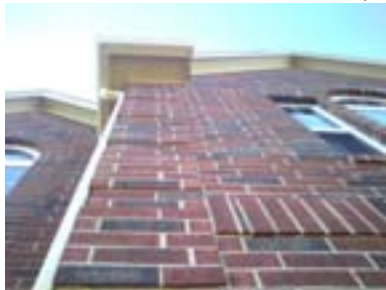
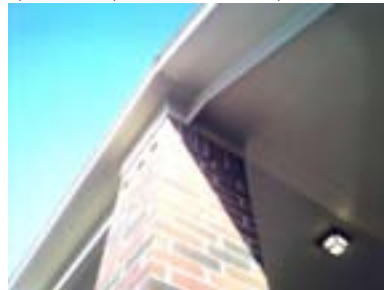
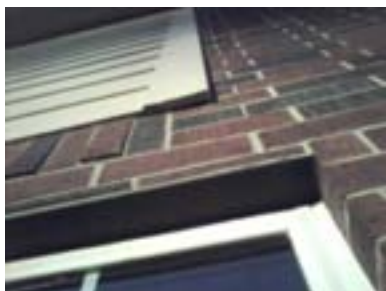
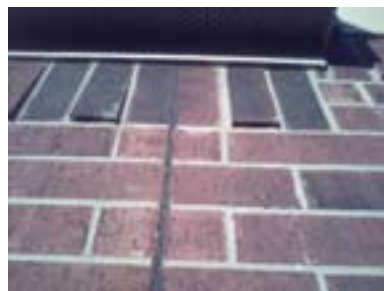
⌋ Caulking/sealant is separated or missing in some areas and should block/seal any and all openings between the wall and trim work;front,corners,back and trim,

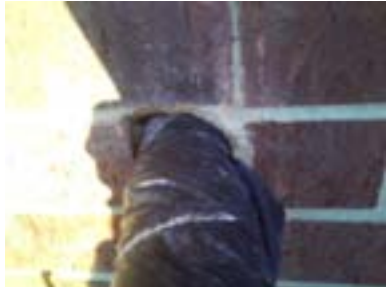
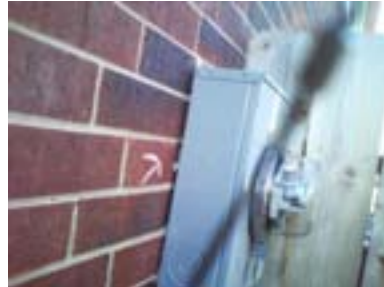
- .. Some above door and window lintels are rusted and should be sanded and painted.
- .. Weep holes not open and/or improper spacing of over 33" on center;
- .. Flashing missing over windows or window trim;
- .. One or more areas were obstructed by foliage and/or other items; all around should be cut back,

Note: All openings and penetrations around the exterior should be examined and improved as needed to provide a solid seal (caulk) against water penetration. This includes all trim, plumbing water and gas pipes, electrical boxes and air conditioning flashings that break the wall.

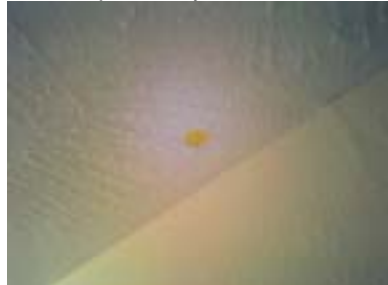
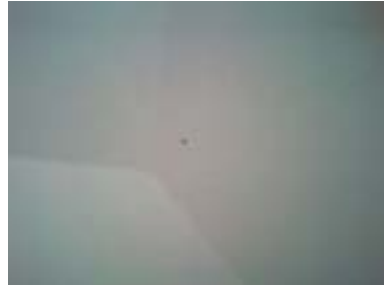
⌋ Nail pops in ceiling which could be addressed; master entry hall, front up bedroom, up back clothes closet, up hallway next to return,

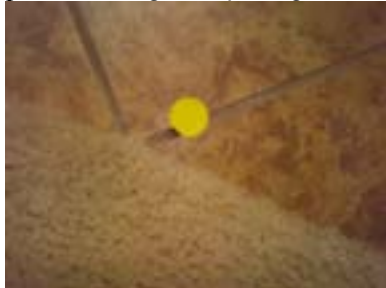
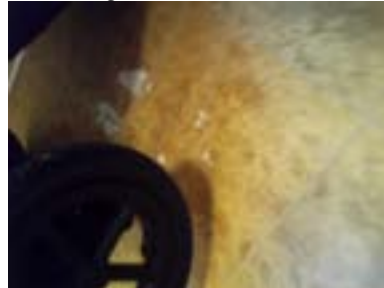
- .. Floor cracks, scratches, or grout/seal openings in some areas;
- ⌋ Stains or grout opening on floor;between grout in down shower room,laundry room,

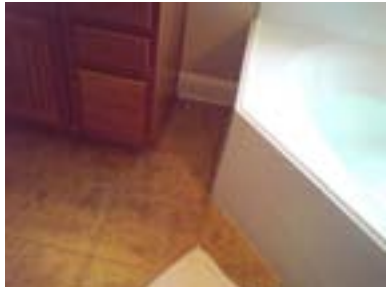
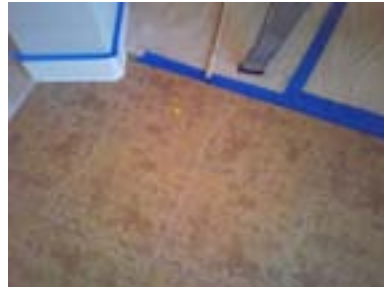
- .. Linoleum or floor covering is torn and/or some carpet trim is exposed or needed,
- .. Carpet and floor covering is stained and dirty throughout the house
- .. Freshly painted or stained floor
- .. Floors were uneven or creaked when walked across or warped/bowed in areas:
- ⌋ Observed tiles that sounded hollow when tapped with a hard object which is a result of lack of adhesive spread evenly underneath tile, loose tile, air pockets or water has penetrated underneath the tile. Discovered 1 or more in the front entry, 0 or more in the kitchen, 0 or more in laundry, 2 in master bathroom and 1 or more in corner behind sink island (very minor at corners).

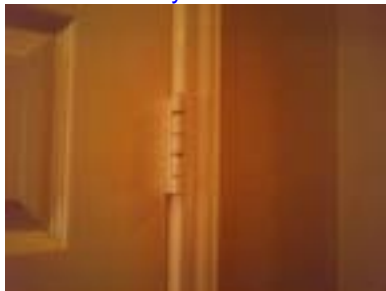
- ⌋ Observed that the automatic self closing device/hinge required by current IBC (International Building Code) on the door between the house and the garage needs adjustment to operate properly or is not present. [This is recommended to help prevent fumes in the garage from entering the living area and to ensure is always fire blocked.](#)

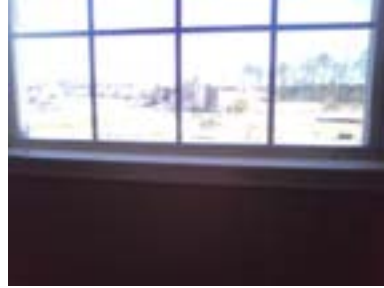
- Some window lift supports are loose, damaged, (popped out) or missing at:
- Some missing or damaged trim or latches at: trim turned in office, middle game room out of square,

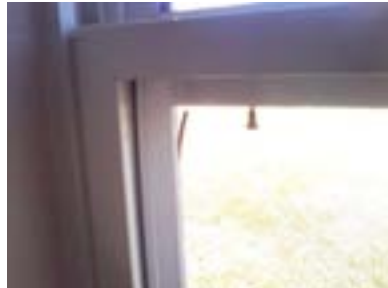
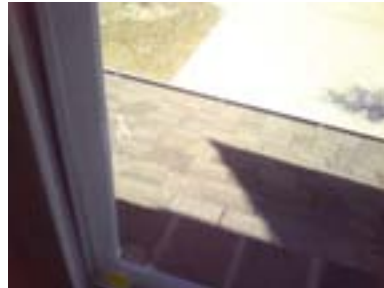
- Some missing and/or damaged screens at: top of laundry bedroom, up front bedroom on 2 screens and some screen pulls are not working properly in several rooms, 1 in living room pulled out when checked,

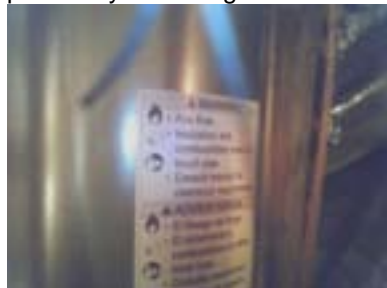
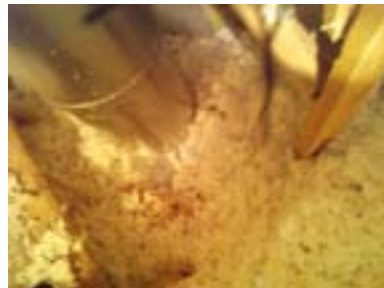
⌋ Currently the chimney flue is accessible. Building insulation in contact with a metal chimney can cause hot spots that can burn out over time. Contact the chimney manufacturer for exact requirements. In the absence of the manufacturer's requirements, a free space of at least 2" is recommended to all construction materials and insulation should be remedied for safety against the possibility of damage that can lead to a fire if determined the chimney is in contact.

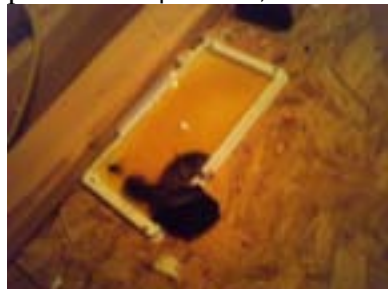
- .. Fence is showing signs of wood rot or pickets are warped, leaning or falling off:
- .. Gaps underneath the fence that should be addressed:
- .. Observed a dead tree which should be removed or monitored to ensure does not fall on house:
- .. Address not visible from the street or road:
- .. Observed gate locks do not latch properly and should be adjusted:
- .. Some debris or bricks are leaning against the house/garage:
- .. Some bricks are stacked in garage and would be a good idea to spread the load;
- þ Some wasps nests, insects or ant beds were observed at:mice dead in attic,

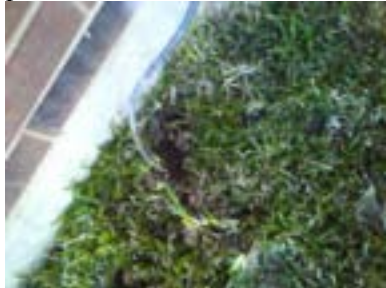
- ⌋ Ground wire/rod could not be verified or buried in ground;

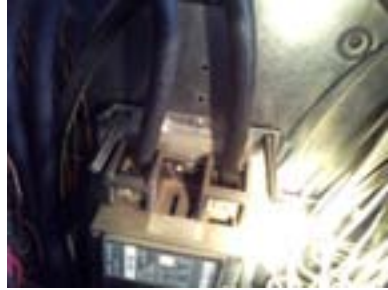
⌋ Lack of anti-oxidant grease on the aluminum service entrance conductors from the power company;both top and neutral lead.

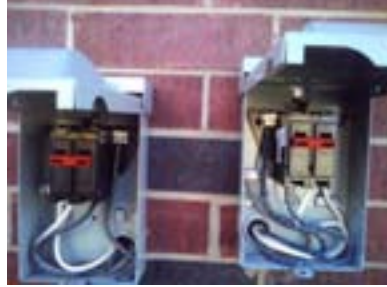
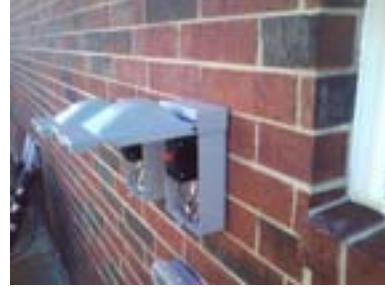
Observed the A/C disconnect(s) over the A/C unit has the line load consistent or correct. The line side (this panel is the TOP wires per the diagram) should always be the hot wire and load should be neutral and this one is consistent. Should silicone around ac disconnects.

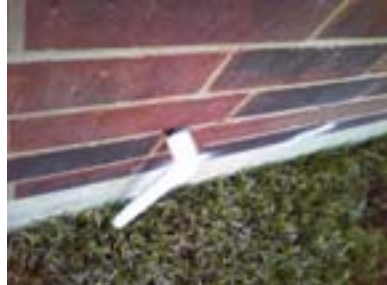
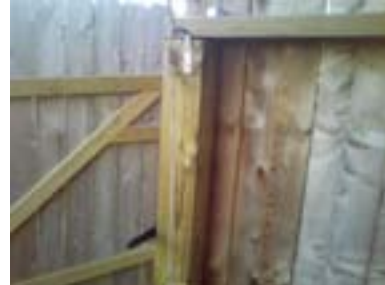
Ⓟ One or more wiring connections or wire splices are not in junction boxes or fully enclosed conduit; wire slightly exposed at sprinkler wires on wall and may protect sensor wires.

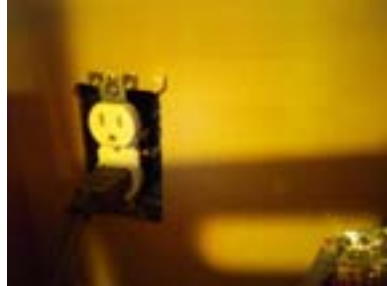
Ⓟ Observed one or more outlets, switches or electrical device installed through combustible material that are not flush mounted as required by code or is missing a plastic (fire rated enclosed spark ring) box at: may be under sink as seen above range;

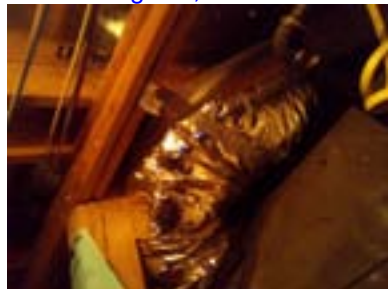
⌋ Ducting is kinked or restricted in one or more places which may be affecting airflow or found a heat differential less than 8 degrees per room at:The heat was set on high as would go and ran for about 10 to 15 minutes and registered from **103 to 115F downstairs and office and master bath 115 and others around 103/105F and 119 to 129F upstairs** using an infrared thermometer and testing each register;

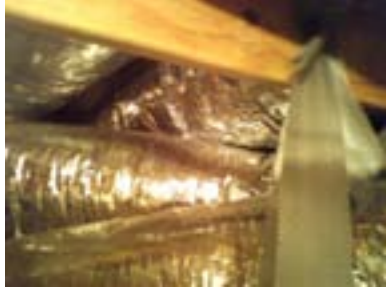
- Return air plenum is open inside and/or wires, plumbing pipes which may be allowing air to escape and could be enclosed with duct board for increased efficiency and cover wires/pipes even when on an interior wall.
- ⌋ Ducting is lying on the attic floor or resting against each other throughout the attic which should be well suspended throughout the attic;

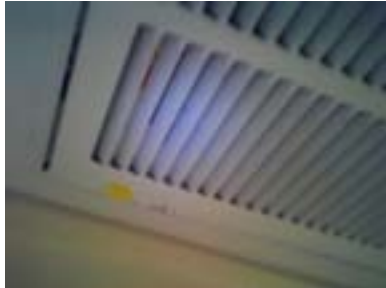
- ⌋ **Return air filters are present throughout the house and should be replaced because are dirty or torn at:**

- ⌋ 12x12x1-media room dirty ⌋ 12x24x1-master ⌋ 16x25x1-master entry hall and laundry hall which both clips are not latching properly, ⌋ 20x25x1-up hall is dirty • 20x30x1; • 20x25x4-in line/attic;

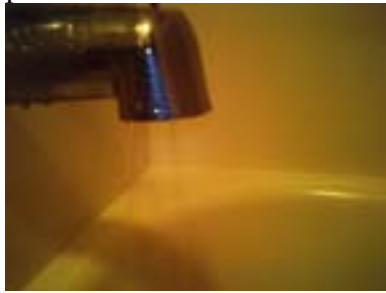
- Leakage around tub(s)
- Faucets have low water pressure
- Water hammering noted
- Leakage around shower(s)
- Absence of safety glass enclosure
- ⌋ Shower head is leaking;master,
- .. Shower head is loose or missing;
- .. Shower or tub has rust behind drains/faucets,
- .. Hot and cold water reversed;
- Loose/damaged faucet handles
- Improper slope of shower floor
- .. Tile loose and/or missing;
- Shower diverter valve not operating
- ⌋ Shower diverter valve allowing water from tub faucet when shower is in operation;upstairs,

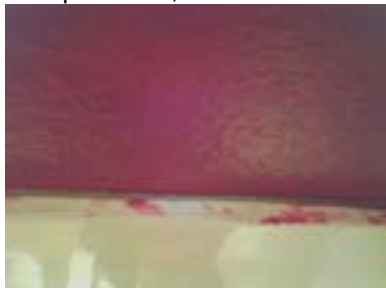
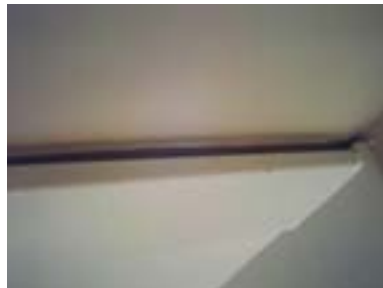
- .. Enclosure needs to be sealed;or bottom drip guard damaged;
- .. Shower walls with installed shower heads shall be finished with a nonabsorbent surface (tile, fiberglass, etc.) not less than 6 feet above the floor,(R307.2);
- ⌋ Caulking or grout in need of repair;over both downstairs showers and slight up between wall and top surface;

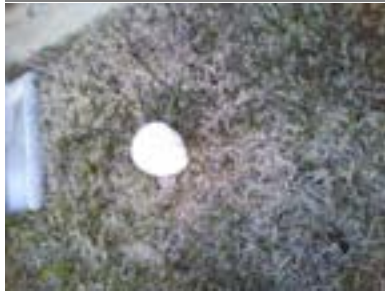
Main sewer cleanout is located Ⓟ Front corner and should not be exposed to elements;paint;

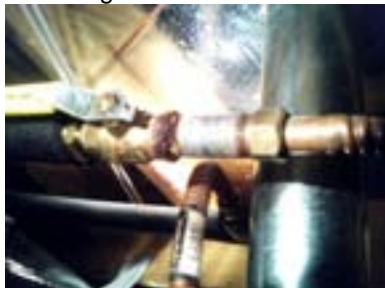
Ⓟ Corrosion and/or signs of an intermittent leak at isolation valve, and/or plumbing connections;right heater right connection.

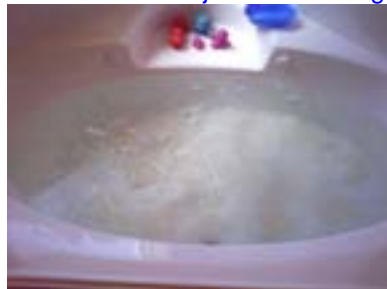
⌋ The motor for the hydrotherapy tub was not accessible, thus not visible for inspection. Proper grounding/bonding could not be verified. Ideally a readily operable inspection door should be provided in order to access the whirlpool motor.

Operated the jets for several minutes and checked for GFCI,leaks and all other accessible items and confirmed that 6 jets are working including the suction;

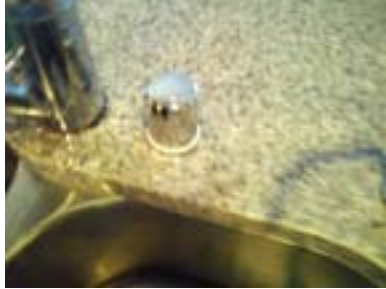
- ⋮ Unit leaking
 - ⋮ Unit hardwired (should be plug device)
 - ⋮ Anti-siphon loop at the drain line is missing and/or the loop is not tacked high enough to keep the waste water from backing into the dishwasher;
 - ⋮ Soap dispenser not functioning properly, missing rack rollers or sprayer parts missing.
- ⌋ Unit is slightly loose in cabinet and most likely needs tightened and the vent cover is a little loose,

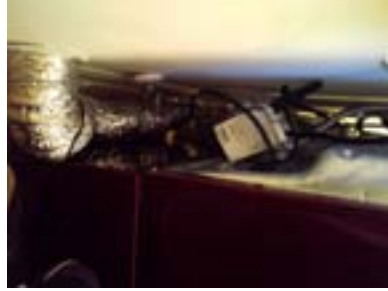
- .. Dryer vent cover is loose, damaged and/or missing
- .. Dryer vent is not vented to the exterior wall or roof;or did not view/confirm,
- ⌋ The dryer hose is too long and seems to be bunched/kinked or clogged. May want to shorten.

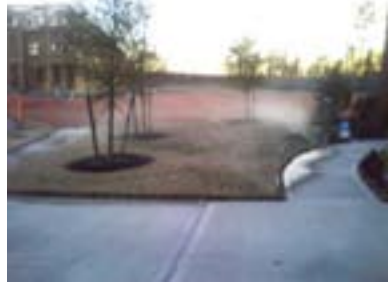
STATION 1:

Observed about 11 total heads at; front yard;

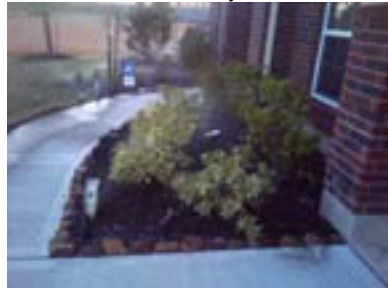
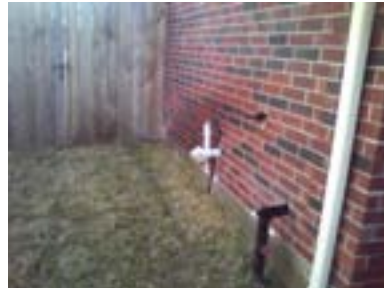
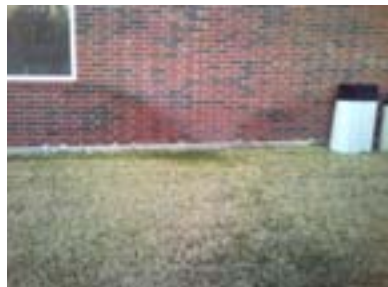
STATION 2:

Observed about 12 total heads at; 10 in front beds and 2 on west side yard and those spray the wall which should be adjusted;

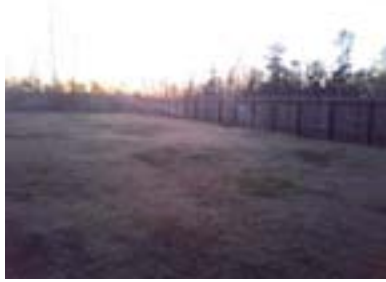
STATION 3:

Observed about 6 total heads at;back fence;

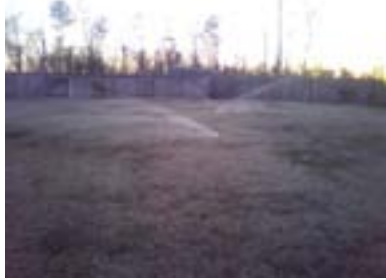
STATION 4:

Observed about 6 total heads at;back center and west back;

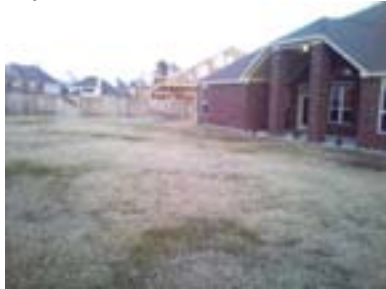
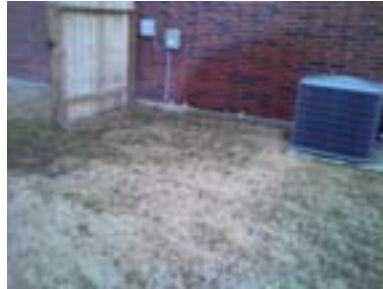
STATION 5:

Observed about 7 total heads at;back center and east side and side spray the wall which should be adjusted;

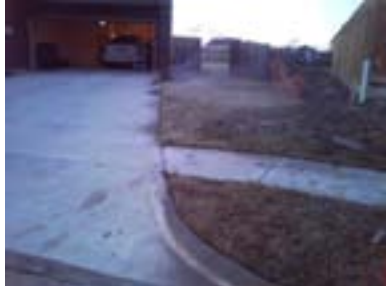
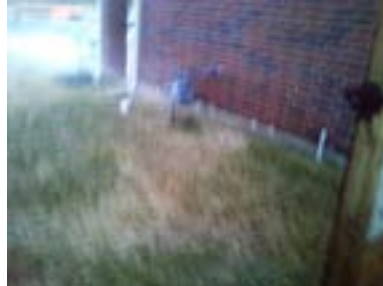
STATION 6:

Observed about 6/7 total heads at; east side and several spray the wall which should be adjusted;

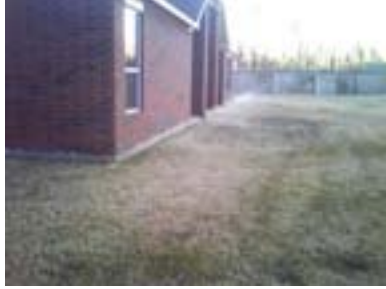
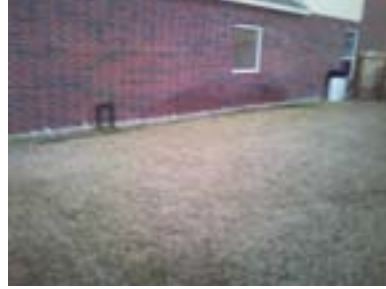
STATION 7:

Observed about 13 total heads at;back by house and east back side and a few spray the wall;
